RISER SYSTEM WEAR – AN UNRECOGNIZED DRILLING RISK

Tom Prosser – Maurer Engineering Inc.

Copyright 2001 AADE National Drilling Technical Conference

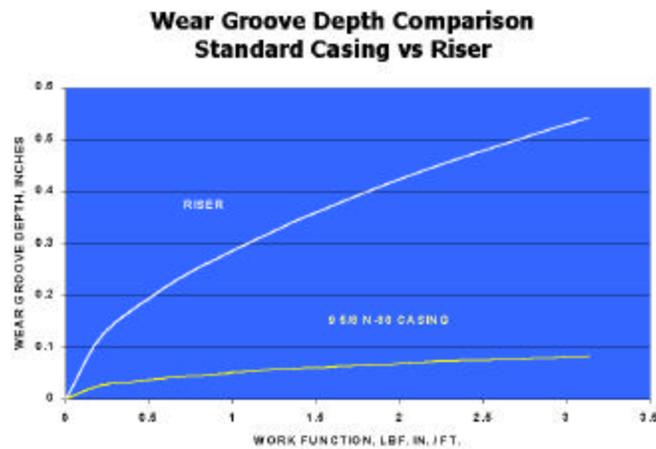
Fig.3

However, a test was run on a small section of the failed riser, and it was found to wear at a rate 15 times faster and produced almost 5 times more wear than N-80 (Figure 3). Since the contractor had operated prudently,
