# **Analysis of High-Collapse Grade P110 Coupling Failures**

Michael G. Burns, P. E., Stress Engineering Services, Inc., Houston, Texas USA

Keywords: Grade P110, couplings, hydrogen stress cracking, high-collapse

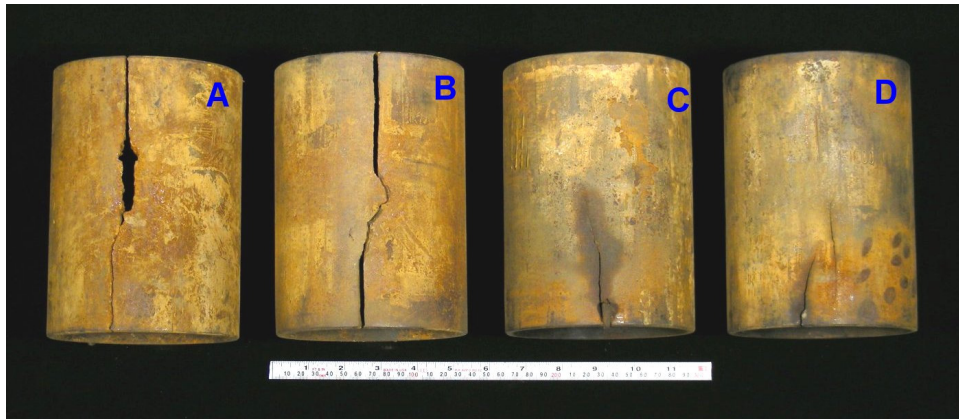
Figure 1 Four cracked couplings from a single casing string.

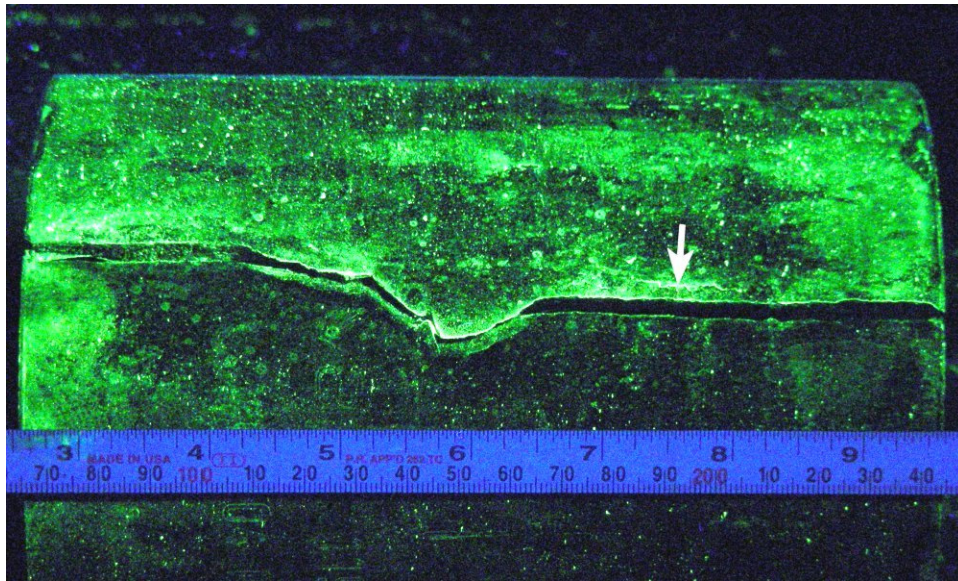
Figure 2 Wet fluorescent magnetic particle indication, arrow, at a secondary crack.

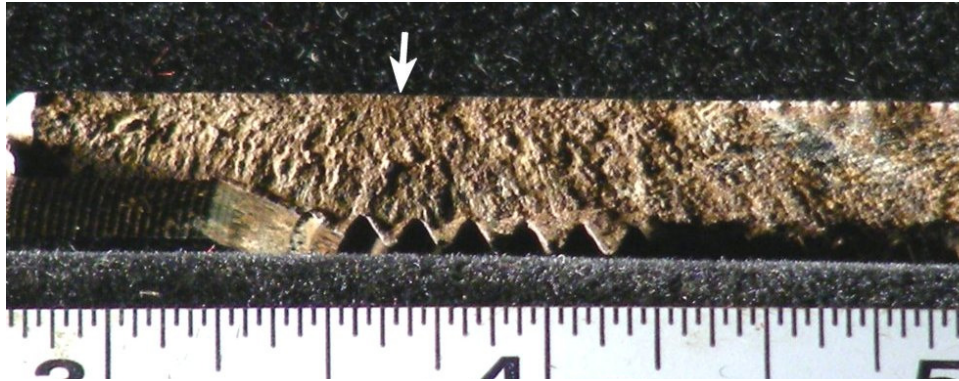
The fracture surface generally shows an area of brittle fracture radiating from a location on or near the outside surface approximately 1-inch from the end of the coupling, which is the most highly stressed location in a coupling. The fracture origin may be elsewhere, particularly if the coupling has mechanical damage or a significant metallurgical issue. The fracture surface may or may not show multiple origins. In couplings with satisfactory CVN toughness, the balance of the fracture surface is generally slanted, ductile fracture. Chemical analyses of the brittle fracture by energy-dispersive spectroscopy (EDS) rarely provides definitive evidence of iron sulfide: sulfur is either not detected or is detected in concert with barium, which only indicates contamination with barium sulfate from drilling mud. The presence of iron sulfide is understood

*Figure 3 Typical crack surface, with an arrow indicating a crack origin.*

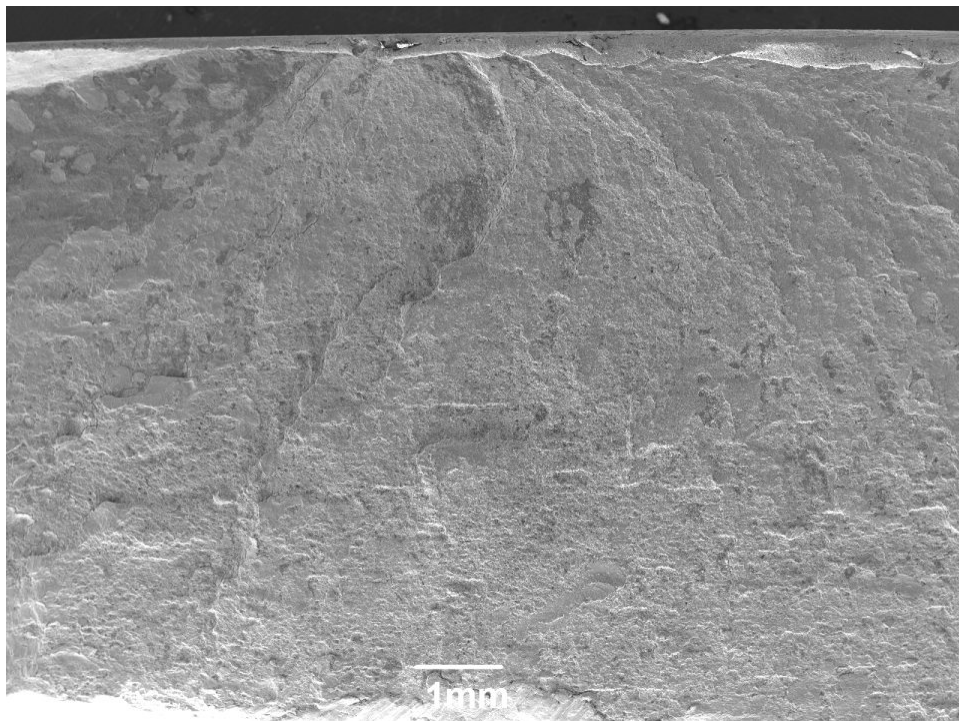
Examination of the fracture surface with a scanning electron microscope (SEM) shows brittle fracture at the origin. The brittle fracture may be intergranular or transgranular quasi-cleavage fracture, but is most commonly a mixture of the two.

*Figure 4 SEM image of a fracture origin (top).*

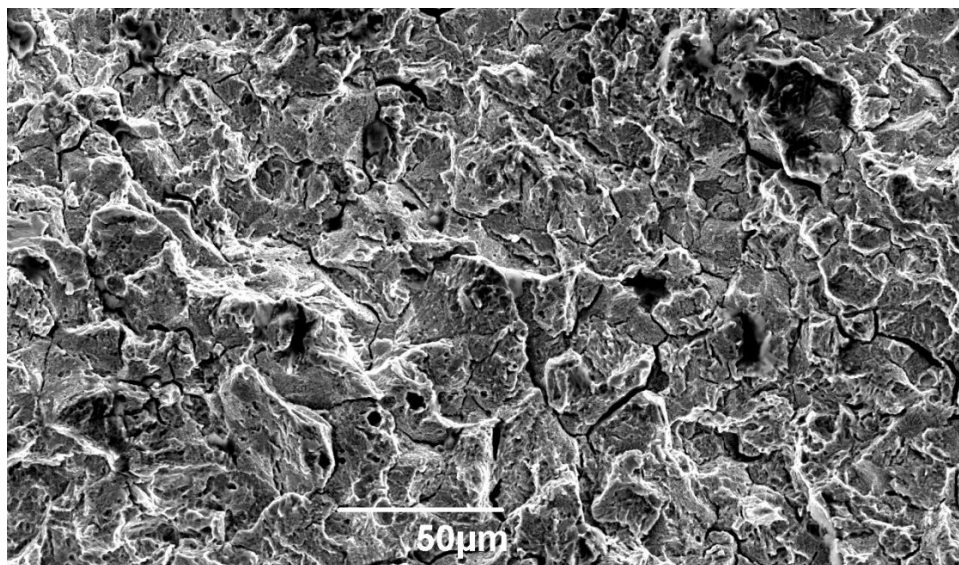
*Figure 5 SEM image of brittle fracture near a fracture origin.*

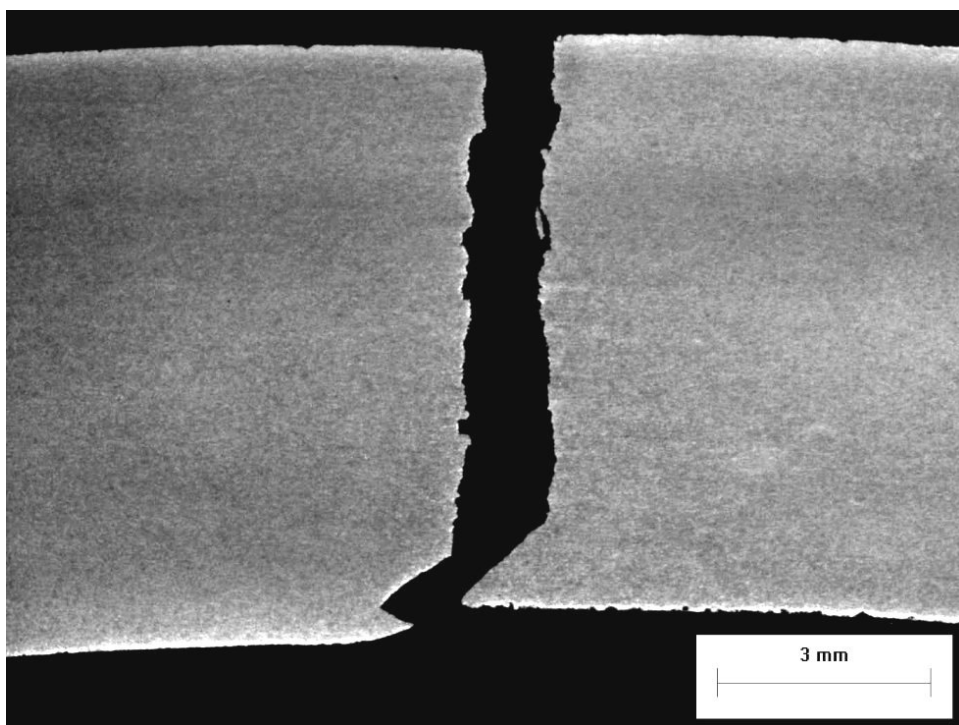
Metallographic examination of the fracture profile generally shows a brittle radial fracture with a shear lip on the inside surface. There may also be a shear lip on the outside surface, indicating a subsurface origin. Branched cracking may be present, but is generally quite limited.

*Figure 6 Transverse matched-fracture metallographic section at a fracture origin.*

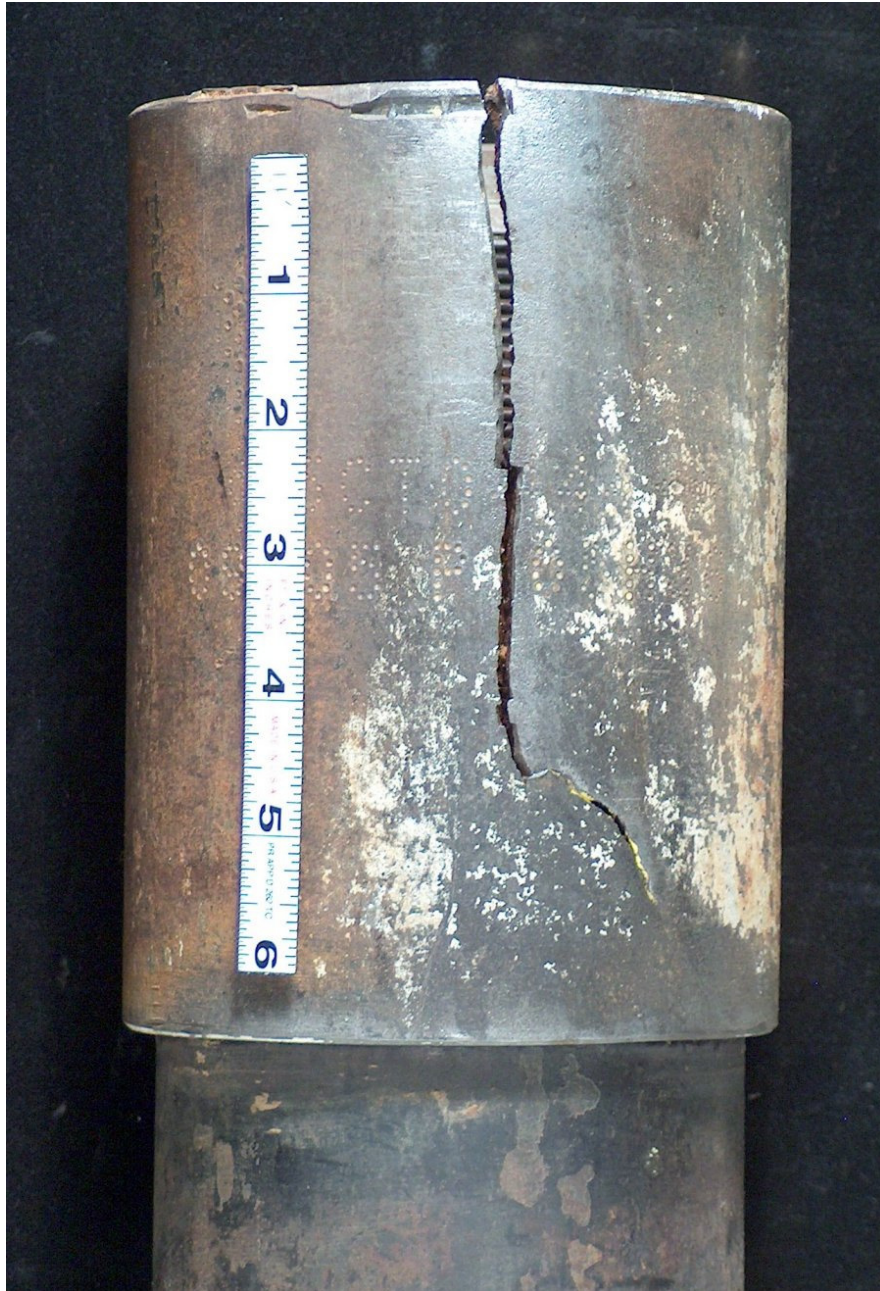
Cold work due to mechanical damage is particular injurious to Grade P110 couplings.

*Figure 7 Grade P110 coupling failure that initiated at mechanical damage, shown at the top.*

Even if the damage is insufficient to cause an immediate failure, the cold-worked metal at the damaged location is much more susceptible to hydrogen-stress cracking, and superficial corrosion can generate enough atomic hydrogen to crack such highly susceptible steel.

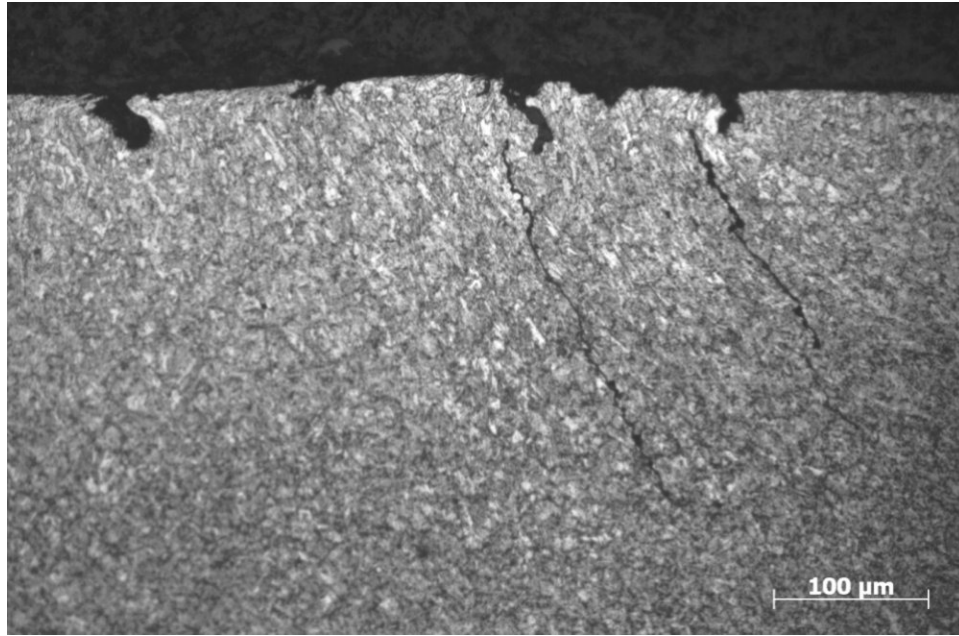
*Figure 8 Photomicrograph of cracks initiating at pits in a cold-worked layer on the surface of a Grade P110 coupling.*

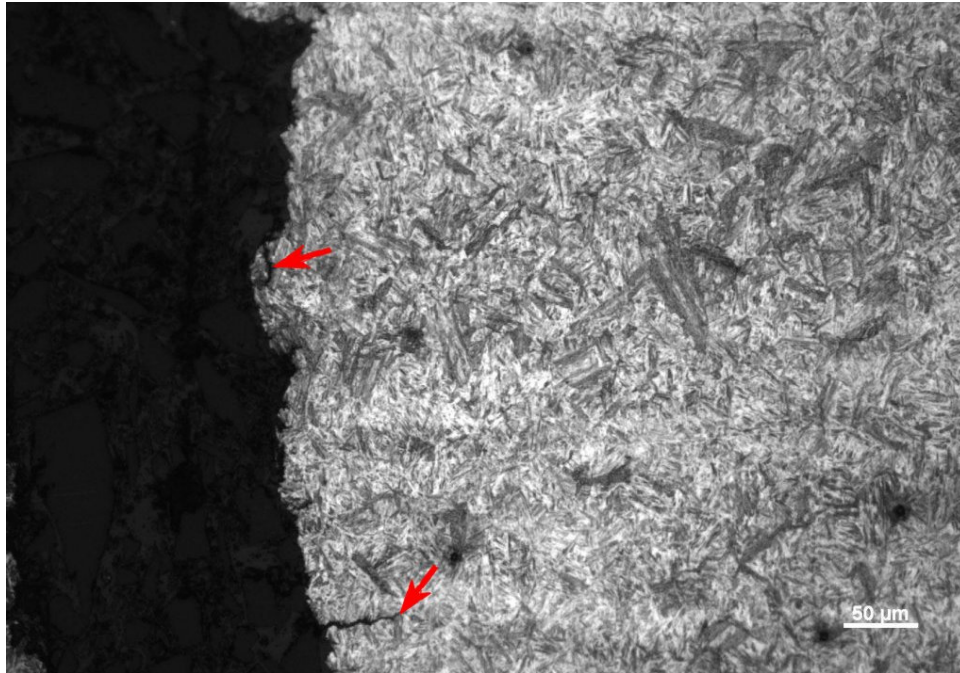
Failure to properly quench and temper Grade P110 can also increase its susceptibility to hydrogen stress cracking and brittle fracture. One of the peculiarities of Grade P110 is that it often contains enough alloy content to be air hardening, and normalized coupling stock may exhibit satisfactory yield strength and tensile strength, and typical hardness for Grade P110. However, the Charpy values of a coupling inadvertently machined from coupling stock that has not been quenched and tempered will be quite low, as will be its resistance to hydrogen-stress cracking. Likewise, failure to temper a coupling will result in a hard microstructure with very high susceptibility to brittle fracture and hydrogen-stress cracking.

*Figure 9 Photomicrograph of untempered martensite in a cracked coupling.  
Arrows indicate secondary cracks.*

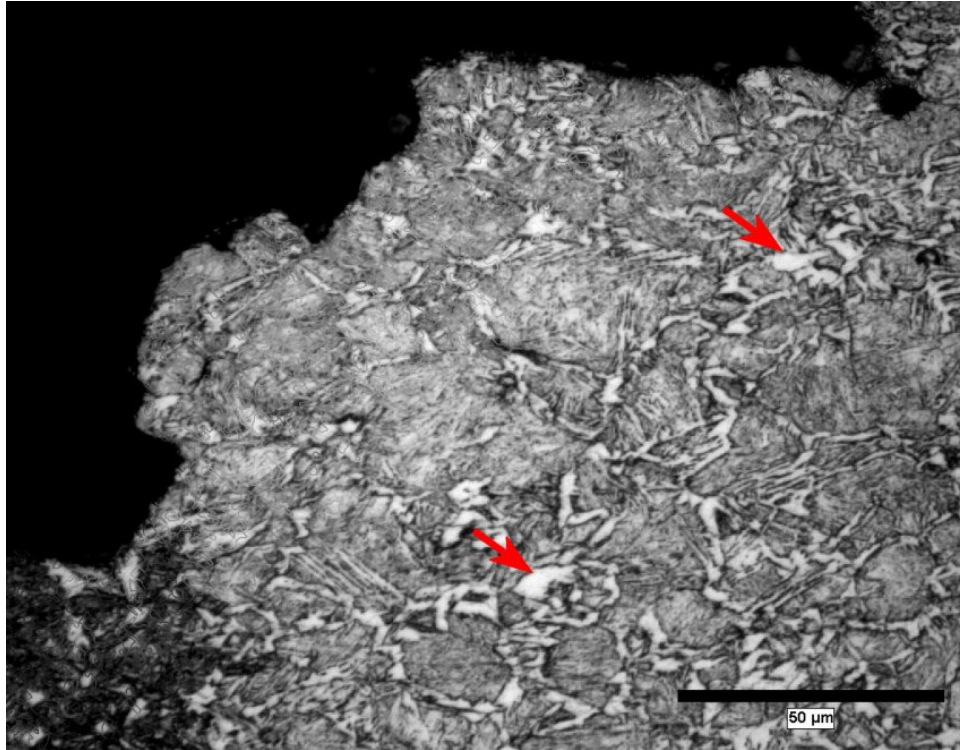
A less obvious heat treatment error is inadequate austenitization. If the coupling stock does not get hot enough during austenitization, or is not held at temperature long enough, residual ferrite may remain, resulting in a mixed microstructure upon subsequent quenching and tempering. It has been well-established that, at a given strength level, a uniform microstructure of tempered martensite shows optimum resistance to environmentally assisted cracking.

*Figure 10 Photomicrograph of ferrite, arrows, in a cracked Grade P110 coupling.*

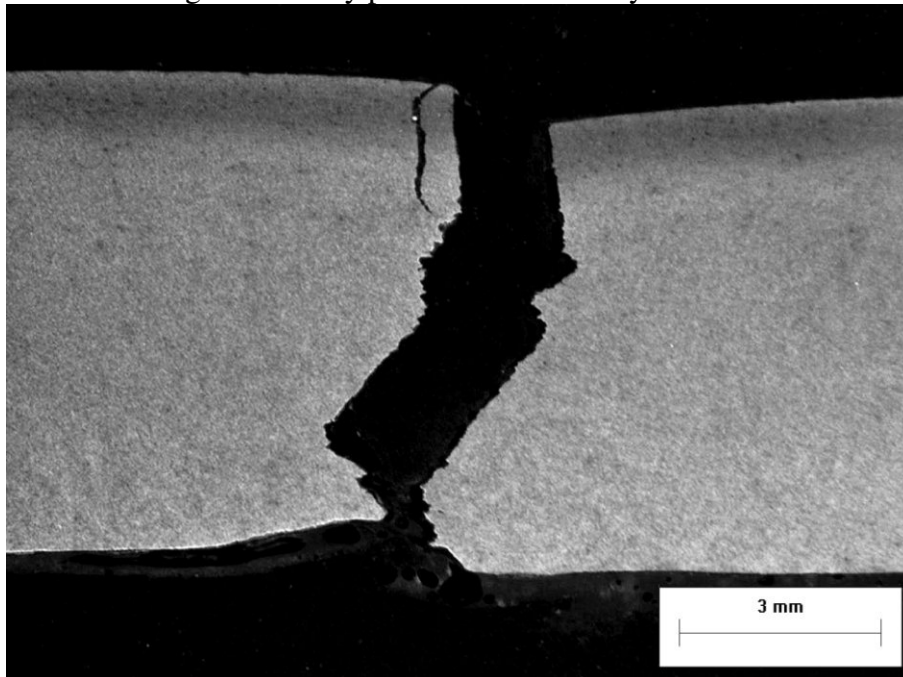
Local variations in microstructure and hardness, due to localized heating, may also affect the susceptibility of a coupling to hydrogen stress cracking. Specifically, hard spots show higher susceptibility to environmentally assisted cracking and may fail in environments where satisfactory Grade P110 might ordinarily perform satisfactorily.

*Figure 11 Photomicrograph of cracking initiating in a hard spot.*
