PDC Corrosion Resistant Cutter Testing and Validation in the Permian

Greg Andreasen, Chad Conry, Ron Eyre, Fen Yu, Paul Higgins, Mike Siracki and Neil Chaney, SLB

Copyright 2023, AADE

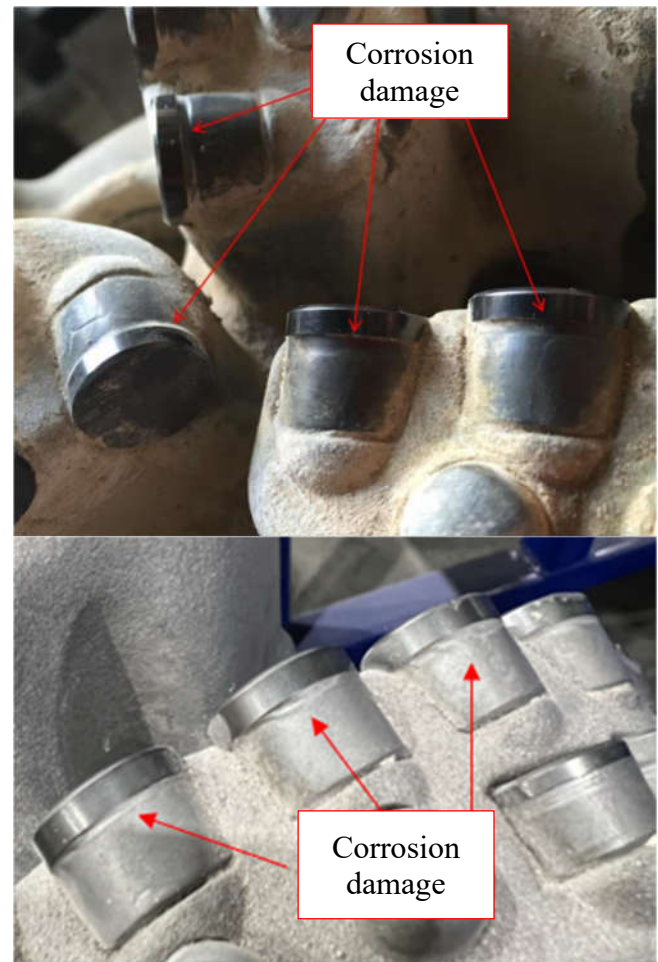
Even as companies have transitioned to the more efficient Polycrystalline Diamond Compact (PDC) type bits, corrosion from the brine-enriched environment remains a problem. The corrosive environment attacks the interface between the tungsten carbide substrate and the diamond table. *See Figure 1.* The corrosion removes a thin band in the tungsten carbide behind the cutter resulting in the diamond table being unsupported and leading to premature cutter breakage. This substrate damage from corrosion has been observed on all the cutter types and shapes run in the Permian.

Figure 1 PCD cutters with corrosion damages after drilling service

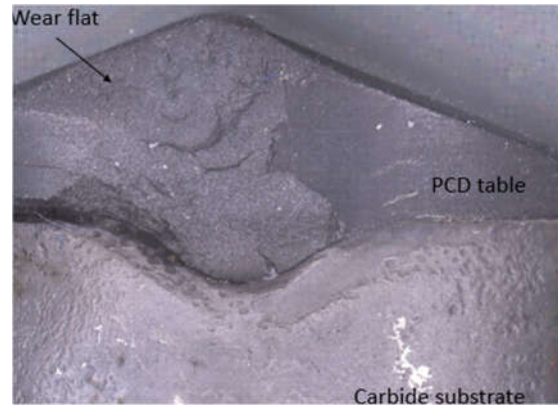
In one cutter sample, separation between the PCD table and the carbide substrate was evident (Figure 3). Internal cracks initiated from the tip of separation (Figure 4), resulting in PCD fracture in the bottom of PCD table. The damaged carbide substrate was studied by the scanning electron microscopy (SEM). The microstructural observation indicated cobalt was leached out of the carbide material in the work area of the cutter, resulting in a loosely bonded skeleton of tungsten carbide grains (Figure 5). The cobalt leaching was attributed to corrosion. Understanding the impact corrosion had on the cobalt layer and the detrimental effect it caused to the cutter's strength and integrity allowed for an enhancement of the chemical composition of the substrate.

Figure 3 Side-view of a dull cutter

proprietary new binder solution for the WC substrate which is more passive than cobalt and was introduced to replace the original cobalt-based binder. The cutters built on modified substrate material showed much improved corrosion resistance in the paired cutter tests, as shown in Figure 9.

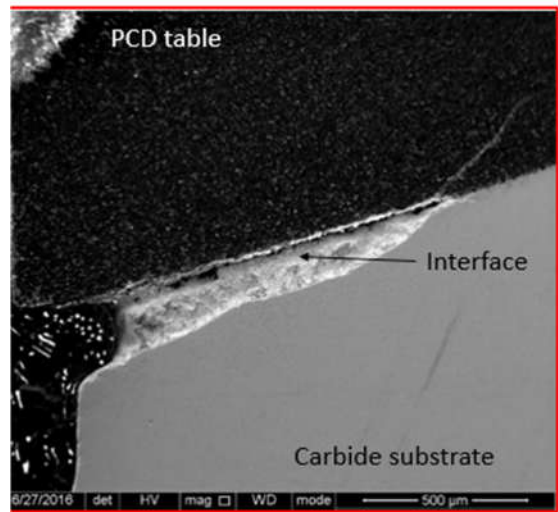
Figure 4 Cross-sectioned view of a cutter with damage along the cutter interface

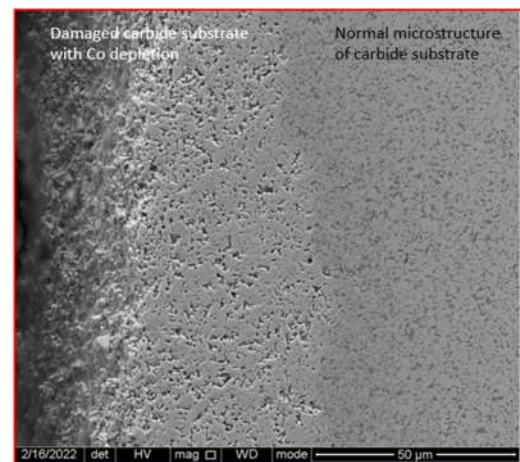
The electrode potential of cobalt in the current substrate material was -0.28 volts. As a result, the team chose to create a

Figure 5 SEM image showing the microstructure of damaged carbide

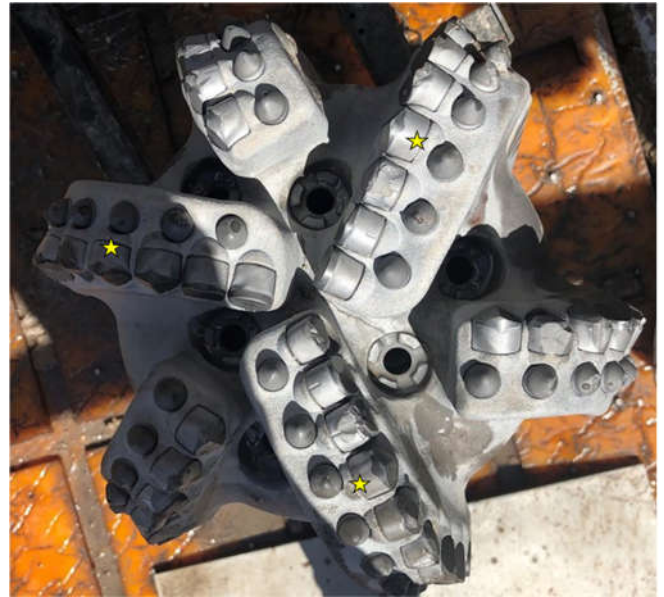
The condition of the corrosion resistant cutters compared to standard cutters was telling. The corrosion resistant cutters displayed little to no damage as compared to non-corrosion cutters on either side. Figure 7 and 8 show the overall condition of the bit.

Figure 7 Condition of Dull after run. Yellow stars designated corrosion resistant cutters

These cutters were sent back to the cutter vendor for further analysis. Their analysis confirmed that the corrosion resistant version did not show any signs of corrosion (Figure 7 & Figure

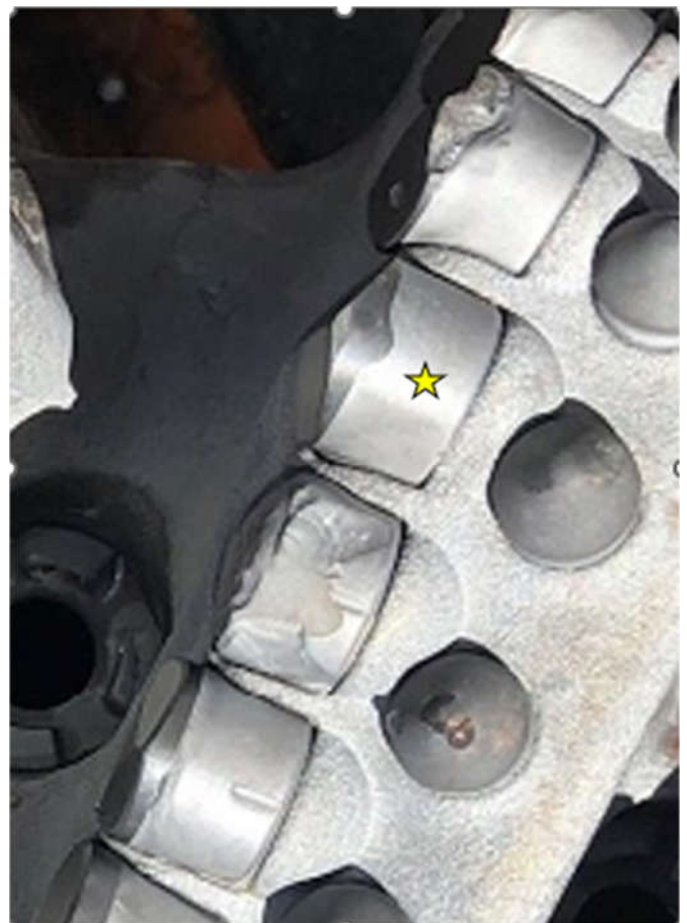
Figure 8 Close up view of cutters

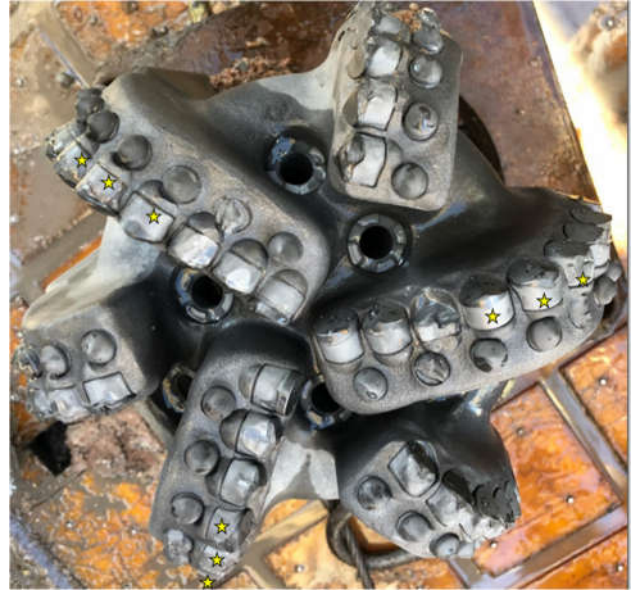
The second test followed a similar trend. The bit was able to drill 6,745 ft, an improvement of 21% over the offsets. The run also finished in 60 hours for an overall ROP of 113 ft/hr, a 20% improvement over the offsets. The corrosion resistance cutters showed again to be great shape as compared to their non-corrosion resistance counterparts. Placement further out on the shoulder improved overall durability, resulting in the bit drilling more footage with an improvement in ROP and a better dull condition as shown in 11 Figure 11 Dull condition of 2nd corrosion resistant cutter test. This further confirmed and validated the development of the corrosion resistant cutter.

Figure 11 Dull condition of 2nd corrosion resistant cutter test
