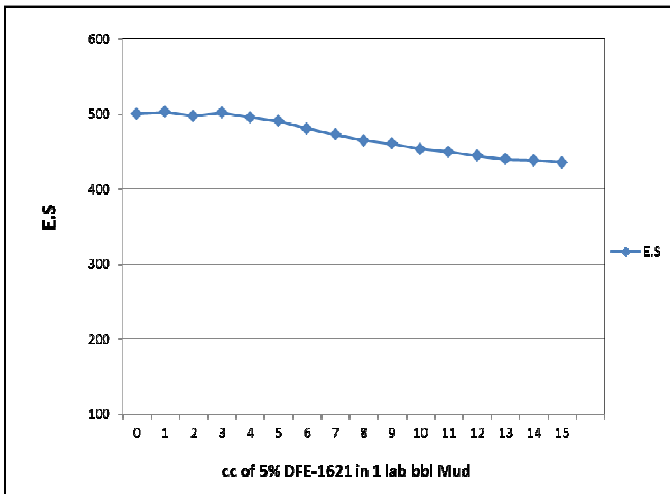
Figure 8: The effect of MCP contamination on the ES of the mud. No adverse affects is observed in the event of accidentally contaminating the mud with MCP.

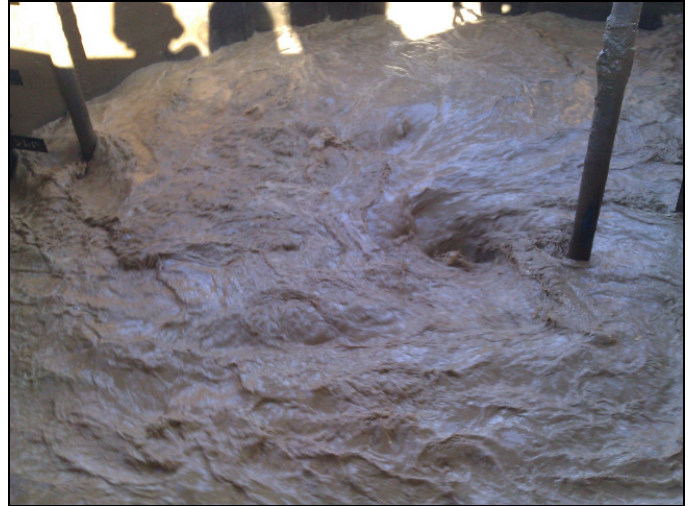
Figure 10: MCP mixed inside the tank and agitated using the gun lines.

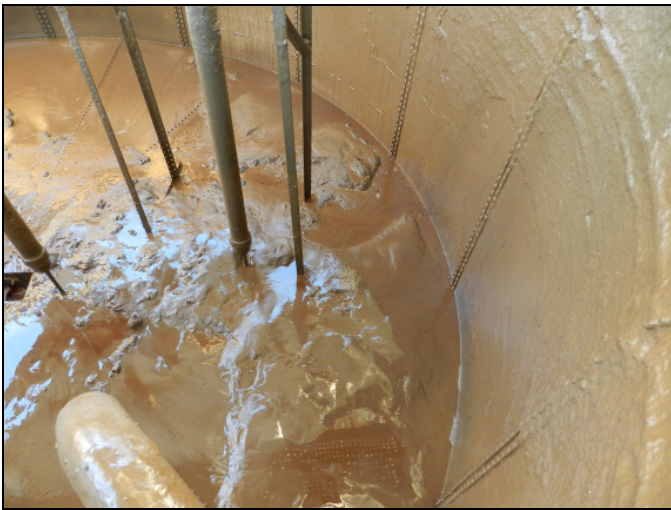
Figure 9: Oil-based mud residue settled in the mixing tank. Areas inside the tank have large sediment deposits accumulated over a period of time.

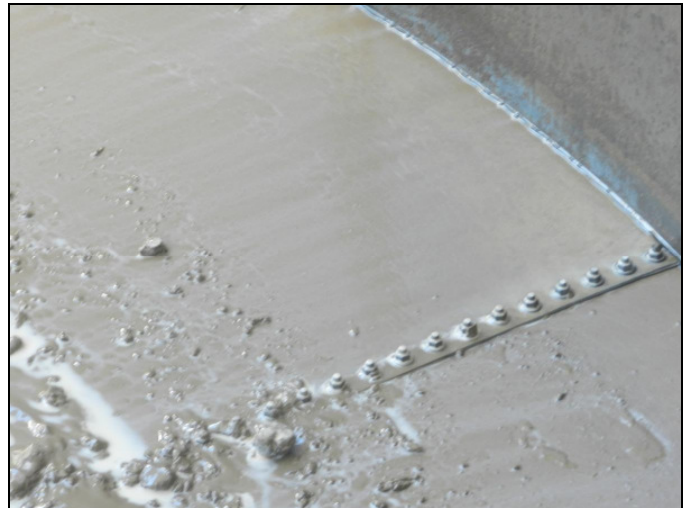
Figure 11: Inside the tank is considerably cleaner with solids easily dispersed in water.

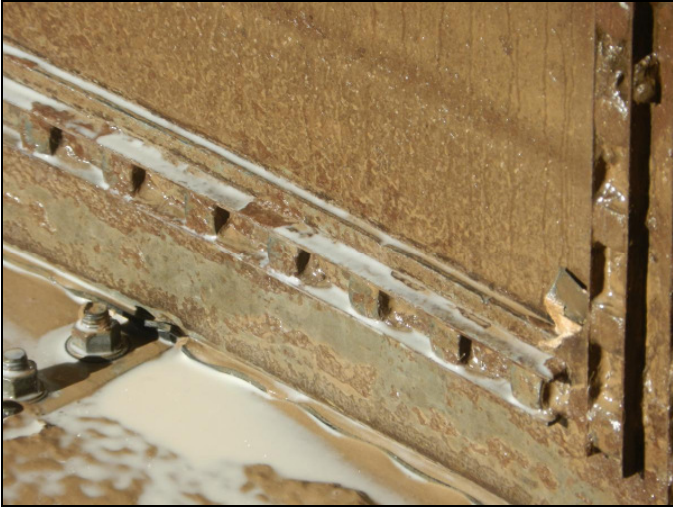
Figure 12: Sides inside the mixing tank where there was maximum agitation were completely free from oil-wet sediments.
