## AADE-11-NTCE-31

# Prevent Rotary Shouldered Connection Failures

Jim Douglas, Gagemaker, LP

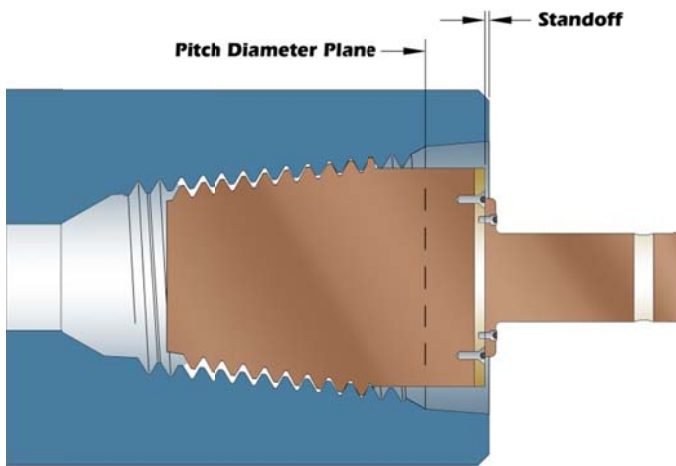
Figure 1: Plug Gauge Standoff

- Standoff:** The standoff of the working gauge is intended as a method to locate the plane of the pitch diameter in relation to the sealing shoulder of the connection. It is dependent on the other elements of the thread, notably lead and taper. (Figures 1 and 2)
- Lead:** The distance a screw thread advances along a taper cone in one revolution.
- Taper:** The increase in pitch diameter of the thread in inches per foot.
- Thread Height:** The distance between the crest and root, normal to the axis of the thread.
- Thread Form:** The form of thread is its profile in an axial plane for a length of one pitch.

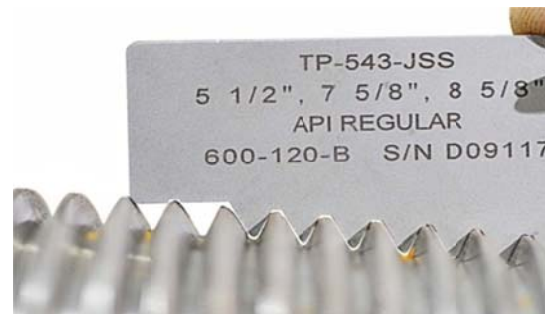
Figure 3: Magnified view of stab flank worn due to fretting, caused by insufficient thread interference.

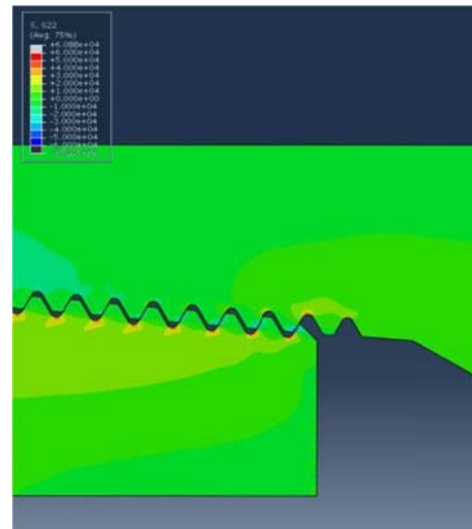
**Figure 13: Closer Look at Figure 12.**

Finally in Figures 12 & 13, using the pitch diameter tolerance of  $\pm 0.012$  which is the maximum allowed pitch diameter tolerance using ring and plug gauges, the stress experienced by the entire connection is obvious, especially in the box. By examining the exploded view in Figure 13, the lack of thread interference is evident as well as the number of critical hot spots. Essentially, this box and pin would have passed inspection using ring and plug gauges but this connection may not be able to endure what is required down hole.

In summary, the connections shown in Figures 12 & 13 are examples of oversized boxes and undersized pins which would have been approved using the current API sanctioned ring and plug gauging methods. However, most importantly, these connections would NOT have been approved if the pitch diameters were measured with a pitch diameter gauge using tolerances of  $\pm 0.002$  and  $\pm 0.004$ .

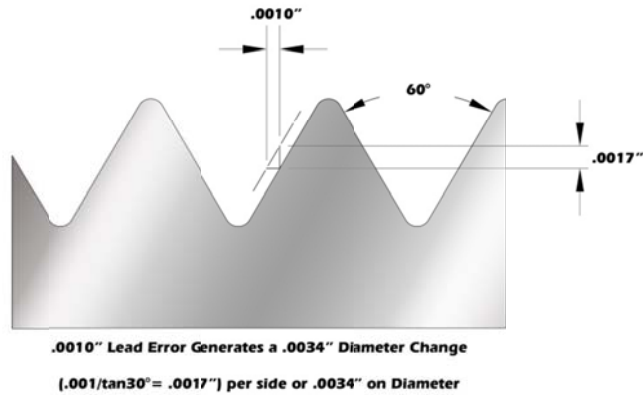
**Figure 14: Effects of lead error on pitch diameter.**

Geometrically a .001" Lead Error generates a .0034" diameter change as illustrated in Figure 14.  $\text{Lead Error} / \tan 30^\circ = \text{Radial change}$  ( $.001 / \tan 30^\circ = .0017$ )  $\times 2 = .0034$ " on Diameter for every inch of thread.

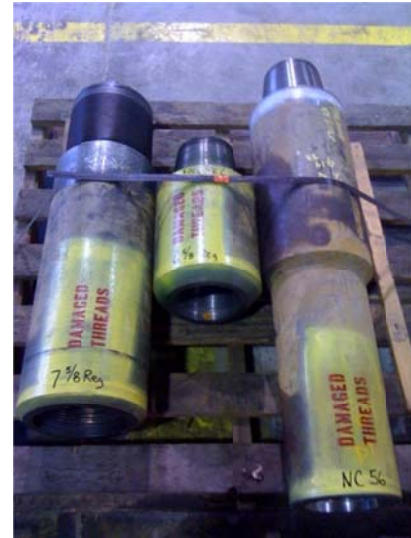
Figure 15: Damaged threads declared by Lewis Inspection Group.

They passed the 15 NC70 connections as there was no excessive damage. Only two boxes showed slight galling on second thread from stabbing damage. This was field dressed and ready to go. These results thrilled Nichols and StrataLoc Technology now requires all tapered threaded connectors be measured using the JSS which provides precise measurements for lead, taper, height and most importantly pitch diameter. Since implementing this new inspection in their procedures, StrataLoc has seen an 85% improvement in performance of their connections and has had fewer failures in the field.

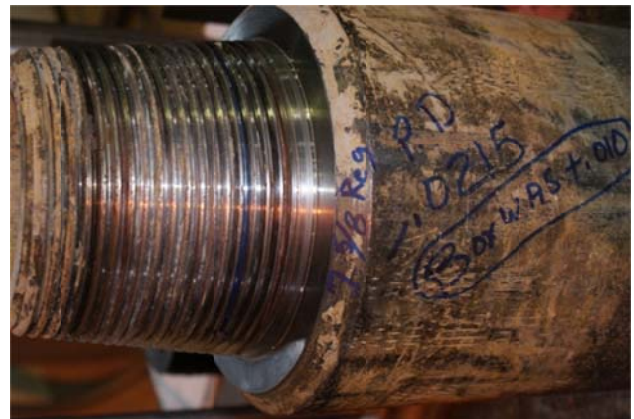
Figure 16: 7 5/8 API Regular displayed evidence of thread fretting. After inspection, it was determined the pin pitch diameter was  $-.021$ ".

The third party inspection group, Lewis Inspection Company, rejected the 6 5/8 Regular box X 7 5/8 Regular pin bit sub, 7 5/8 Regular box API cross over (drill bit Sub to BHA) and the NC56 cross over to the drill string for excessive thread damage per current API RP7G inspection specifications. The damaged parts, shown in Figure 15 & 16, were from the set of connections only inspected to minimum API requirements which included ring and plug gauges and not JSS.

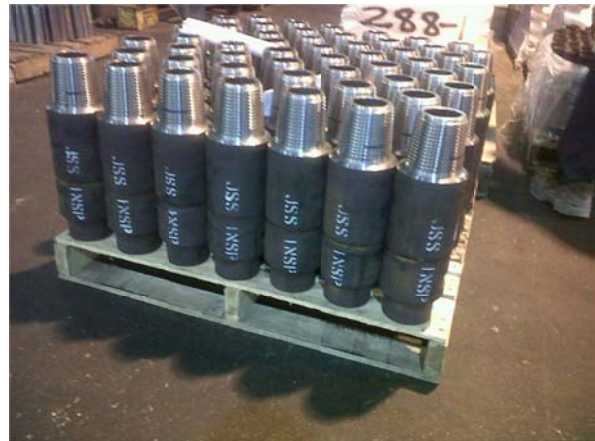
**Figure 17: Tejas stamps each connection with “JSS INSP” which shows that they have not only been inspected to current API Specifications, but the precise pitch diameter has been measured and documented.**
