## AADE 01-NC-HO-24

### Title: Subsidence Remediation – Extending Well Life Through the Use of Solid Expandable Casing Systems

Company: Enventure Global Technology, LLC

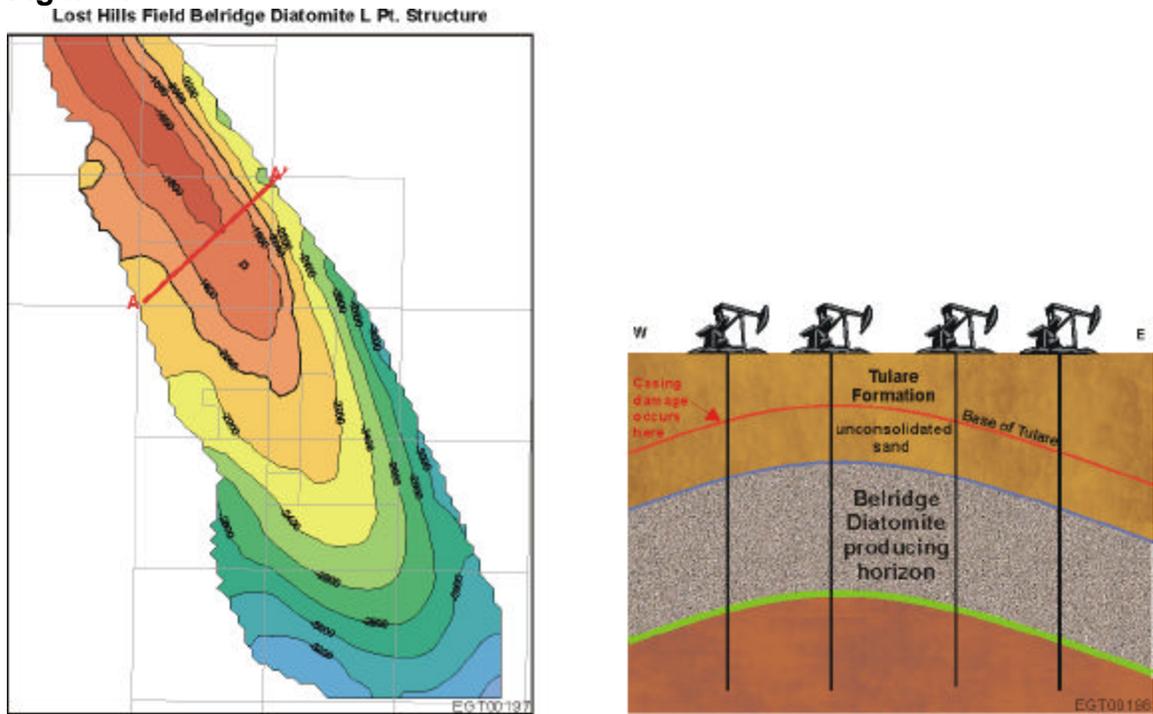
Figure 1 - Lost Hills field Belridge diatomite structure

Subsidence is expected within and above a producing formation where the reservoir rock is weak and porous (Fig. 1). As the fluids are extracted from the reservoir the rock is compacted, and in a shallow reservoir, this compaction can alter the over-

The Lost Hills field consists of a massive (up to 1,000 ft thick), fairly soft, high porosity (up to 50%) diatomite in the shape of a plunging anticline (Fig. 1). This anticline is overlaid with a series of sands, silts and shales. There is no surface indication of the anticline in the Lost Hills field.

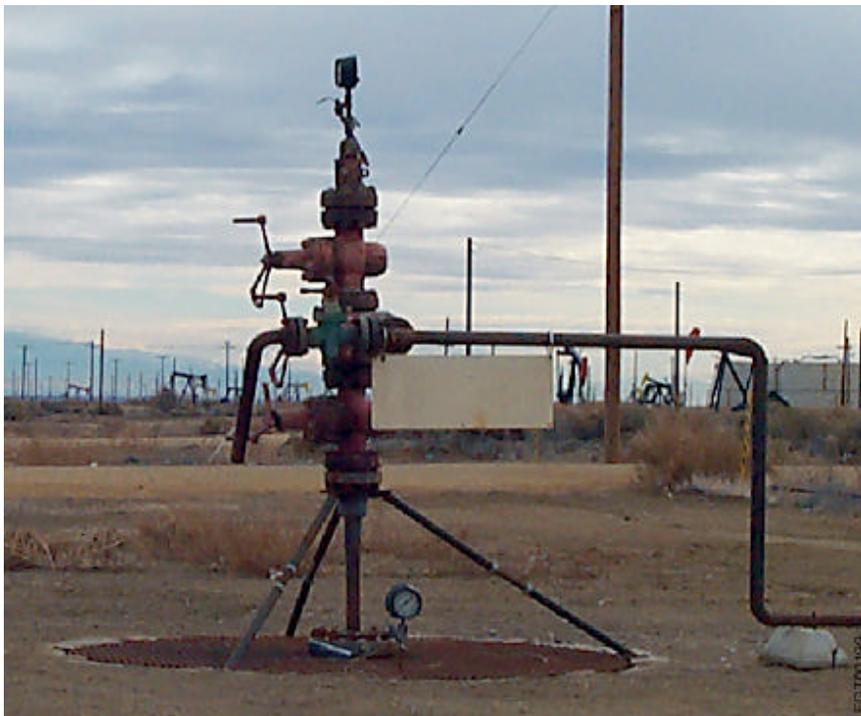
Figure 2 - Photo showing the results on the surface of compaction as fluids are extracted.

burden and may even be observed on the surface (Fig. 2).

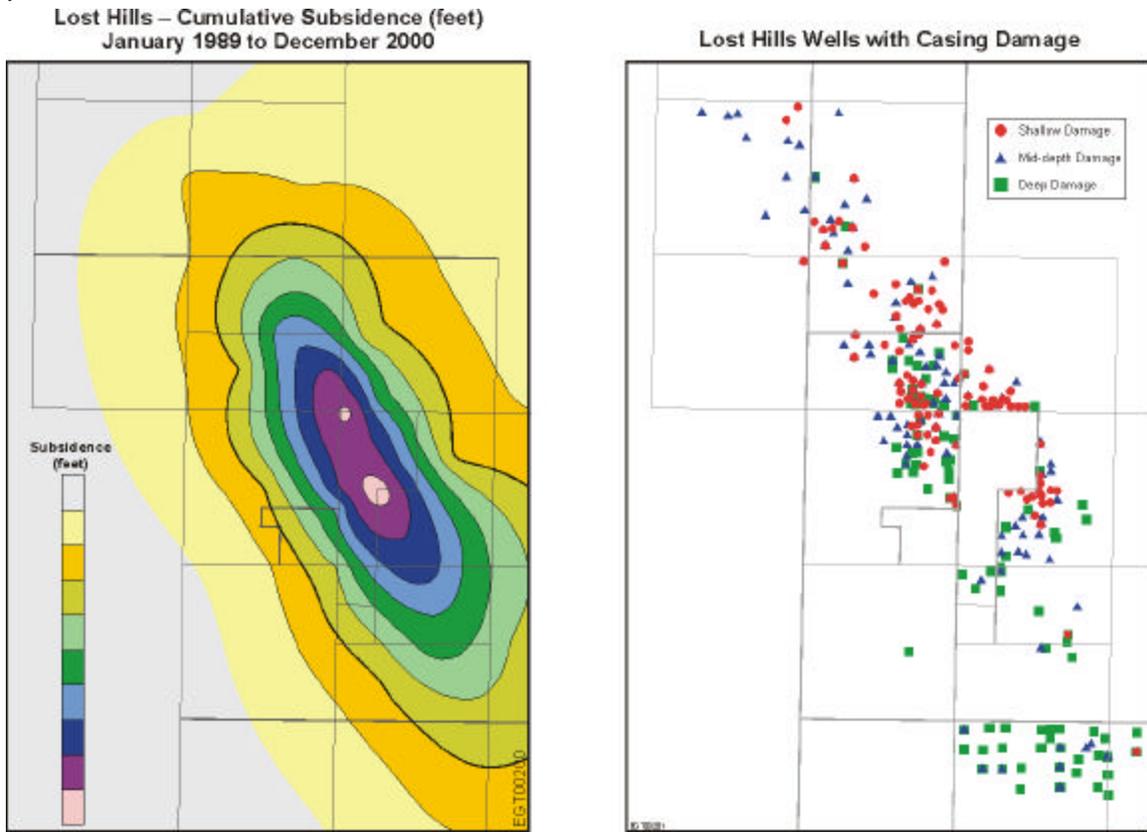
Figure 3 - Diagrams of Lost Hills field illustrate: (left) production from the formation has caused surface subsidence in the center up to 20 ft and (right) the variety of casing damage caused by subsidence throughout the field

of up to 20 feet in its center (Fig. 3). This process manifests itself as a bowl-shaped indentation dipping to the center of the field. Primary production is proportional to reservoir thickness; and as expected, waterflooding has greatly slowed, and in some areas arrested subsidence in Lost Hills.<sup>2</sup>

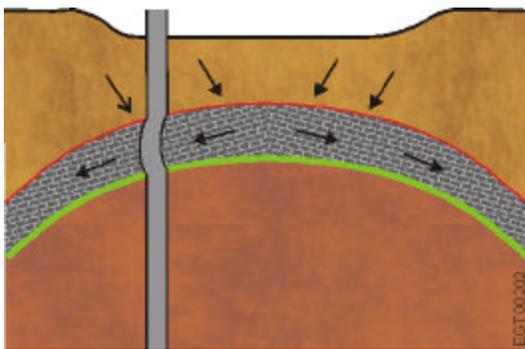
Figure 4a - Subsidence evidenced in well damage due to side-loading of casing

The mechanism that produced this "bowl" has caused two non-exclusive modes for casing failure. At the edges of the bowl, the overburden can slide on the soft clays toward the bowl center (Fig. 4a). This side-loading causes the casing to bend with the flow, thus creating a dogleg. Bending of the casing can happen at various depths in the same wellbore.

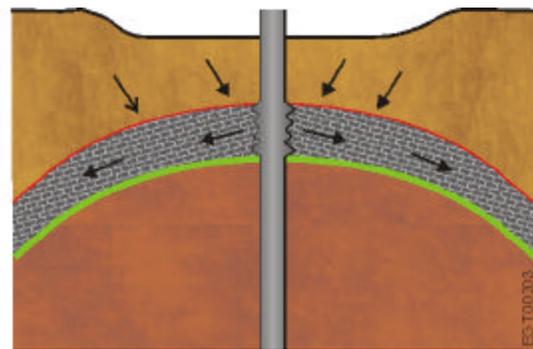
Figure 4b - Extensive compaction near "bowl" center causes shortening of the distance from surface to bottom of the well, buckling the pipe

Near the center of the bowl (field), a different problem exists. The extensive compaction of the diatomite, over time, causes a shortening of the distance from the surface to the bottom of the well (Fig. 4b). As expected, the casing buckles, just as it would if the same length of casing was run into a shorter length hole.

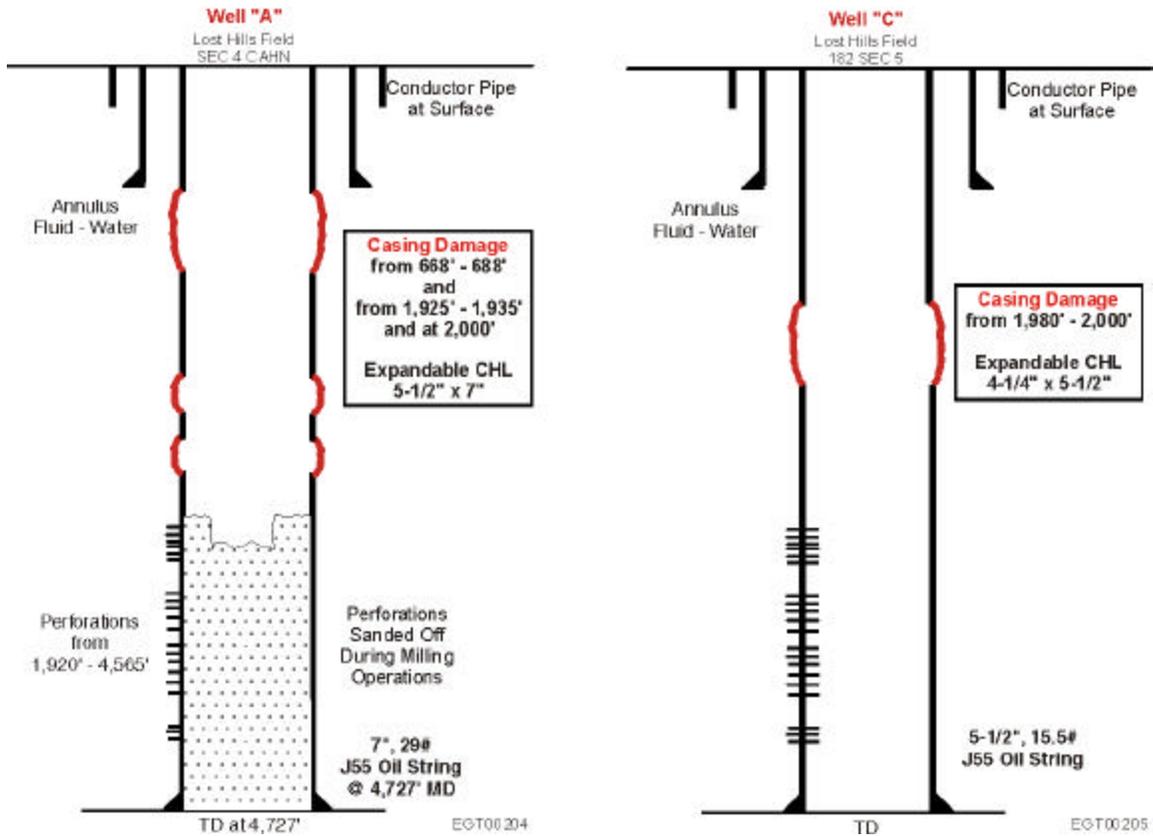
Figure 5 - Wellbore schematics of Well A and Well C

The wells selected for the pilot program will be referred to as Well A, Well B and Well C. (Figure 5 depicts Wells A and C. Well B was not remediated.) The casing in Well A was 7-inch 29 ppf, that in Well B was 7-inch 23 ppf and the casing in Well C was 5-1/2 inch 15.5 ppf. The dogleg had become so severe

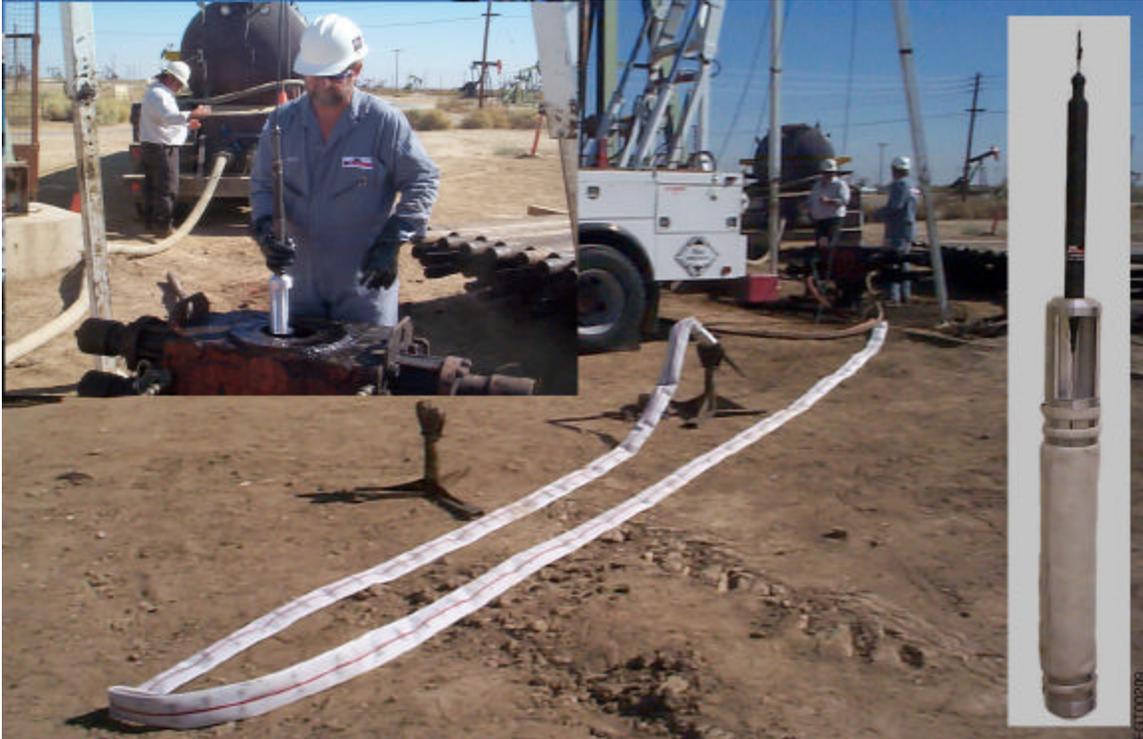
Figure 8 - The ESCaPE system is pictured at far right. One of the key components is the pliable flexible housing, shown onsite.

**Explosives theory and use.** The ESCaPE system utilizes specific engineered explosive material housed within a pliable flexible housing (Fig. 8). The system is customized by the type and length of explosive material used to create the specific energy needed to either re-form or remove the casing damaged by formation subsidence.

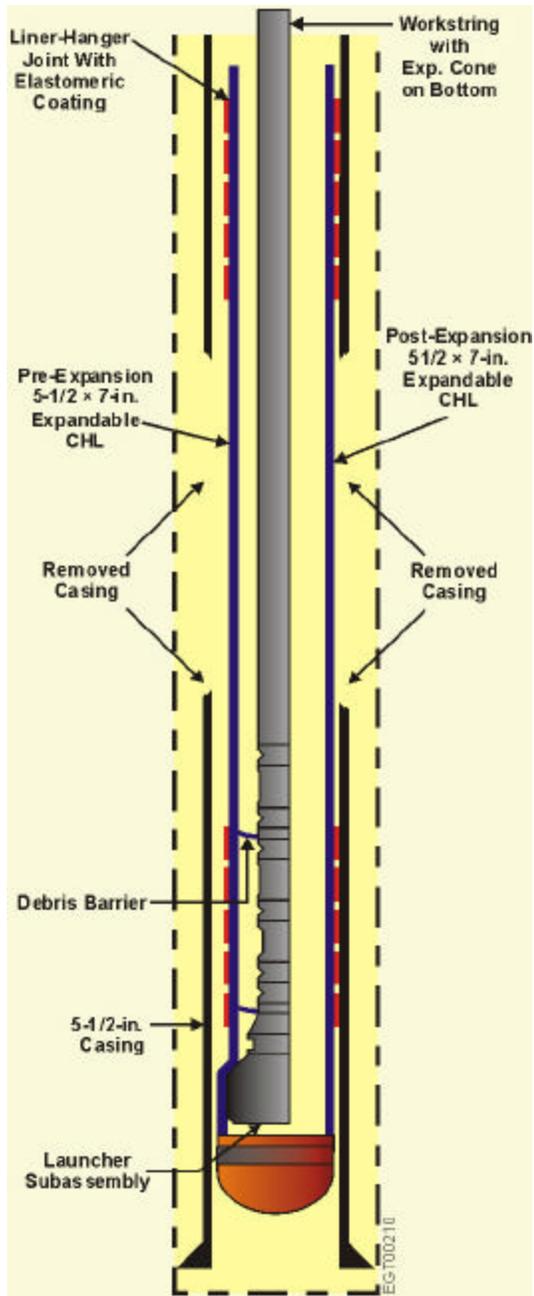
Figure 9 - Schematic of 5-1/2" X 7"  
Expandable Cased-Hole Liner System

removed or "impinged" (pushed back), the expandable casing was positioned in the prepared wellbore and expanded across the damaged casing, sealing it against the ID of the undamaged cased wellbore (Fig. 9).

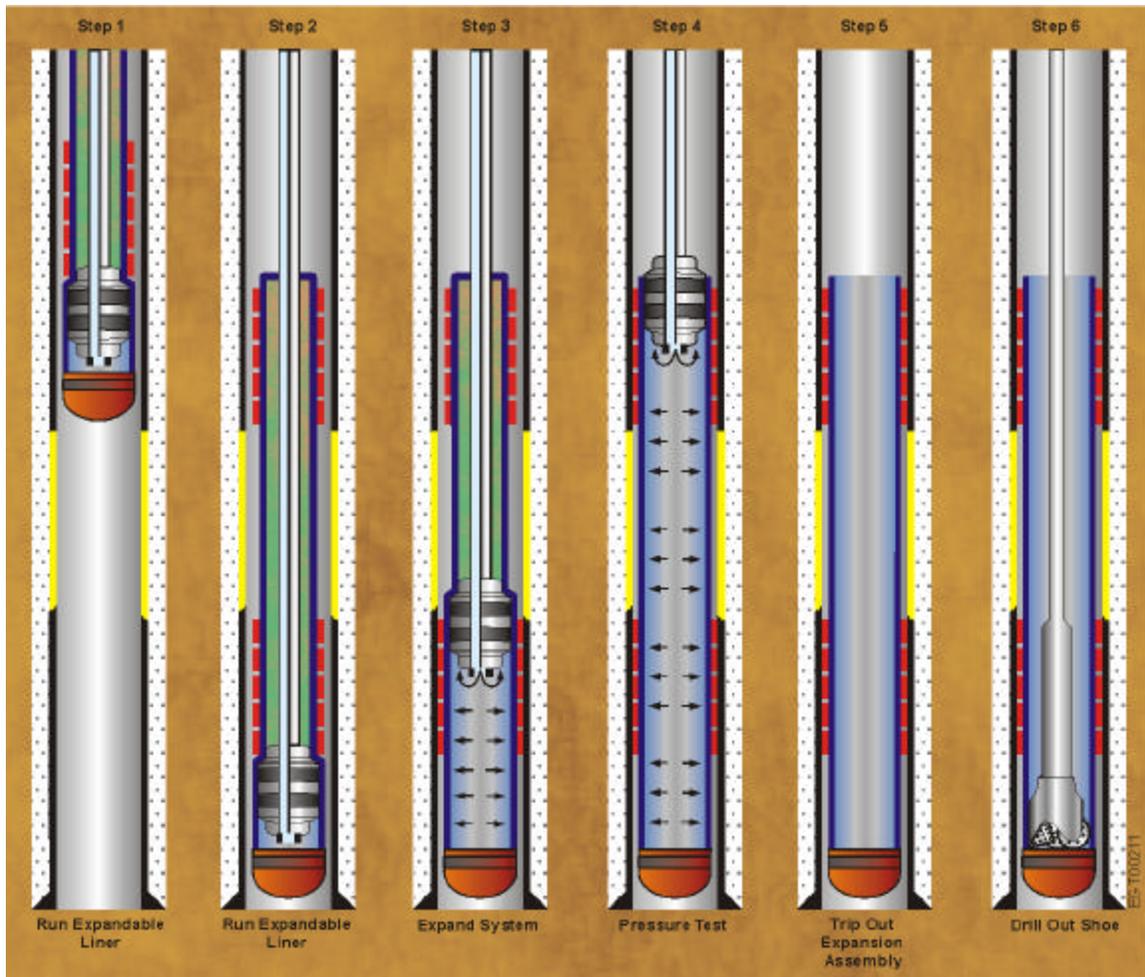
Figure 10 - Installation sequence for Expandable Cased-hole Liner System

Figure 10 illustrates the steps required to install an expandable cased-hole liner system. First the CHL launcher is run and the system hung off in the slips. (The CHL launcher contains the expansion cone and mandrel, as well as the casing that is to be expanded.) The workstring is then run inside the expandable CHL system and latched onto the top of the expansion cone. Next, the entire assembly is run into the wellbore, supported by the workstring.

The CHL system is then positioned across the prepared area of the wellbore damaged by subsidence. The surface pumping unit increases hydraulic pressure down the workstring, through the expansion cone and into the pressure chamber area. When the pressure inside the pressure chamber (across the expansion-cone / expandable-casing interface) reaches the required mechanical force, the casing begins to extrude over the expansion cone.

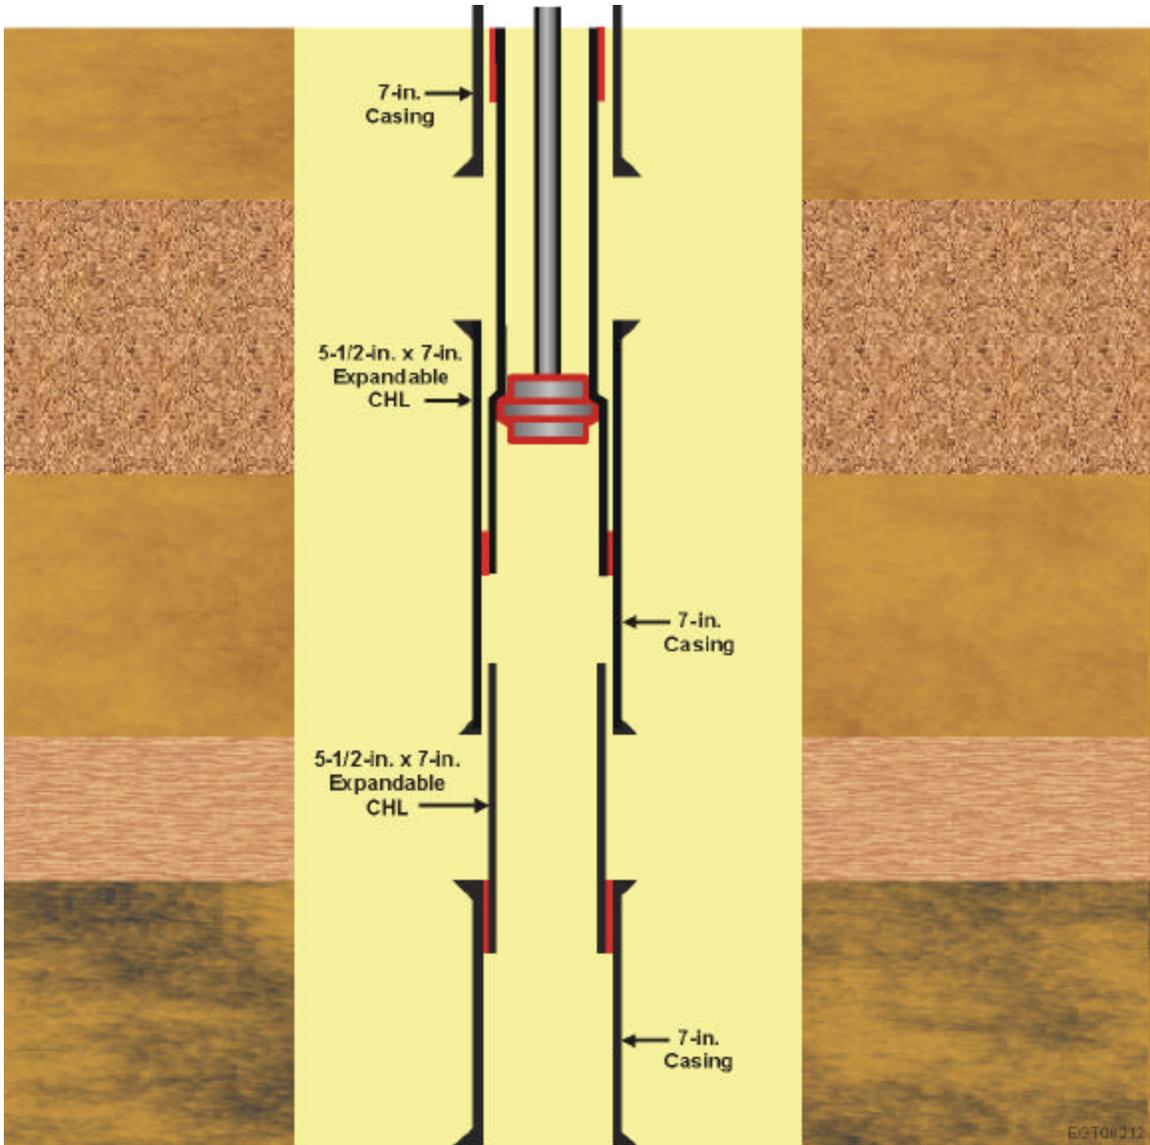
Figure 11 - Second CHL installation in Well A

In Well A, for instance, once the damaged casing was milled out, a casing centralizer arm was partially exposed, protruding into the wellbore. When the CHL was run in, the sharp end of the tempered steel centralizer arm severely damaged the expandable casing connection. This reduced the expansion pressure, halting the expansion process.

The casing was then cut just below the transition face, above the damaged base casing. The unexpanded casing and the expansion face were removed from the well. After retrieving the upper portion of the casing, the expansion cone was retrieved, allowing repair of the well to proceed. The second CHL system was then run in and placed on the top of the first CHL (Fig. 11).

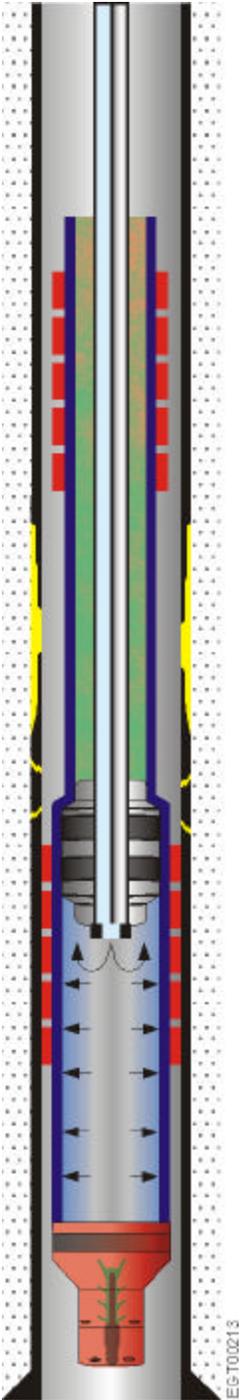
Figure 12 - Expandable CHL  
system using standard float shoe

Another enhancement to the CHL system is the use of a standard float shoe (Fig. 12) on the bottom of the launcher. The float shoe allows circulation and / or annular control through the CHL while running in the hole and before removal of the debris and "flowing formation" from the backside of the liner, prior to expansion. When running the second cased-hole liner in Well B, this aforementioned system enhancement would have allowed the removal of a bridge created by the diatomite formation flowing into the wellbore from the opening where the casing had been removed. This formation bridge, formed between the CHL and wellbore casing, presented problems during expansion of the second system (Fig. 13a).

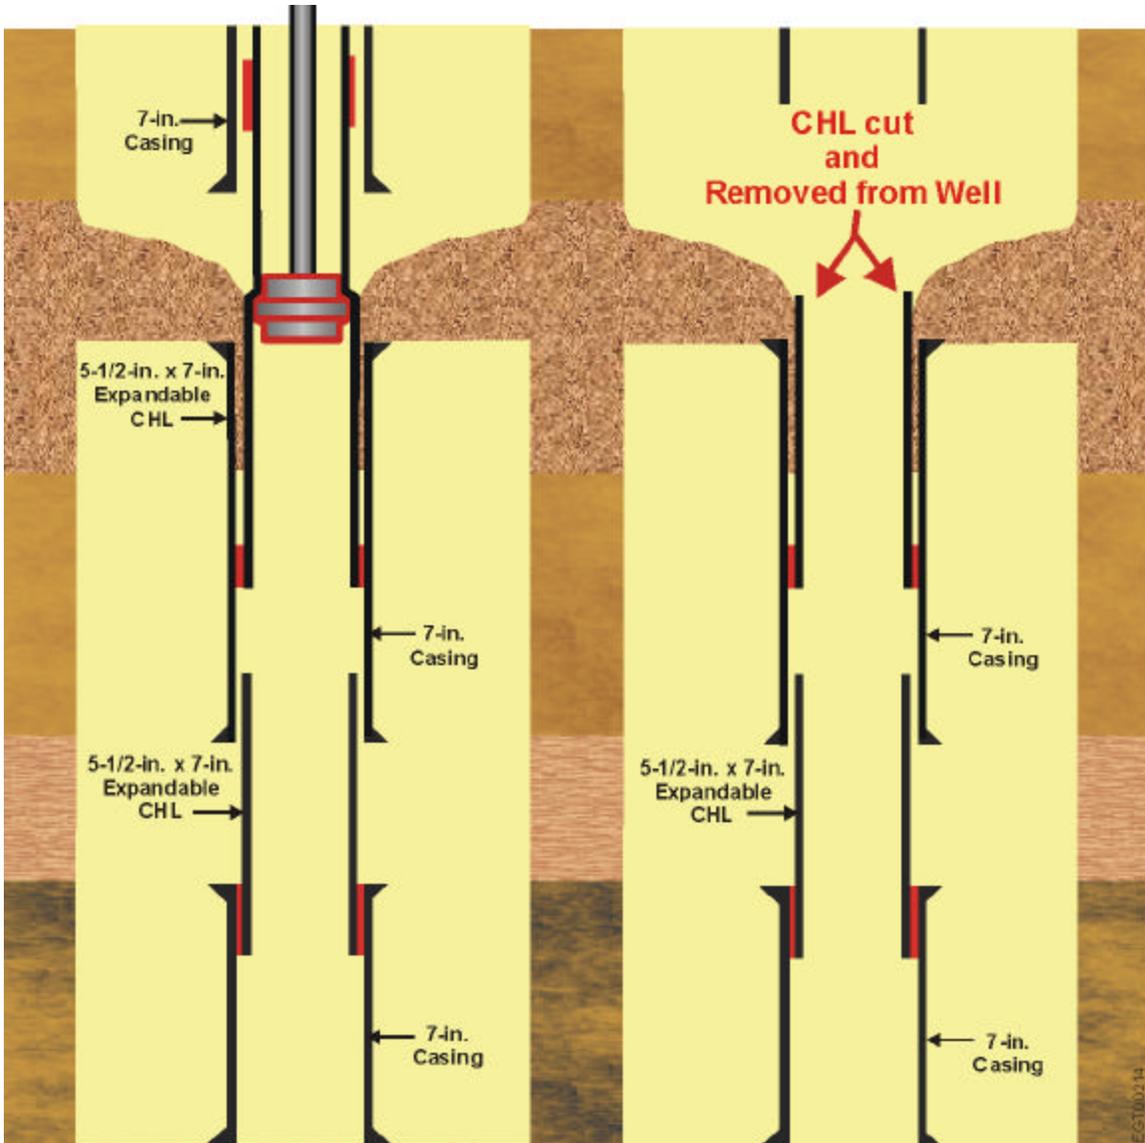
Figure 13a – Diatomite formation flow shown in Well A schematic

Figure 13b - Unexpanded casing and expansion face removed from Well A

The unexpanded casing and the expansion face were removed from the well (Fig. 13b). Then both the upper section of the casing and the expansion assembly were retrieved, freeing the wellbore so the repair could be finished.

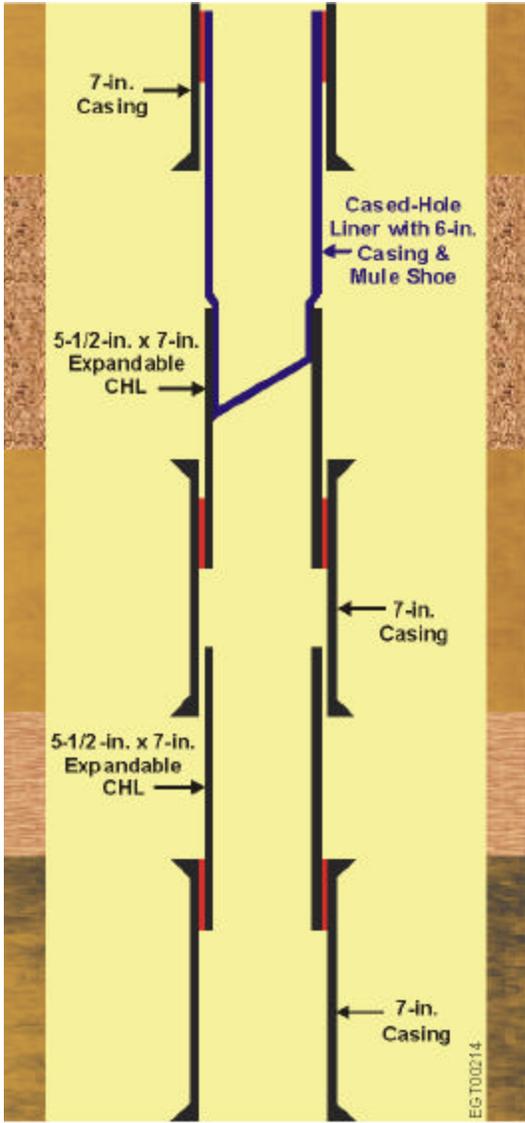
Figure 14 - Customized CHL with mule shoe installed in Well A

The repair was completed with a third, specially-designed CHL that incorporated a 6-in. diameter "mule shoe" extension below the CHL (Fig. 14). Once this "special" CHL was installed, the mule shoe was inserted into the second CHL installation, and the "special" CHL was expanded, bridging across the subsided area of the wellbore that had been removed. Figure 15 depicts the CHL installation originally planned for Well A.

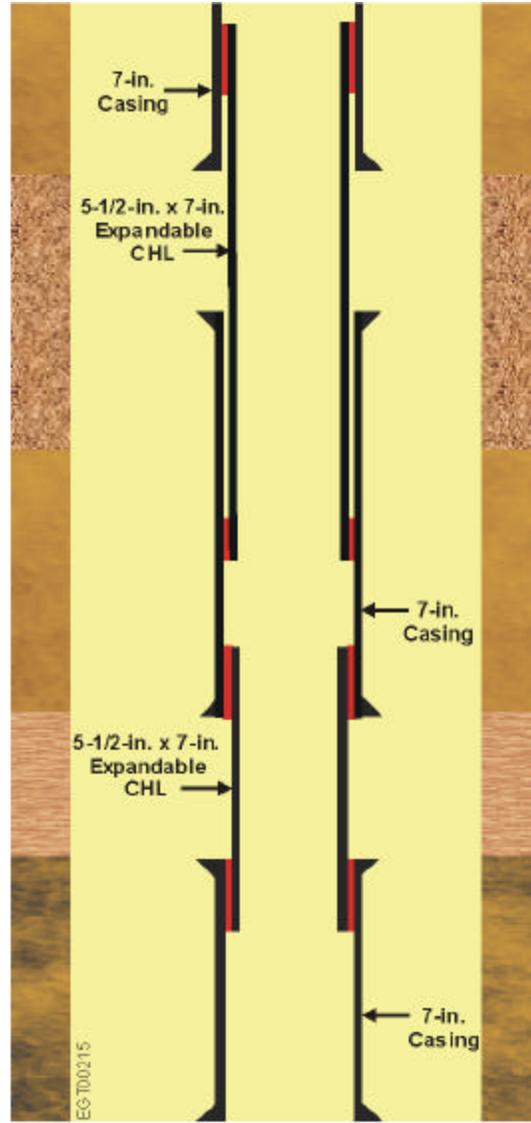
Figure 15 - Originally planned CHL installation for Well A
