Real-time Alkene Detection and XRF while drilling to monitor the efficiency of PDC Drill Bits in US Land Tight Rocks: A Case Study.

Isaac Easow, Barzin Chiniwala and Matt Regan Geolog International Surface Logging.

Copyright 2019, AADE

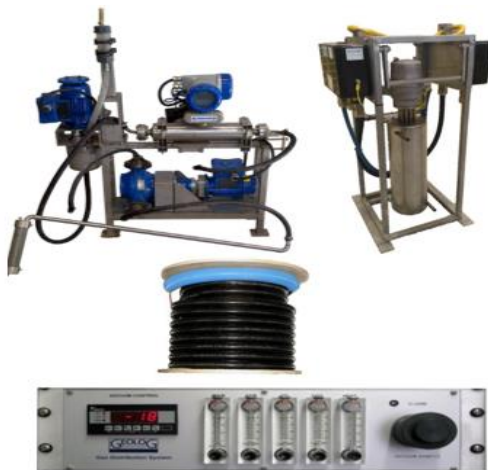
Fig.01. Advanced gas extraction and gas chain distribution system.

By having the ability to track and monitor the trends of the alkenes generated, one has an indication of the condition of the drill bit down-hole. To achieve this, standard mud logging equipment is used to extract gas samples using continuous mud flow at constant volume from the shale shakers. (Ref. Fig.01.) The extracted gas is then sent to a dedicated alkenes analyzer located inside the surface logging unit onsite. In standard drilling operations, artificially-generated alkenes are considered as contaminant as they affect the measurement and analysis of naturally-occurring formation gas. Chromatographic response of alkene peaks appear very close to those of natural alkanes, potentially skewing the outcome of alkane analysis.

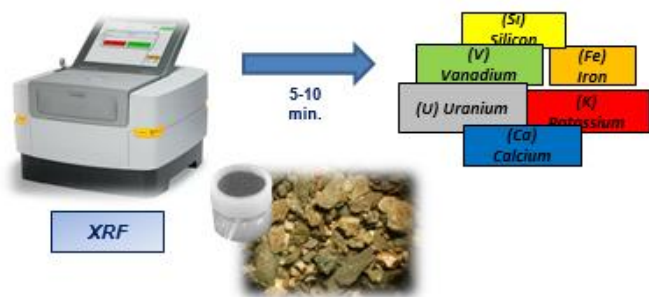
Fig.04. High precision X-Ray Fluorescence technique used on-site to track the elemental composition of the drilled cuttings.

In parallel to bit wear monitoring, unconventional reservoir analyses can be optimized by gathering precise information on its rock properties. The analytical breakdown of rock composition aid in identifying the properties of brittle intervals of the formation to optimize hydraulic stimulation. The content of quartz and calcite, in addition to mineralogy, petrophysics and rock mechanics, govern the brittleness property in shale formations. X-Ray Fluorescence (XRF) technique is used to analyze the rock properties in drill cuttings. (Ref. Fig.04.) High precision bench-top instruments were utilized on-site to generate XRF logs displaying mineralogical composition of drilled cuttings. The cuttings analysis identified calcium and silica to be the two major elements which can be considered as proxies aiding to geo-steer in the most suitable layers of the formation.

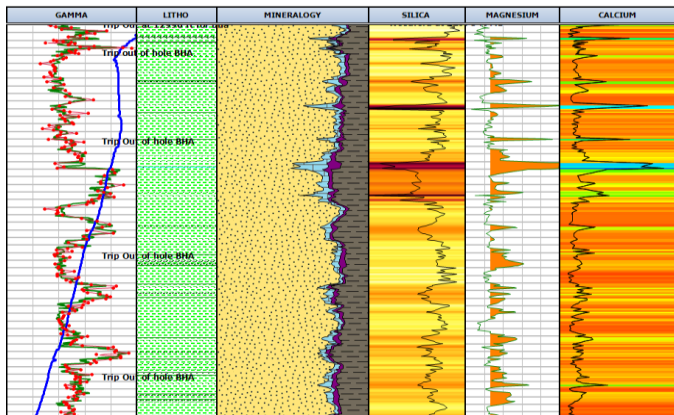
Fig.05: Example of a typical XRF log which is generated using the results of the drill cuttings analysis on-site in near real-time.

After the synchronization of all the mud-gas and cuttings data, a composite log is generated consisting of the drilling parameters including ROP, RPM (rotations per minute), torque and WOB (weight on bit), and cuttings lithological column. The lithological information is derived from examination of drill cuttings under the field microscope. XRF analysis complements the cuttings descriptions and aids in confirming any heterogeneity in the mineral content of the drill cuttings, which would be under evaluated with a typical field microscopic examination.

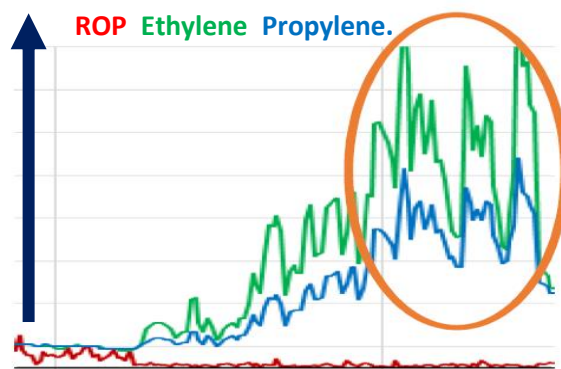
Fig.06. Illustration of alkenes detection in real-time and the corresponding reduction in the ROP curve.

The first sign of bit wear comes from the advent of alkenes mixed with the liberated gas while drilling, resulting from the inefficient drilling and potentially dysfunctional bit behavior and consequent reduction in ROP. The outcome is primarily dependent on the type of lithology and so the chemical composition of the rock types drilled. The presence of silica, for example, in the form of chert or arenaceous lithology such as sandstone, is primarily responsible for the abrasive nature of the rock. With timely recognition of changes to the rock properties complemented with real-time alkenes detection, the drilling parameters can be altered to efficiently negotiate the progress and avoid premature bit wear.

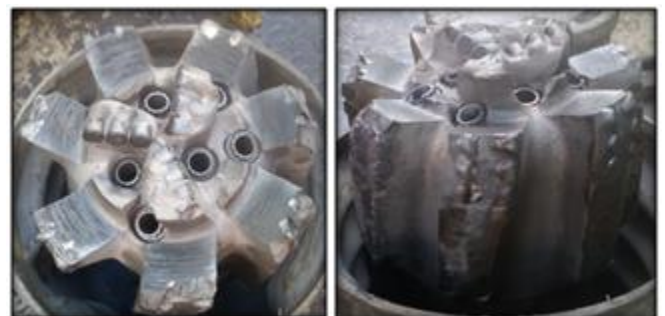
Fig.08: Worn PDC cutters on the shoulder and gauge area of this hybrid drill bit when examined at surface after POOH.

As the bit cut through silica-lean rock, the ROP increased and the bit appeared to drill more effectively. The bit drilled for 900ft, when a drop in ROP was recorded as indicated by the arrow in the ROP track. This drop in ROP correlated with an increase in the alkenes gases (ethylene and propylene) recorded at surface. Both these occurrences could be correlated to the increase in the silica content, as found in the drill cuttings analysis using XRF. The indication for the bit inefficiency were noted, however the operator decided to persevere with the same bit for another 200ft, before it was decided to POOH (Pull Out of Hole) for a bit change. The used bit was found to be damaged beyond repair (DBR) with lost cutters, bit body on the shoulder and gauge completely under-gauged, and substantially rung-out. Ref. Fig 08.

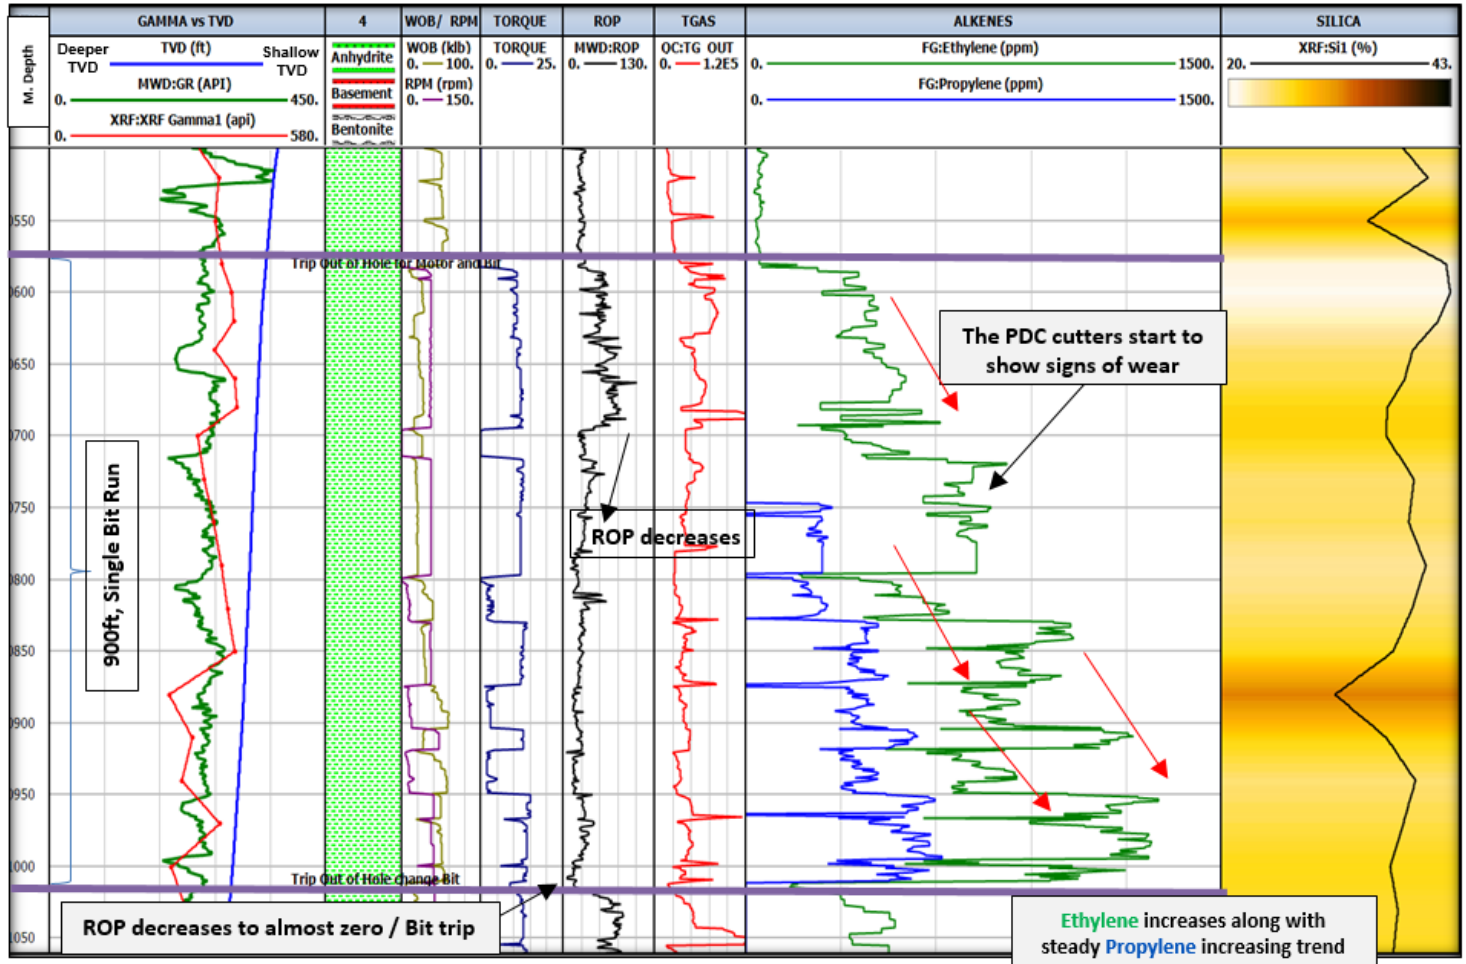
Fig.09: Composite log indicating the increasing alkenes trend and corresponding slow-down of ROP, indicating potential bit wear.

The lack of efficient progress would have a huge impact on the overall well expenditure and would threaten to cut their campaign short. Alkenes detection at the well-site was deployed to track the health of the bit while drilling. The intention was to correlate the increase in the alkenes to the drilling response. When the bit started drilling the lateral section, the ROP was consistent and the bit made good progress (Ref. Fig 09). As the bit drilled farther through sandy shales, the cutters naturally wore and the ROP started to see a decline, correlated with the rise of alkene levels. as measured by the dedicated alkenes analyzer in real-time. The gradual increase in alkenes were consistent with the high amounts of silica recorded in the XRF analysis of the drill cuttings. The high silica content was observed due to the presence of abrasive sandstones as well as traces of chert. As the dulled bit progressed further, the alkenes trend continued to rise until the ROP reduced to lower single digits. By this time both ethylene and propylene levels were sufficiently elevated to give the drillers enough confidence to make the call on the bit. The driller continued to persevere for a few feet more, before deciding to POOH. Once the bit was on surface, it was observed to be worn out on the shoulder and the

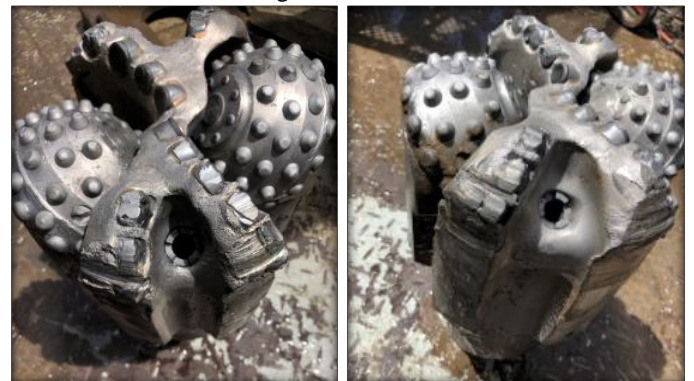
Fig.10: Worn PDC cutters on the shoulder and gauge area of this hybrid drill bit when examined at surface after POOH.

gauge (Ref. Fig.10). This log provides the composite view of the drilling situation. This bit drilled a total of 600ft before it was POOH for a bit change.

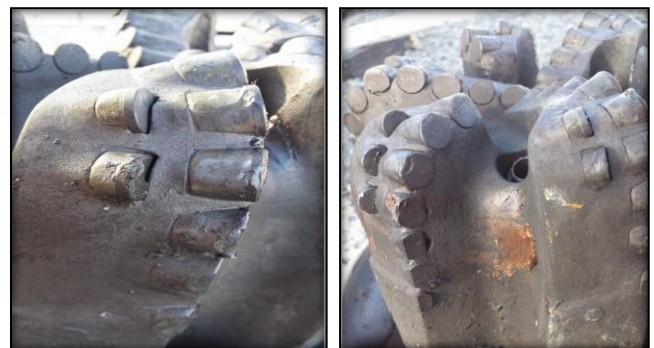
Fig.12. Used bit POOH with worn cutters mainly in the shoulder area indicating a good run for this bit.

Drilling commenced in the 8¼” lateral section of a well in the Arkoma basin. The objective of the bit run was to maximize the footage drilled with optimal drilling parameters, as well as staying in the target, avoiding silica-rich intervals which would be detrimental to the life of the PDC cutters. The PDC bit encounters numerous chert and dolomitic carbonate stringers, as well as organic shales which was confirmed by the elemental composition from drilled cuttings, measured using the XRF in quasi real-time. The increase in silica correlated well with the increase in alkenes and the intermittent slowing down of the ROP simultaneously. (Ref Fig.11.) These trends were frequently communicated to the Geo-steering team enabling prompt correction and adjustments to aid in steering-away from potentially abrasive rock layers, resulting in prolonging the life of the bit. As a result, the alkenes would drop to minimal values indicating a positive change in the type of formation and effective progress to make hole. The bit continued to drill for 5,900ft until the ROP slowed down considerably and the alkenes showed a progressive increase in an interval rich in silica (as proven by XRF), prompting pulling out of hole for a bit trip. The bit came out of the hole in a repairable condition, with worn cutters as expected for a normal bit run, but showing

no indications of excess bit wear or high temperature. (Ref. Fig. 12.) During this run the alkenes detection service potentially saved the operator at least one bit trip by proactively communicating bit life condition status with Geo-steering team, resulting in prolonging the life of the BHA and the drill bit.

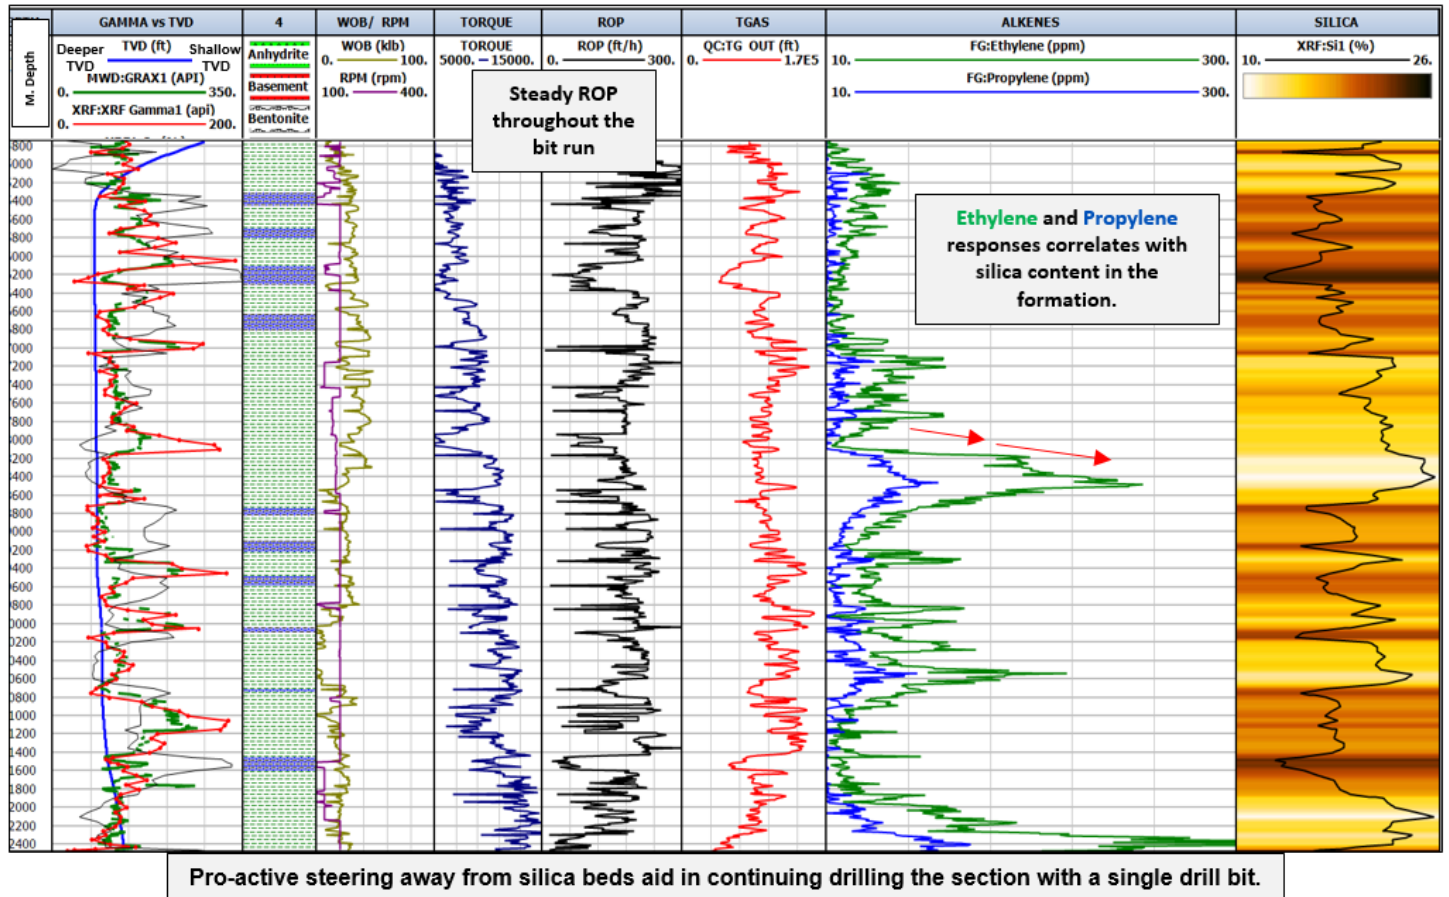
Fig.13. Alkenes trend closely follow the abrasive behavior of the formation. The silica content reduces as the bit steers away intentionally out of the abrasive zone.

A 6-bladed bit was deployed to drill a lateral section of a well in predominantly silica rich formation. The objective of this bit run was similar to the case history #3 discussed earlier. The bit was tasked to reach well TD in this lateral section, which was approximately 7,600ft. The lithology was expected to be comprising mainly of shale with inter-bedded abrasive chert beds and occasional dolomitic stringers. The bit drilled very efficiently through the initial 3,500ft of rock until the cutters started to show some fatigue. Presence of chert is highly detrimental to the life of the cutters. ROP reduction became evident when the bit encountered cherty silica rich beds, where the alkenes reading rose sharply. (Ref. Fig.13.) Geo-steering team was notified of this event and prompt action was taken to steer away from the silica rich layers. Such pro-active responses aided to continue drilling at a constant effective pace. Alkenes trend and the silica content was continuously tracked to help remain in the 'safe-zone' in order to keep the cutters from suffering premature wear. As a result the operator successfully reached well TD in a single bit run as intended and the bit was also pulled out in good condition. (Ref. Fig.14.) The cutters showed normal, evenly-distributed wear on the shoulder and gauge and was in a condition to continue
