Real-Time Stick-Slip and Vibration Detection for 8 ½"-Hole-Size Rotary Steerable Tools in Deeper Wells and More Aggressive Drilling

Junichi Sugiura, Steve Jones — PathFinder Energy Services

Copyright 2007, AADE

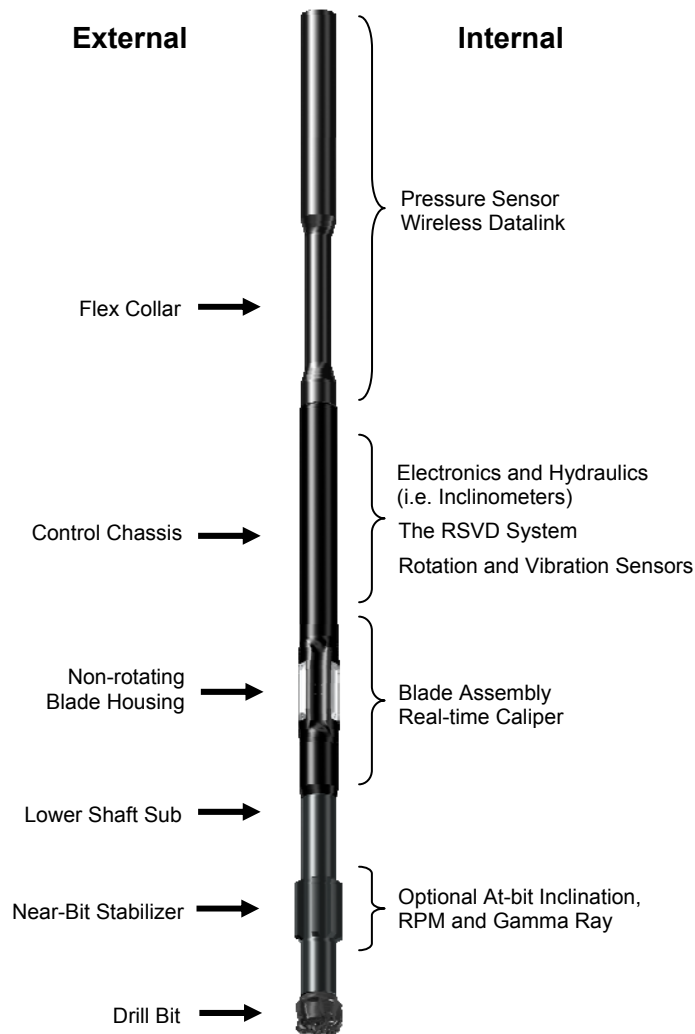
Figure 1. The Real-time Stick-slip and Vibration Detection (RSVD) system integrated into the 8 1/2-inch-hole-size RSS in a point-the-bit configuration. The RSVD sensor is located 11.1 feet above the bit in the point-the-bit RSS. The real-time near-bit caliper is measured 8.2 feet above the bit. Optionally, a Pay-Zone Steering module is placed at the bit for inclination, RPM and Gamma Ray measurement.

Figure 1 shows the 8 ½"-hole-size point-the-bit RSS with the RSVD system. All three principal modes of the drillstring vibration are detected at the RSS and classified into 4 categories of severity for the band-limited mud pulse telemetry. Also, this classification produces effective data

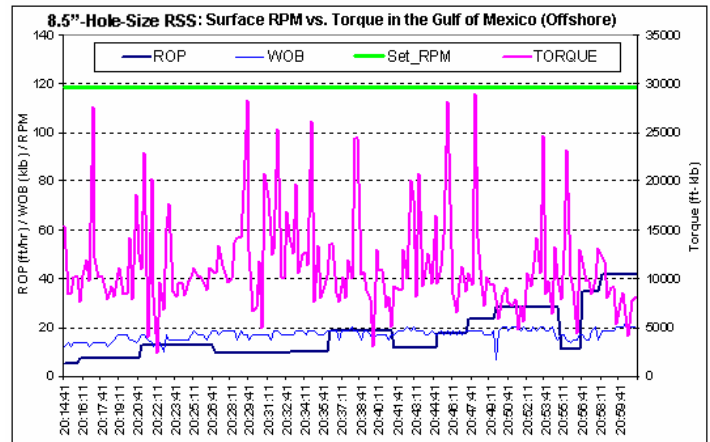
Figure 2. Surface parameters/data during downhole full-blown stick-slip. Notice that rotary torque fluctuation correlated highly with the downhole near-bit stick-slip data in the figure below while the WOB was kept nearly constant. The Set_RPM is the programmed surface RPM that is different from the actual surface RPM. It is noticed in the above figure that stick-slip tends to reduce ROP.

Figures 2 and 3 illustrate the full-stall stick-slip observed on a rig in the Gulf of Mexico while drilling in a "ratty" abrasive sandstone section with the 8 1/2"-hole-size RSS. Post-drilling LWD data analysis showed that this section was composed of high salinity siltstone, shale, and sand. Very slow drilling (low ROP) and high/erratic string torque between 10 to 25K ft-lb were encountered.

Figure 2 shows surface parameters/data during downhole full-blown stick-slip. **Figure 3** shows downhole-computed mean and raw RPM vs. blade housing toolface angle. It is noticed that rotary torque correlated highly with the downhole stick-slip data while the WOB was kept nearly constant. The Set_RPM is the programmed surface RPM that is different from the actual surface RPM (not shown).

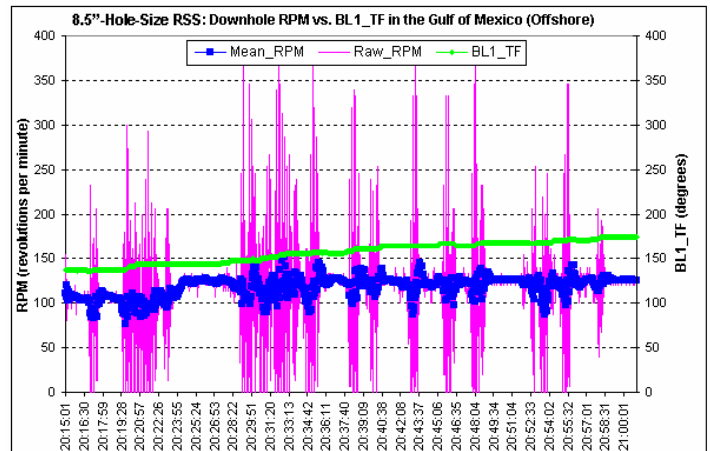
Figure 3. Downhole mean and raw RPM vs. blade housing toolface angle (BL1_TF). The slowly changing BL1_TF (140 ~ 170 degrees) indicates the non-rotating blade housing was substantially stationary, compared with the mean drillstring rotation (about 120 RPM). The raw RPM variations between 0 RPM and 380 RPM indicate the onset of a full-stall stick-slip. The corresponding Stick-slip Severity (SS%) in the period is approximately between 200% and 300%.

In **Figure 3**, the slowly changing BL1_TF (blade housing toolface angle between 140 and 170 degrees) indicates that the non-rotating blade housing was substantially stationary as compared with the drillstring rotation (about 120 RPM). During the stick-slip period, the maximum raw RPM (240 ~ 360 RPM) was 2 or 3 times higher than the surface RPM (\approx 120 RPM). The corresponding Stick-slip Severity (SS%) in the period is approximately between 200% and 300%.

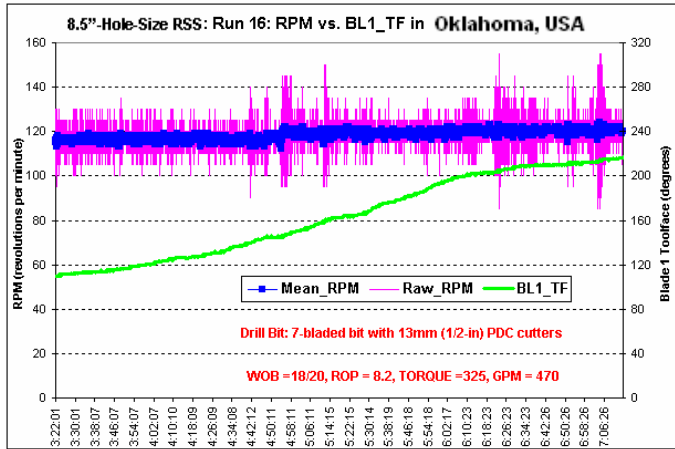
Figure 4. Low RPM variations with a 7-bladed bit with 13mm PDC cutters. The average ROP was reported as 8.2 ft/hr. The slowly changing BL1_TF (119 ~ 219 degrees) indicates the non-rotating blade housing was substantially stationary, compared with the mean drillstring rotation (about 120 RPM).

Figures 4 and 6 show the examples of bit-formation induced stick-slip on the 8 1/2"-hole-size RSS observed in Oklahoma. Mean_RPM, Raw_RPM, and BL1_TF represent average near-bit RPM, raw near-bit RPM, and Blade 1 toolface, respectively. The slowly changing BL1_TF indicates that non-rotating blade housing is substantially stationary.

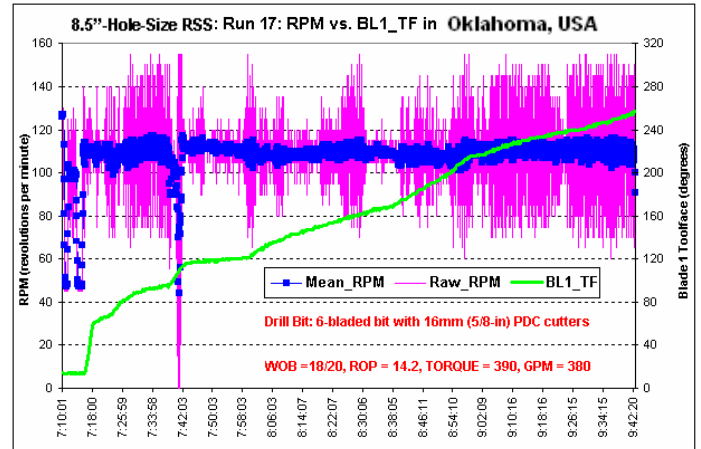
Figure 6. High RPM variations (Stick-Slip Severity $\approx 72\%$) with a 6-bladed bit with 16mm PDC cutters. The average ROP was reported as 14.2 ft/hr. The slowly changing BL1_TF (20 ~ 260 degrees) indicates the non-rotating blade housing was substantially stationary, compared with the mean drillstring rotation (about 115 RPM).

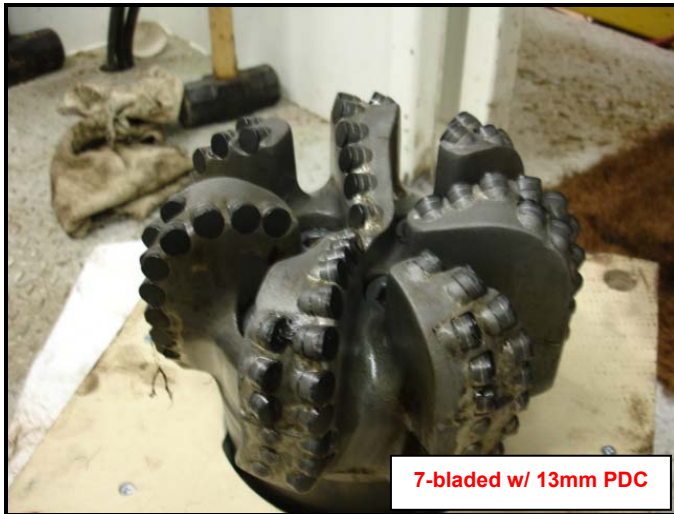
Figure 5. The less aggressive PDC bit used in the above run. This picture was taken after the above run.

A 7-bladed bit with 13mm (1/2-in) PDC cutters shown in **Figure 5** was used in the run (Run # 16). This PDC bit (with 1.5" active gauge) produced ROP less than 9 feet/hour and the decision was made to change for a more aggressive drill bit to

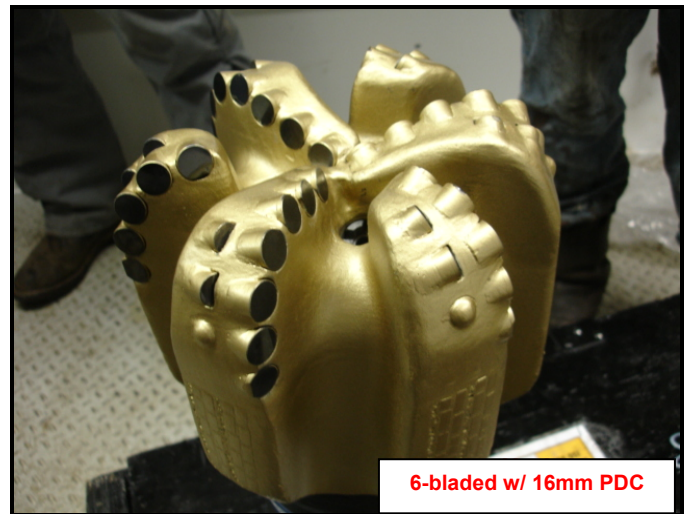
Figure 7. The more aggressive PDC bit used in the above run. This picture was taken before the above run.

A 6-bladed bit with 16mm (5/8-in) PDC cutters shown in **Figure 7** was used in this run (Run # 17). This bit (with 3" passive gauge) produced an average ROP of 15 feet/hour. The ROP was almost doubled while the formation and the surface parameters were practically identical. However, with a more aggressive bit, near-bit RPM varied roughly by ± 40 RPM (Stick-Slip Severity was about 72%). This stick-slip problem became worse while drilling through different formations and eventually resulted in premature failure of the RSS.

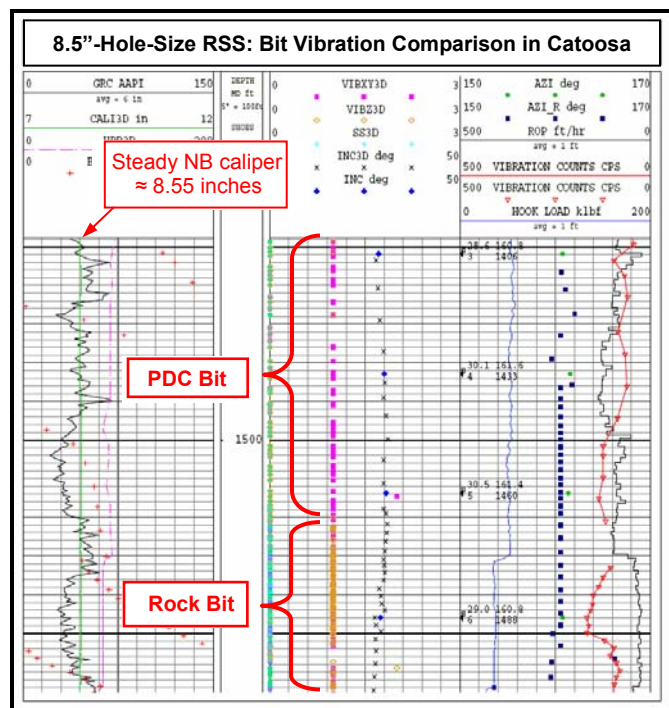
Figure 8. Vibration Comparison between PDC and Rock bit in the real-time MWD/RSS data. Lateral vibration (VIBXY3D = 1) was dominant while drilling with a PDC bit. In contrast, axial vibration (VIBZ3D = 1) was dominant with a rock bit.

The GTI Test Facility in Catoosa, Oklahoma was used to evaluate the prototype 8 1/2"-hole-size RSS for performance, ruggedness and reliability. **Figure 8** shows real-time MWD and RSS vibration data collected at the GTI facility, including the surface parameters. The MWD vibration data was measured approximately 45 feet above the bit, providing the number of vibration counts above 20 G per second.

Vibration profiles between a PDC and a rock bit (a roller cone bit) are compared using the RSVD system. The PDC bit induced more lateral vibrations, whereas the rock bit produced more axial vibrations. The real-time vibration data (Lateral Vibration = Low and Axial Vibration = Low) obtained with the RSVD system at the RSS correlated highly with the vibration counts (≈ 100 counts/second ... considered as a low vibration count) detected at the conventional MWD tool. While drilling through a hard dolomite section, called the Arbuckle group (not shown), this BHA suffered from high vibration counts (≈ 450 counts/second) and high near-bit lateral vibration at the RSS. This vibration problem eventually resulted in RSS failure.

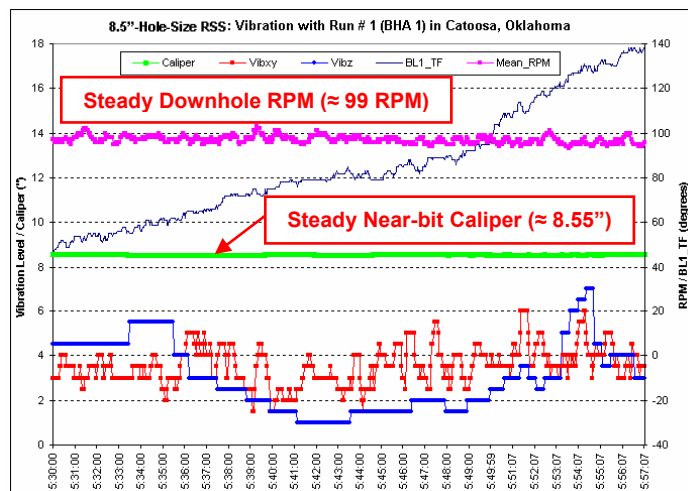
Figure 9. Relatively high lateral and axial vibrations (Vibxy and Vibz) measured in Run #1. The slowly changing BL1_TF (50 ~ 140 degrees) indicates the non-rotating blade housing was substantially stationary, compared with the mean drillstring rotation (about 99 RPM).

At the GTI Catoosa facility, medium-to-high vibration severity was detected with both MWD and the RSVD system while the 8 1/2"-hole-size RSS was drilling in a dolomite section. The Run #1 BHA was initially configured for drilling a high-inclination well (i.e. a horizontal well). 20 joints of 5" heavy-weight drill pipe (HWDP) were used below 10 joints of 6 1/4" drill collars. **Figure 9** shows high lateral and axial vibrations at the RSS in Run #1. The near-bit caliper measurement indicated that hole was in gauge, between 8.54" and 8.56". The near-bit RPM measurement was steady at approximately 100 RPM. There was no sign of stick-slip phenomenon (SS3D = 0). The slowly changing BL1_TF indicated that the non-rotating blade housing was substantially stationary, providing additional stability to the BHA. At this point, the exact cause of the vibration problem was unknown.

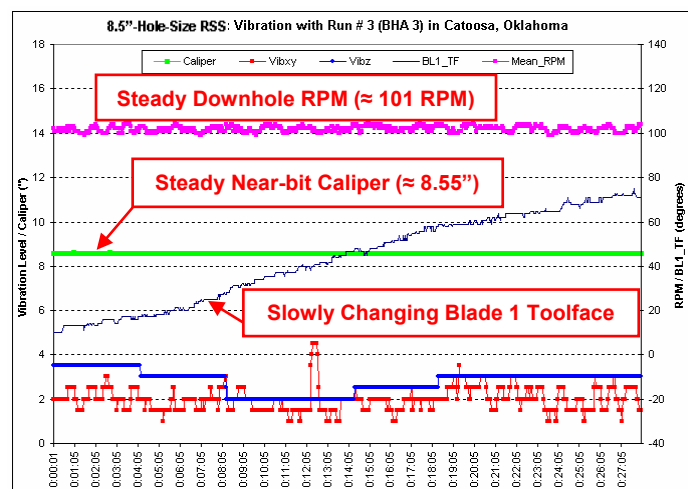
Figure 10. Lower lateral and axial vibrations (Vibxy and Vibz) measured in Run #3. The downhole near-bit vibrations were reduced by almost half from Run #1 after having changed the positions of drill collars and heavy-weight drill pipe in the BHA. The slowly changing BL1_TF (10 ~ 70 degrees) indicates the non-rotating blade housing was substantially stationary, compared with the mean drillstring rotation (about 101 RPM).

In Run #3, the repaired tool from Run #1 with the BHA modification was tripped in and commenced drilling. **Figure 10** shows that the RSS vibration in Run #3 was reduced by almost half from Run #1 while the same RPM and WOB were used. In both runs, the borehole inclination was between 19 and 20 degrees. The formation drilled in Run #3 was similar to that of Run #1.

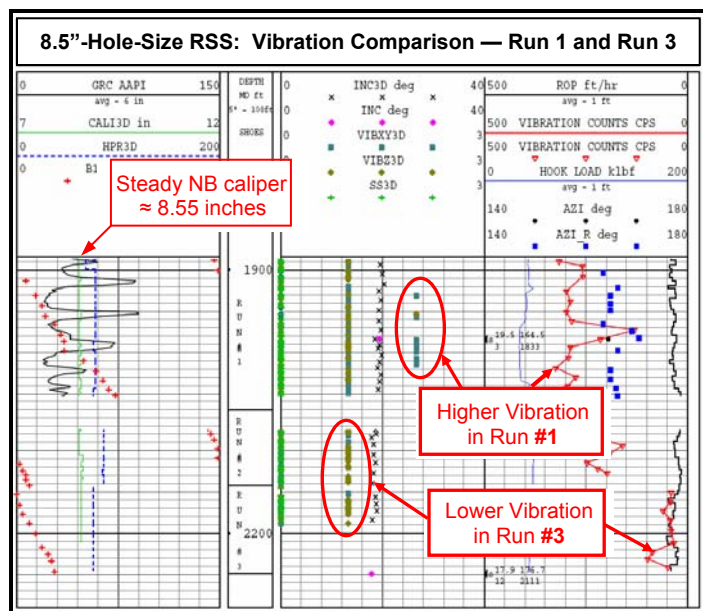
Figure 11. Vibration Comparison between Run #1 and Run #3 in the real-time MWD/RSS data. The RSVD lateral vibration (VIBXY3D) level went up to Level 2 and MWD vibration count was 300 CPS in Run #1. After having changed the positions of drill collars and heavy-weight drill pipe in the BHA, the lateral vibration level (VIBXY3D) became Level 1, and the MWD vibration count was reduced to 50 CPS.

Figure 11 shows the surface parameters and the real-time data measured with the RSVD system. Both lateral and axial vibration severity levels were suppressed to Level 1 (Low Severity). Moreover, the real-time MWD vibration counts were reduced from 300 CPS to 50 CPS. It was concluded that BHA mass imbalance and BHA instability created high lateral vibrations in Run #1.

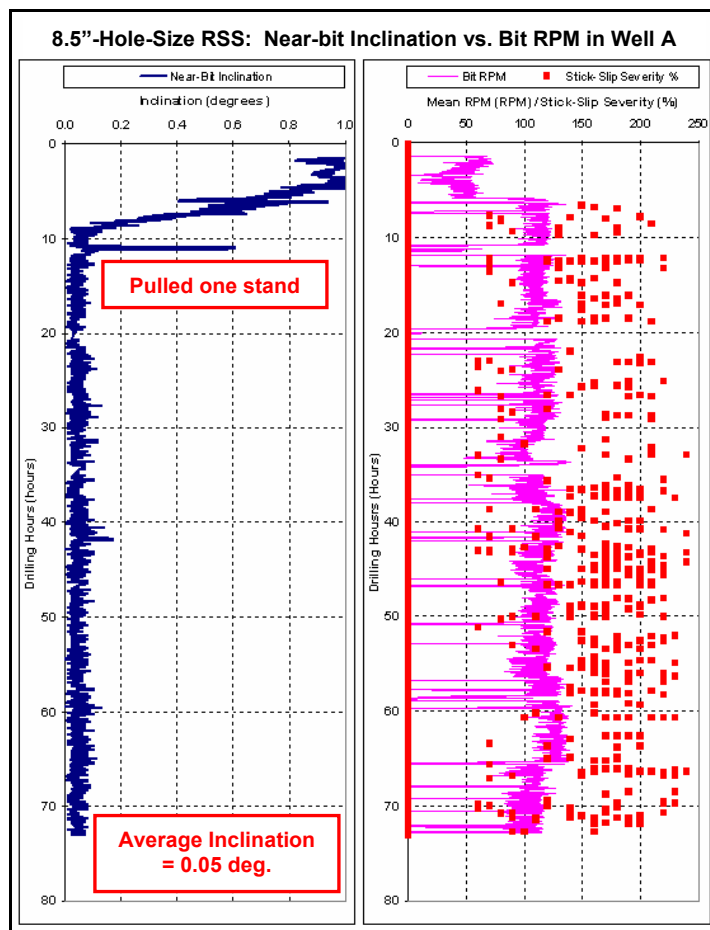
Figure 12. Near-bit Inclination, bit RPM and Stick-Slip Severity in % from Customer Well A. The fully automated RSS maintained excellent verticality for approximately 1,000 ft, while the excessive stick-slip problem hindered ROP. The average inclination of the near-vertical borehole is 0.05°, based upon the MWD static surveys.

While drilling, the RSVD revealed that excessive stick-slip hindered ROP on this well. **Figure 12** shows the near-bit inclination, bit RPM and Stick-slip Severity in % computed at the RSS. The downhole computer applies a low-pass filter to raw RPM readings and records a mean RPM in memory. It was noticed that the filtered RPM was still noisy due to stick-slip.

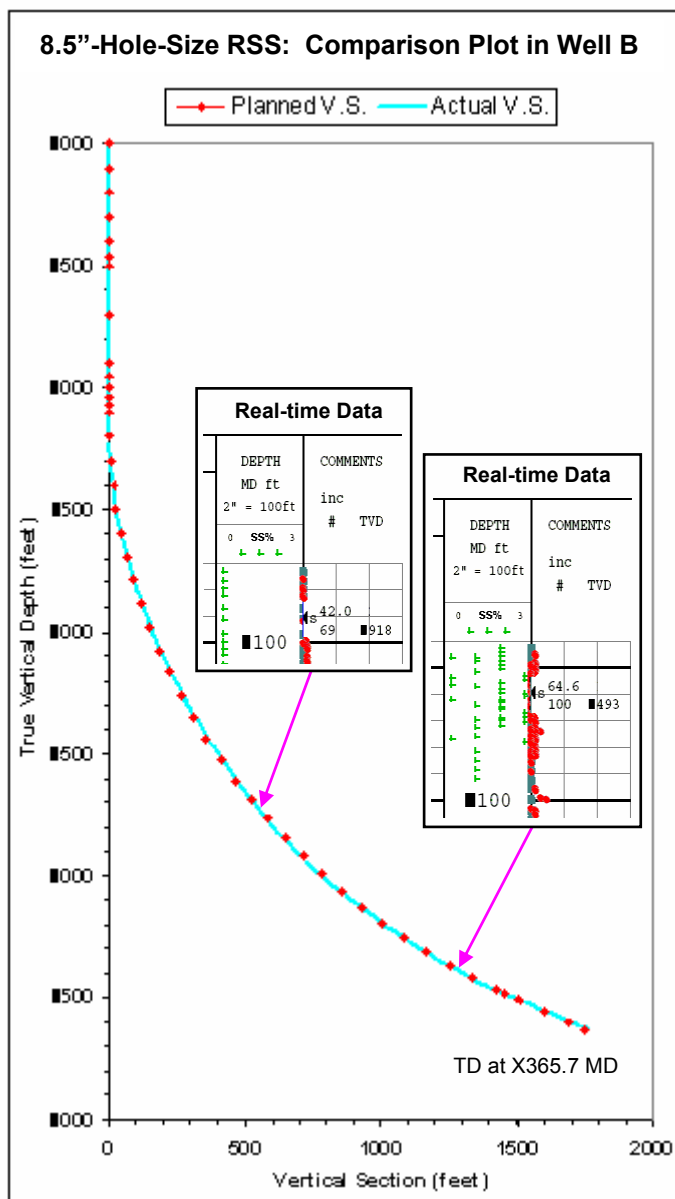
Figure 13. Comparison plot of Planned (red) versus Actual (blue) well path from Customer Well B. The RSS drilled 3,260 ft at an average ROP of 39.7 ft/hr without downhole failure. WOB was maintained at 15,000 to 20,000 lbs. The RSVD detected significant stick-slip in the second half of the well path up to the TD at X365.7 MD.

The 8 1/2"-hole-size RSS was used with a small under-powered rig in New Mexico. The RSS drilled 3,260 ft at an ROP of 39.7 ft/hr, accumulating 82.2 drilling hours and 164.2 circulating hours. WOB was maintained at 15,000 to 20,000 lbs. No major vibrations were observed in the first half of the run as shown in **Figure 13**. In the second half, stick-slip became problematic with Stick-slip Severity between 100% and 200%. Very little lateral and axial vibrations were observed in the real-time data. The RSS operators were able to manage the stick-slip problem and completed 1,700 ft of the problematic footage without downhole failure.

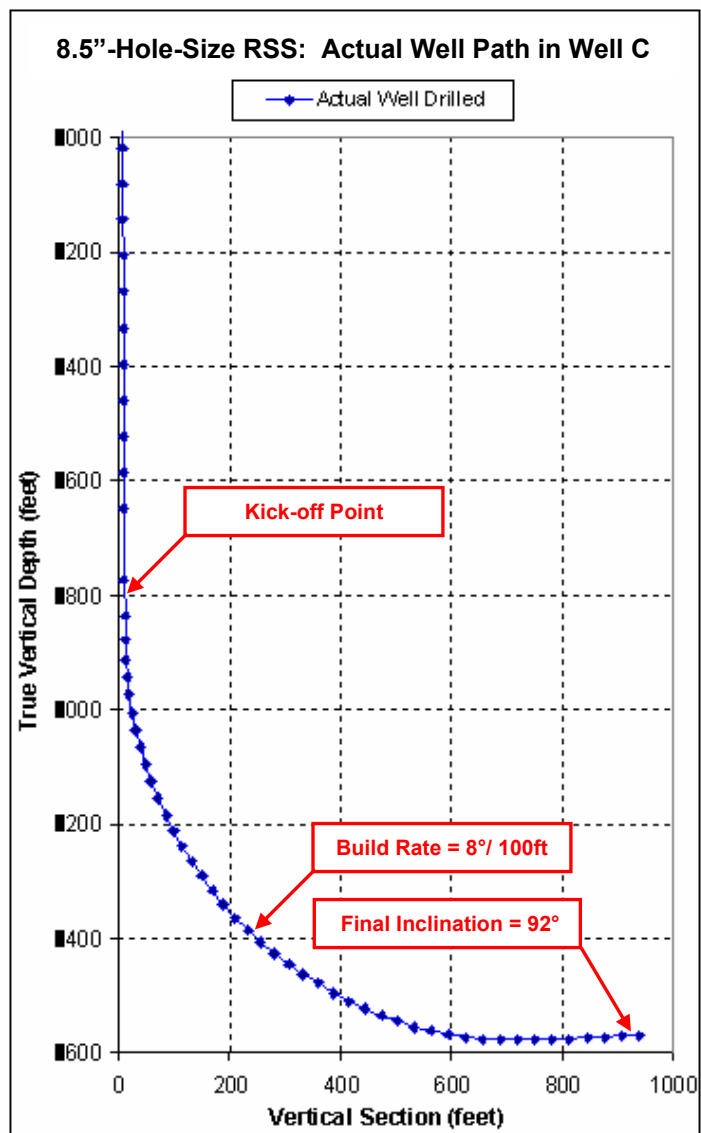
Figure 14. Actual well path drilled in Customer Well C. The RSS was used on the build section of a Fayette Shale well. The well plan called for 8°/ 100ft build rates to land in the reservoir at 92 degrees. Both stick-slip and vibration were low throughout the run as a result of using the motor-assisted RSS assembly. The assembly drilled 1,404 ft at an average ROP of 55 ft/hr.

The 8 1/2"-hole-size RSS was used on the build section of a Fayette Shale well. The well plan called for 8°/100ft build rates to land in the reservoir at 92 degrees as shown in **Figure 14**. Due to rig rotary speed (RPM) limitations, this well was drilled with the RSS below a slow-speed downhole motor and a PDC bit. The well was kicked off and built angle at 8°/100ft using an 80% offset setting. The RSS offset setting was reduced as the angle increased to maintain the desired 8°/100ft build rates. Both stick-slip and vibration were low throughout the run as a result of using the motor-assisted RSS assembly. The assembly drilled 1,404 ft at an average ROP of 55 ft/hr.
