Recent Casing Failures in Horizontal Wells

- For the meeting of AADE membership Denver
- May 14, 2013
- At the Denver Athletic Club
- Presented by: Jack Magill, P.E., consulting drilling engineer

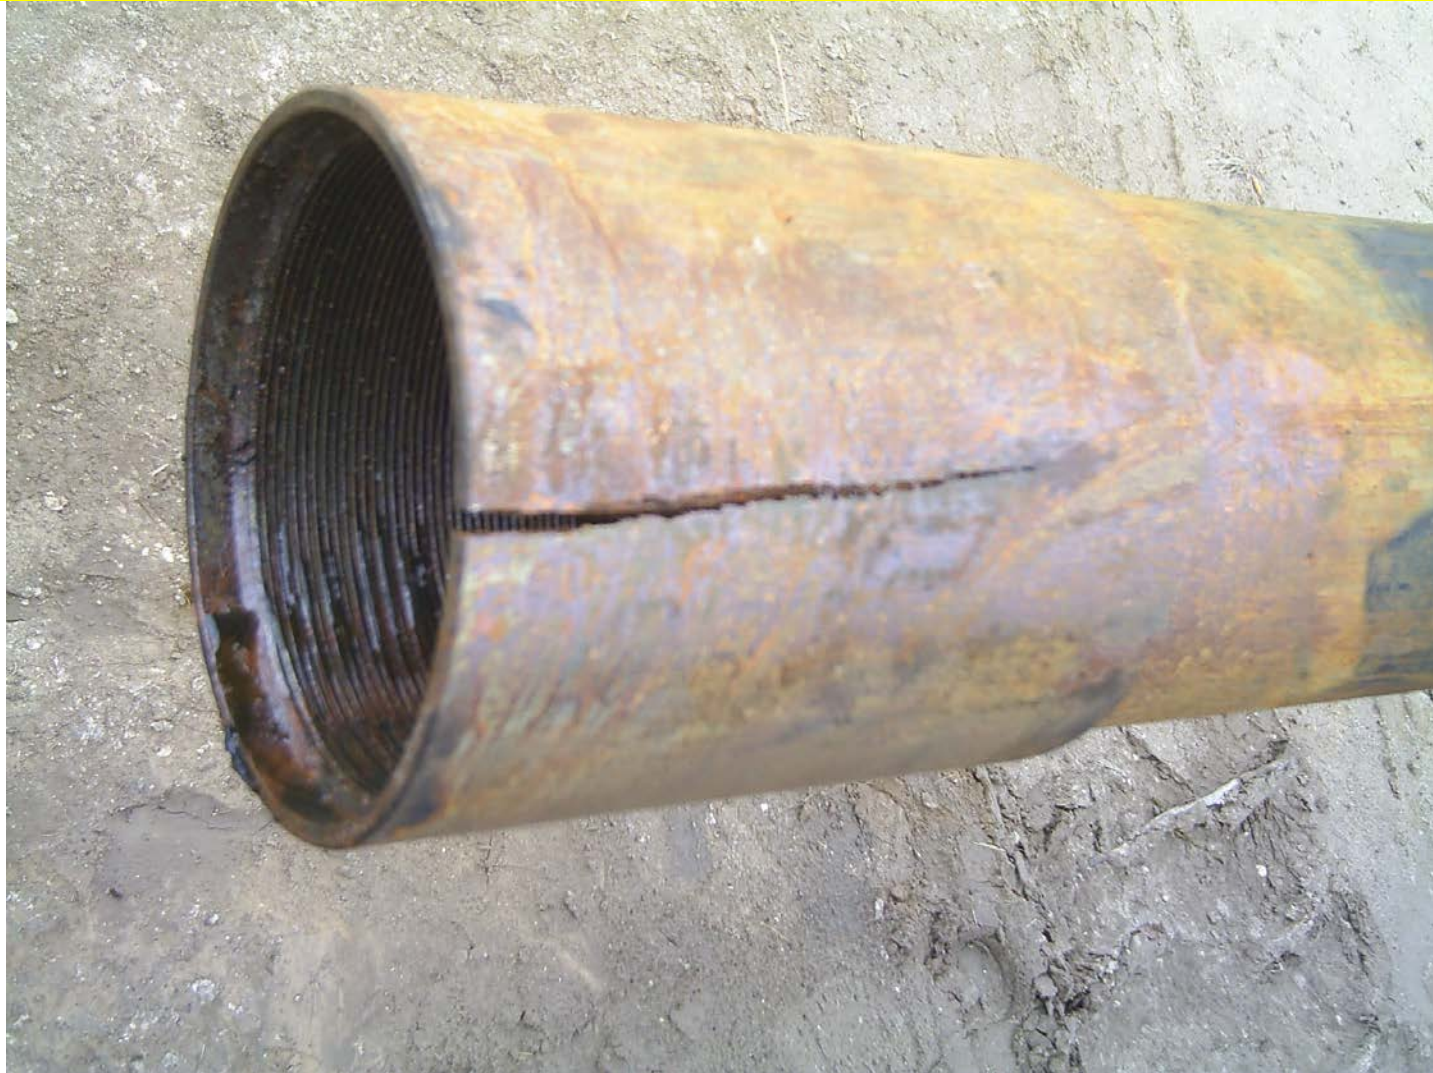
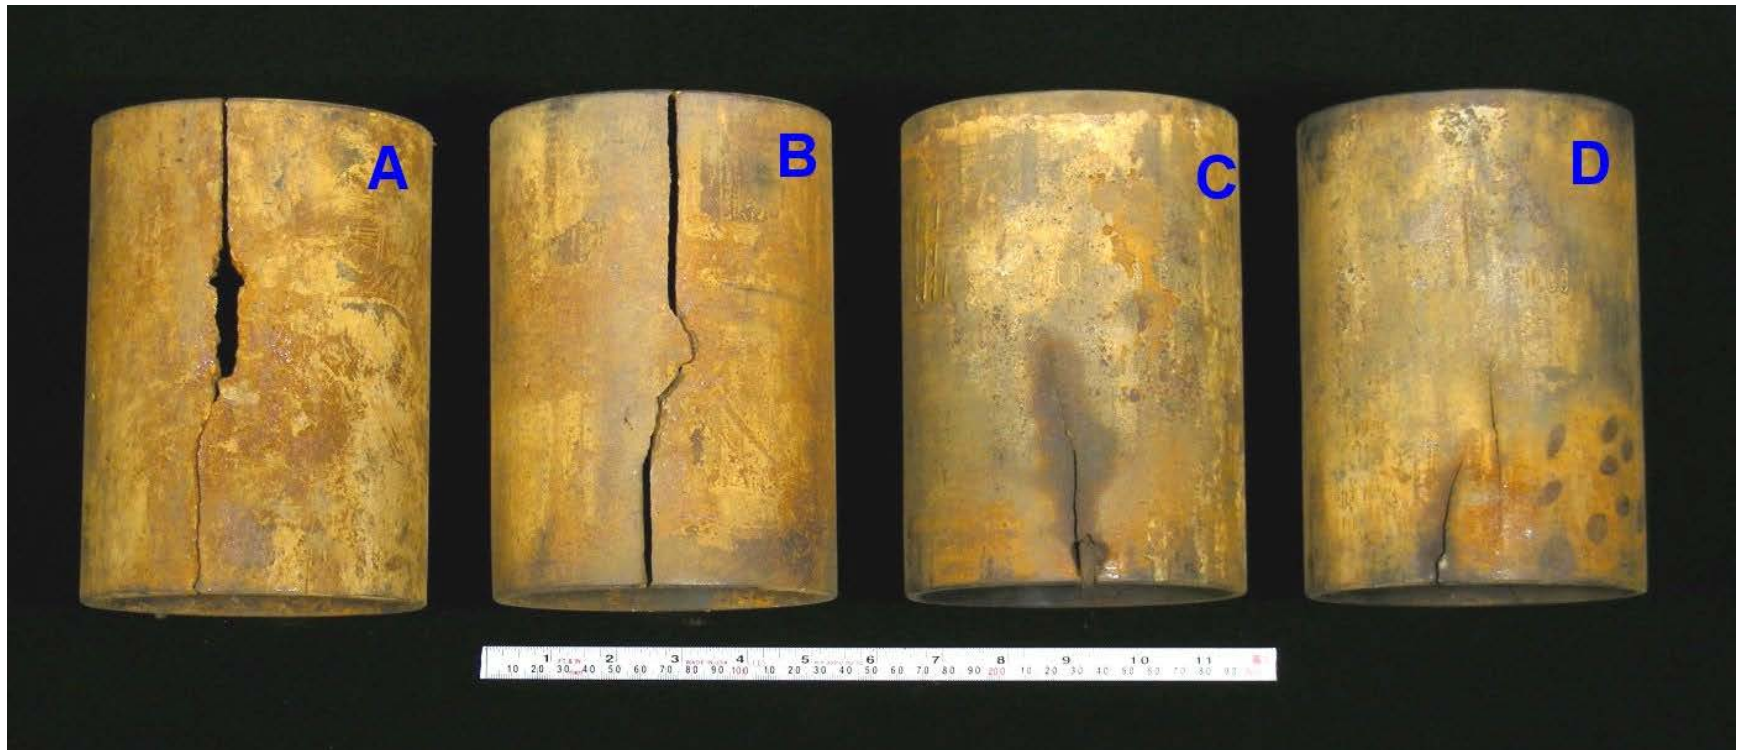
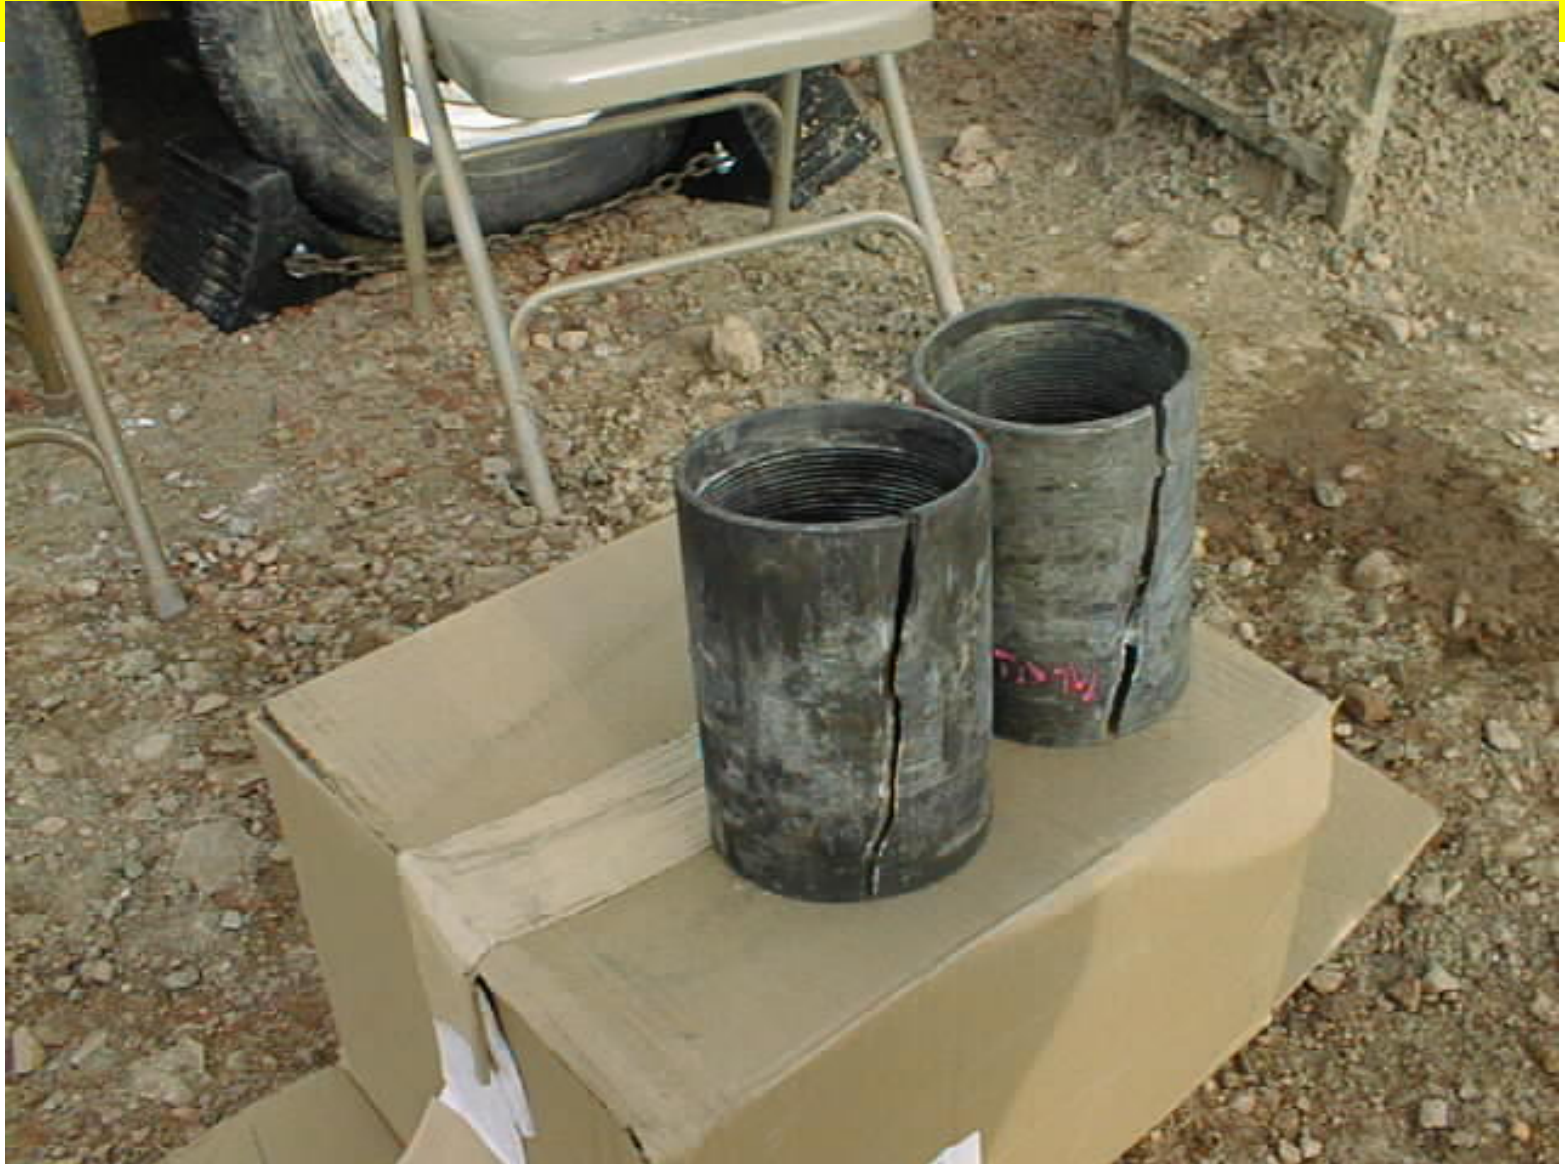
1. Casing coupling failures in P-110 casing, horizontal, multi-frac environments

- Couplings can be located anywhere in string
- Coupling experiences a longitudinal split
- Time of failure is usually after cementing to during frac job
- No evidence of abuse or improper makeup
- Often cause to abort a frac stage
- Can be associated with trace amount of H_2S , but H_2S not required

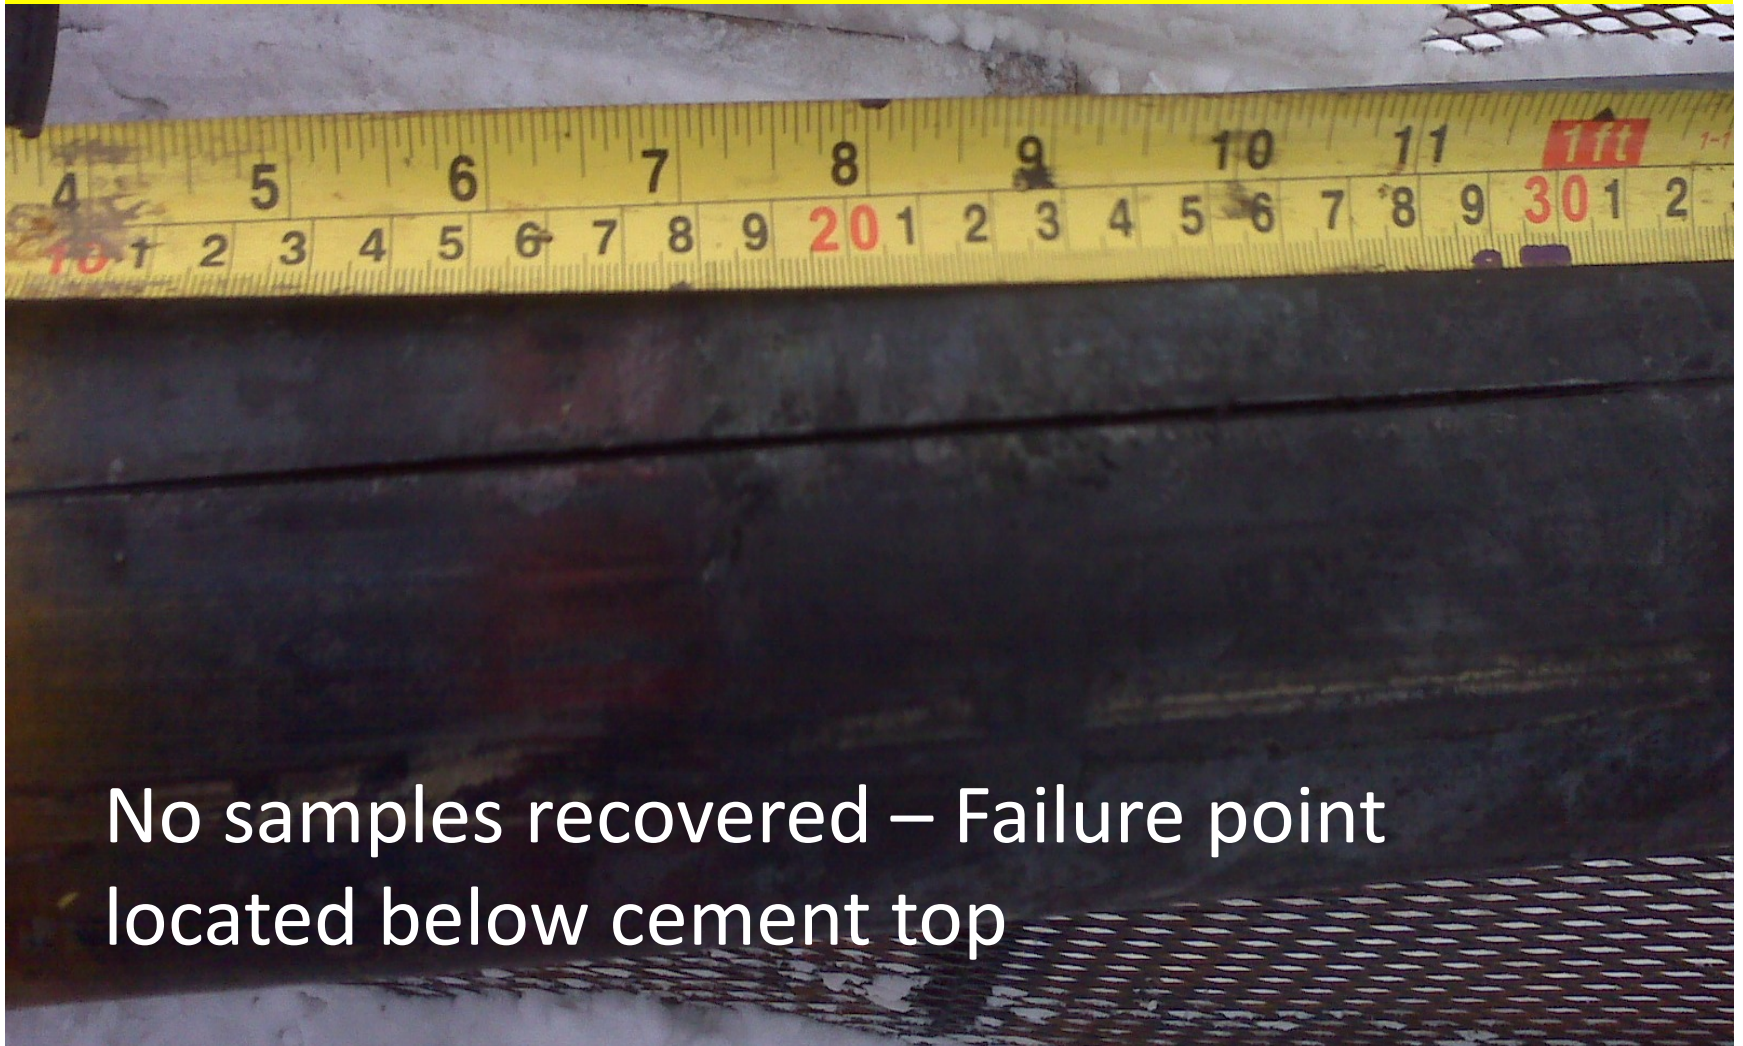
2. Split failures near heel after multiple frac jobs

No samples recovered – Failure point located below cement top

- Wellbore conditions
 - Usually occurs after multiple frac treatments
 - Usually in the horizontal near the heel
 - P-110 material – not L-80 material
 - Water/sand fracs, spearhead w/ HCl acid
 - Wells have not been flowed back or produced
 - High pressure, high rate fracs

- Diagnosis
 - Appears to be related to P-110 properties
 - Acid can cause sulfide stress cracking (SSC) in P-110 material
 - Repeated exposure to HCl acid can allow atomic hydrogen to be absorbed by the steel.
 - Exposure accompanied by lower temperature and high pressure.
 - High yield strength/hardness appears to be make the pipe vulnerable to embrittlement/failure.

- If H_2S content is too high, P-110 grade not appropriate in the well
- Buehler suggests 133 ksi yield strength is an absolute limit for P-110, tube or coupling
- Rockwell 30-31 (depending on source) appears to be a hardness limit, tube or coupling
- Establishing these limits requires special purchasing procedures
- Pipe mills are aware of the problem
- Reputable mills are proactively addressing the problem

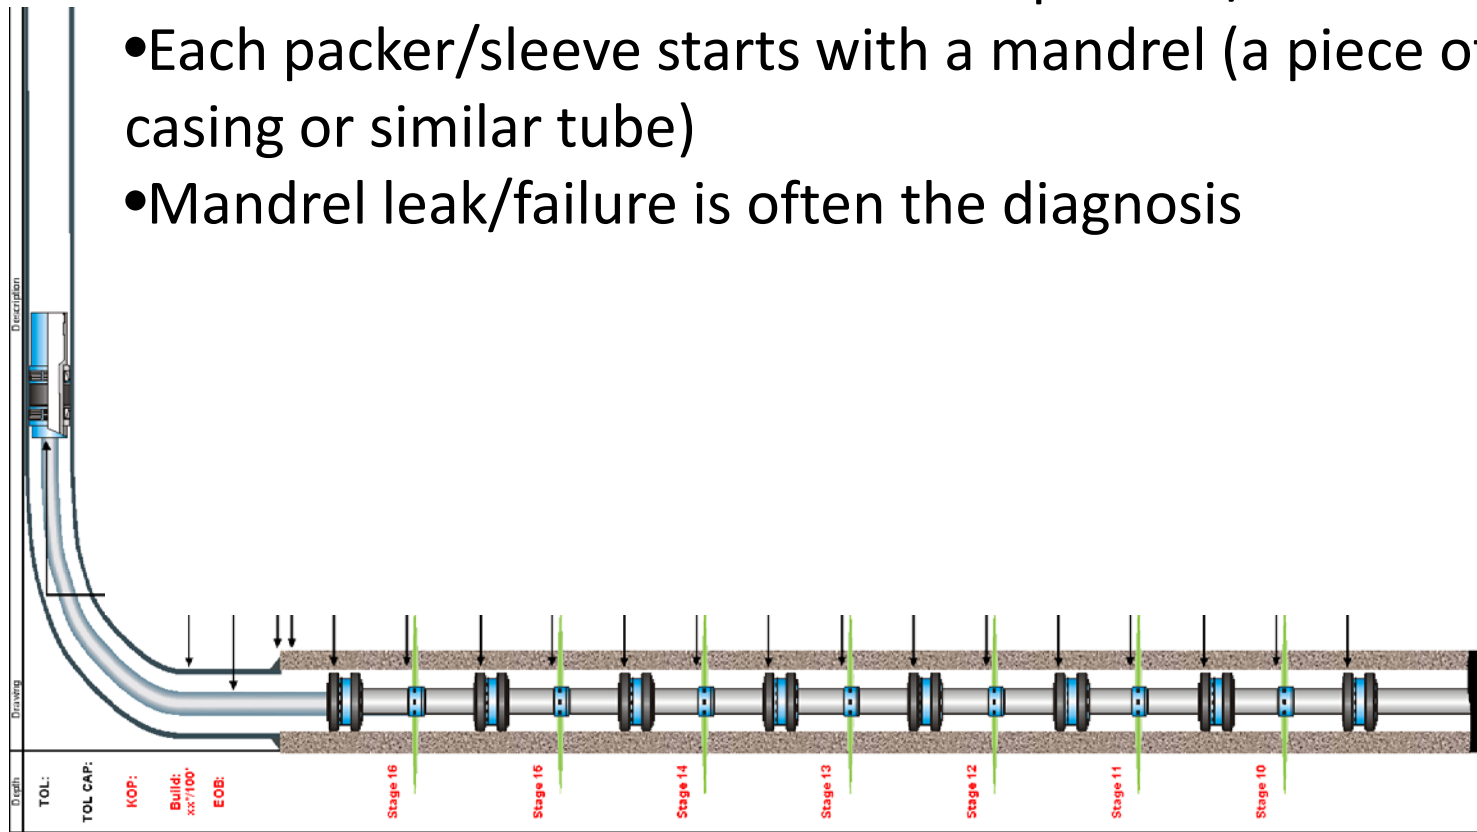
3. Jewelry failures in lateral

- Multiple packers and sliding sleeves - 16 sleeves here
- Leak failures have occurred in the packers/sleeves
- Each packer/sleeve starts with a mandrel (a piece of casing or similar tube)
- Mandrel leak/failure is often the diagnosis

- Diagnosis
 - Possible product design issue – machined mandrel weaker in burst than undisturbed tube
 - More likely: Mandrel metallurgy/heat treat makes the tube subject to same types of failure as 1. & 2.
 - MTR's for mandrel material perhaps do not exist in vendor system
 - Vendor perhaps not buying quality mandrels

- Mitigation
 - If product design issue – make realistic rating calculations
 - Vendor must improve mandrel purchasing procedures / tracking capability
 - Use vendors who can defend quality of mandrels
 - If all fails: Quit using jewelry, fully cement liner and perforate each interval

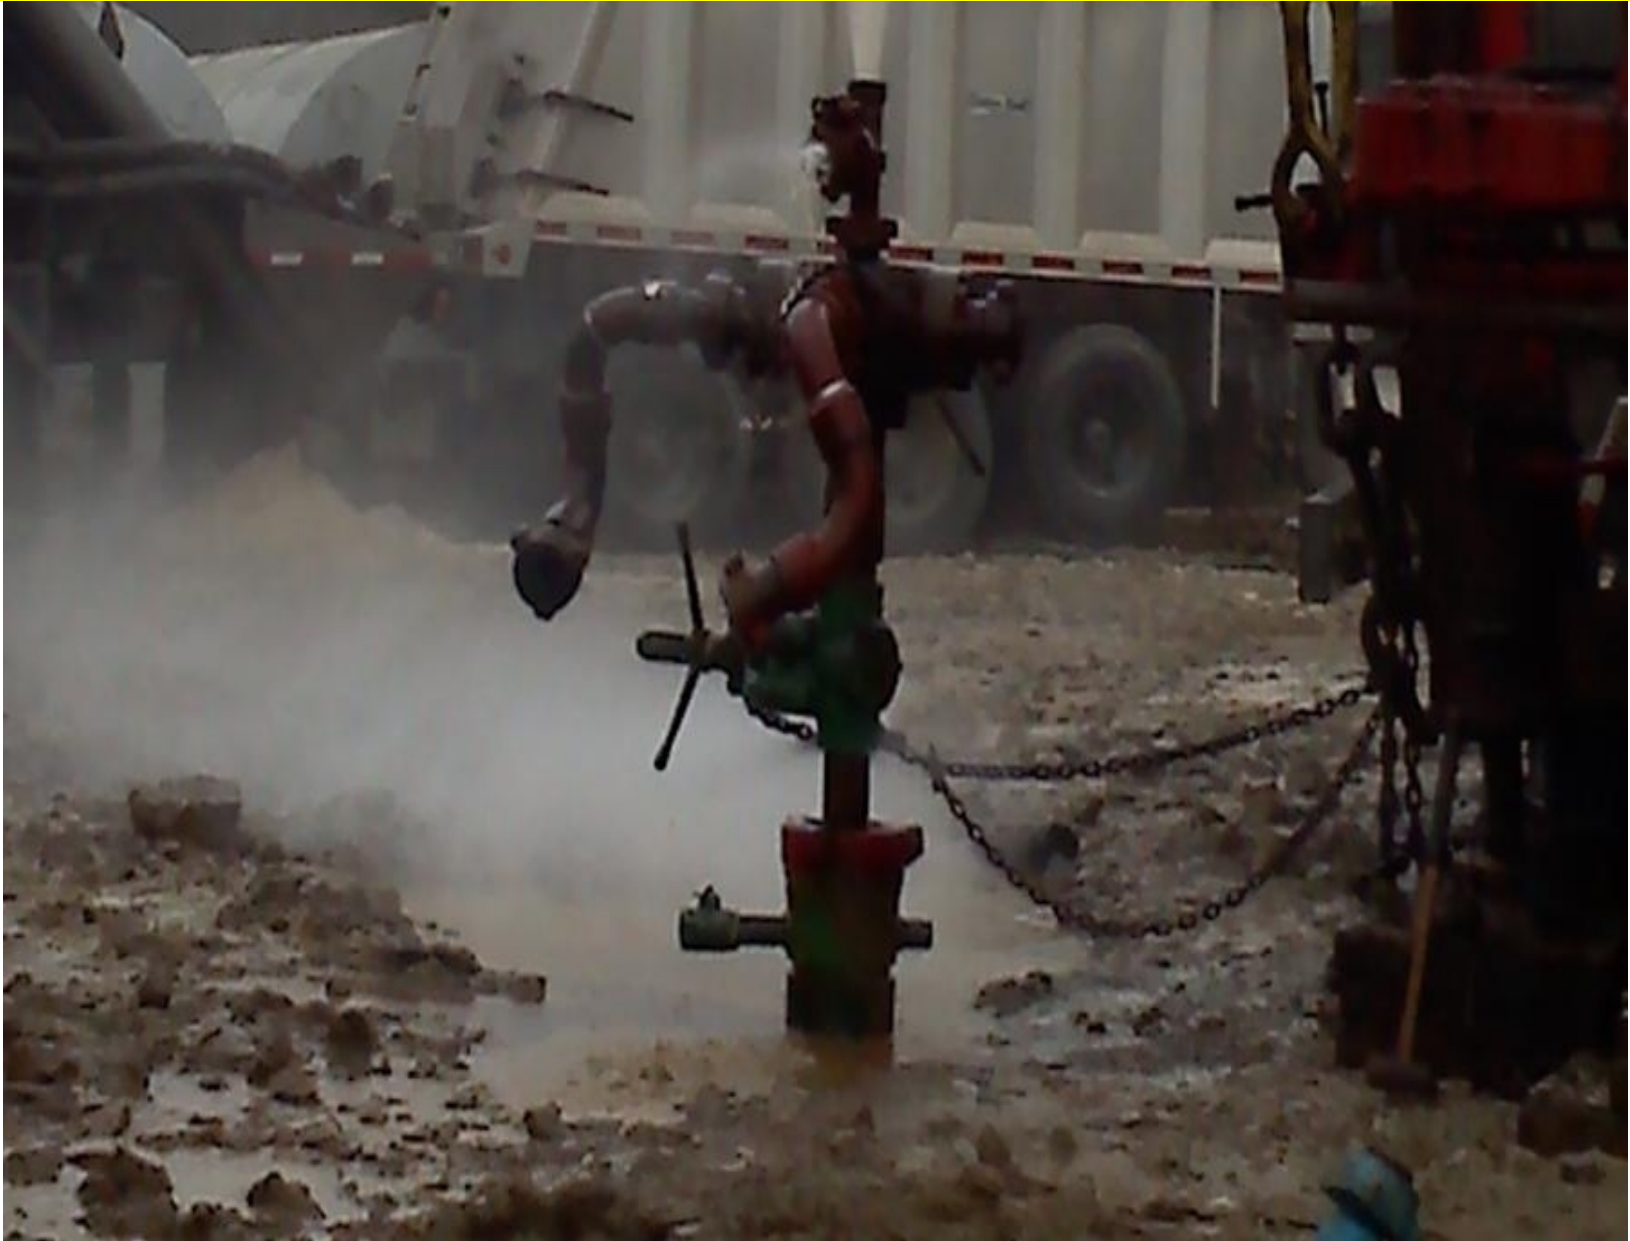
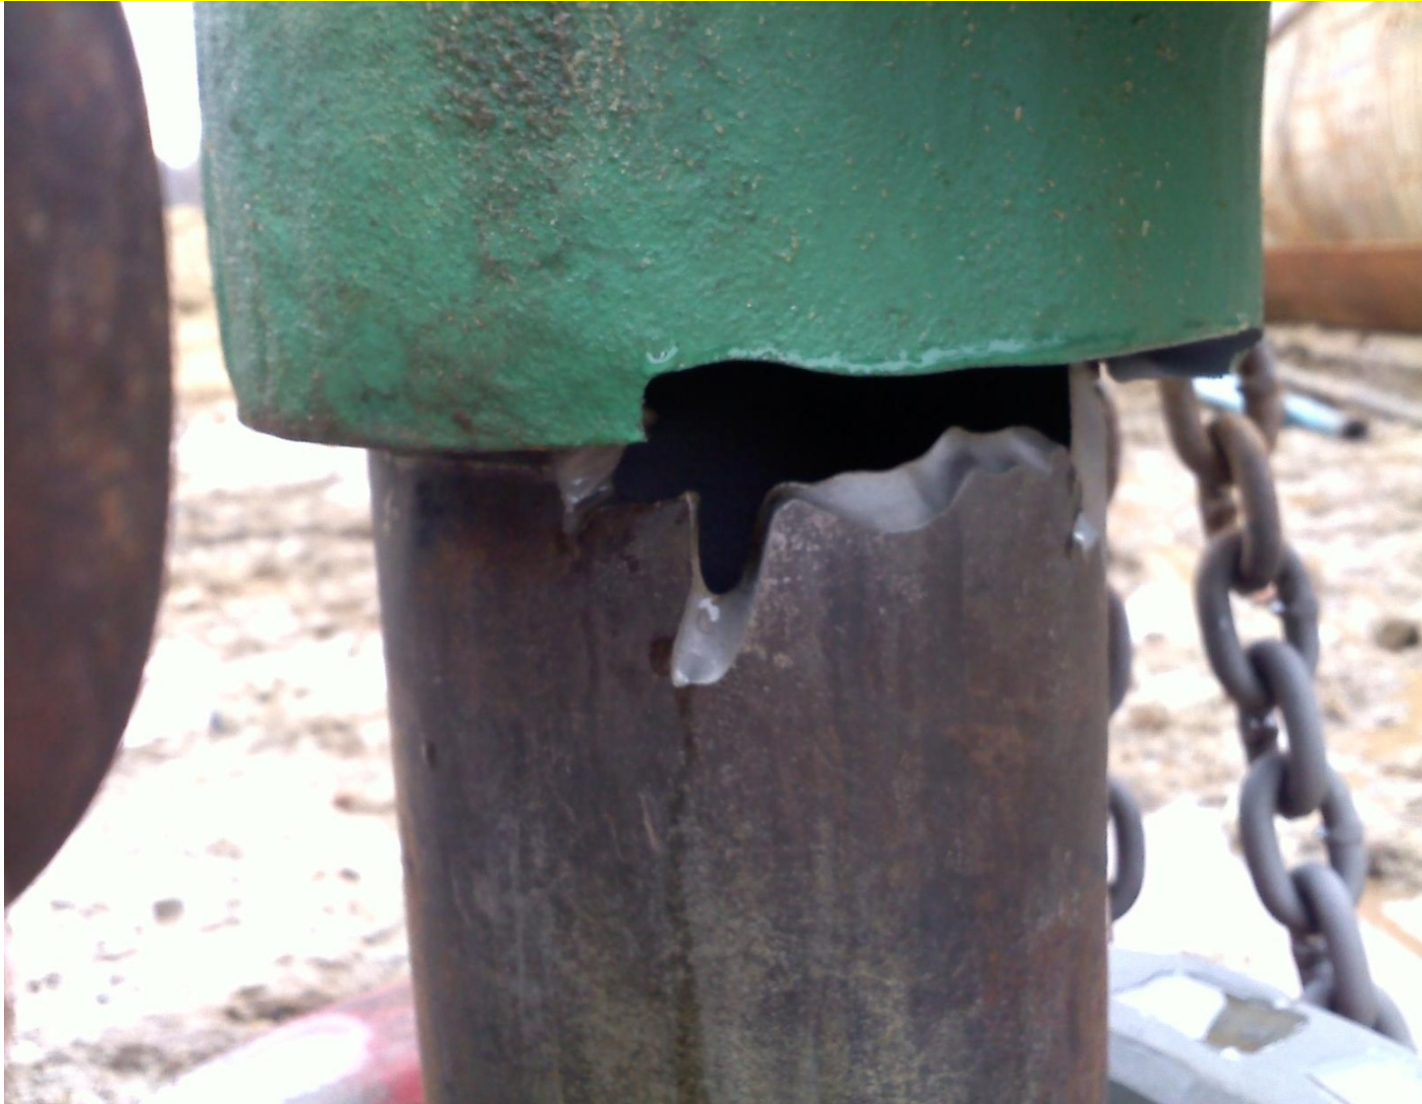
4. Vibrations in wellhead

- Situation
 - Well completed with “Larkin” style wellheads
 - Casing head removed and frac head installed for frac job
 - Casing started leaking “through casing wall” during frac job
 - Job aborted, uncontrolled release of well fluids
- Diagnosis
 - Crack in casing wall at last engaged thread of frac head
 - Vibration induced crack - fatigue

- Mitigation
 - Isolate pump surges from wellhead/frac tree
 - Especially critical where “Larkin” style wellhead equipment is used
 - Use sufficient swings in Chiksan to isolate frac tree from long pulsing lengths of pipe
 - Chain frac tree to secure it laterally

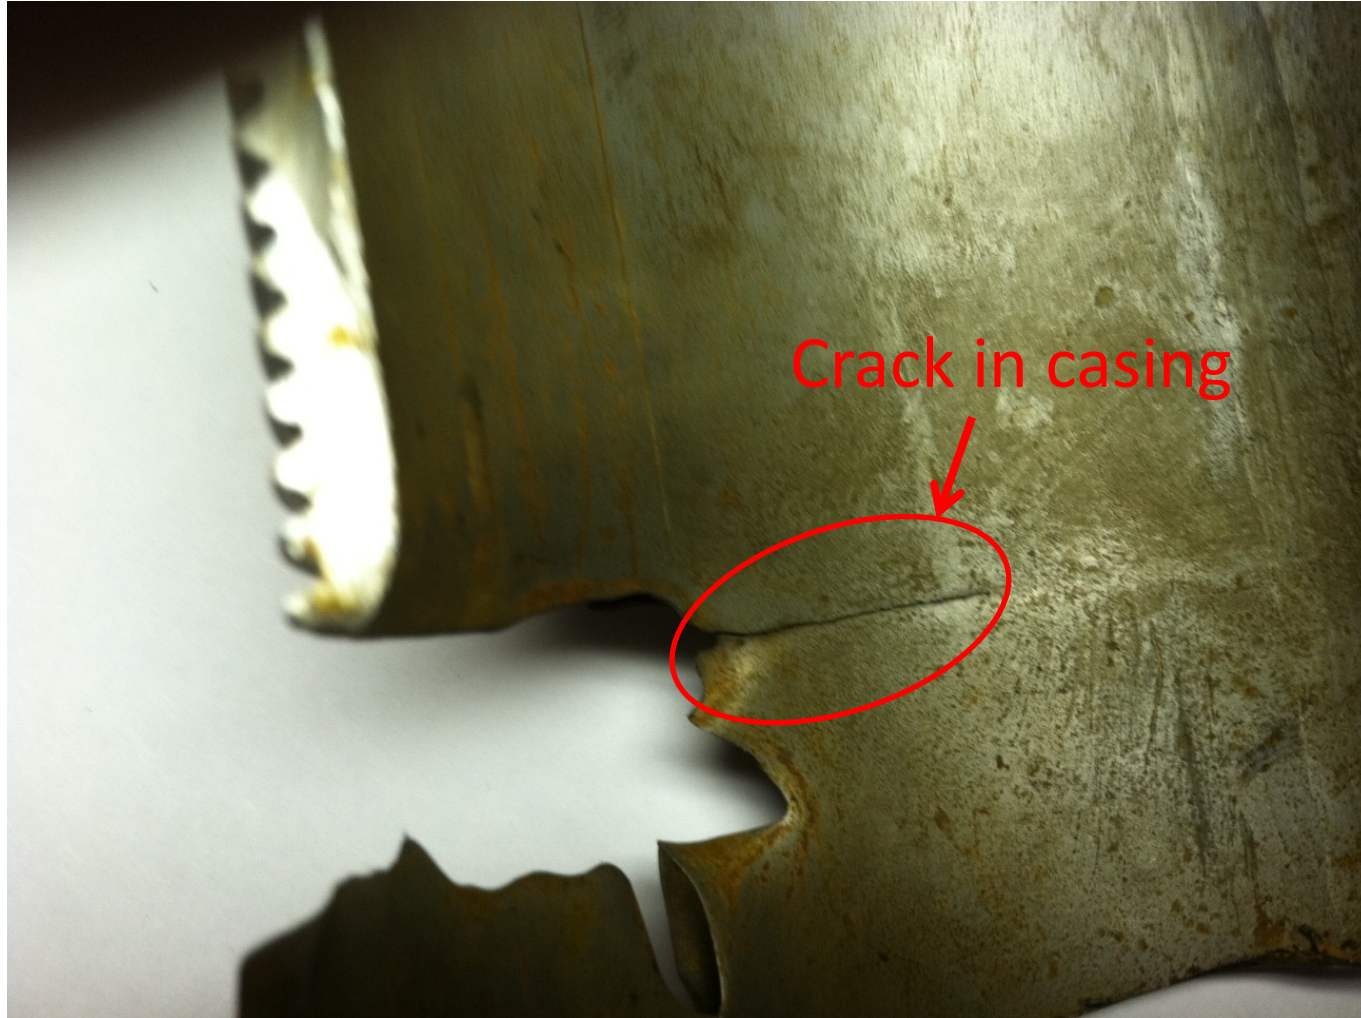
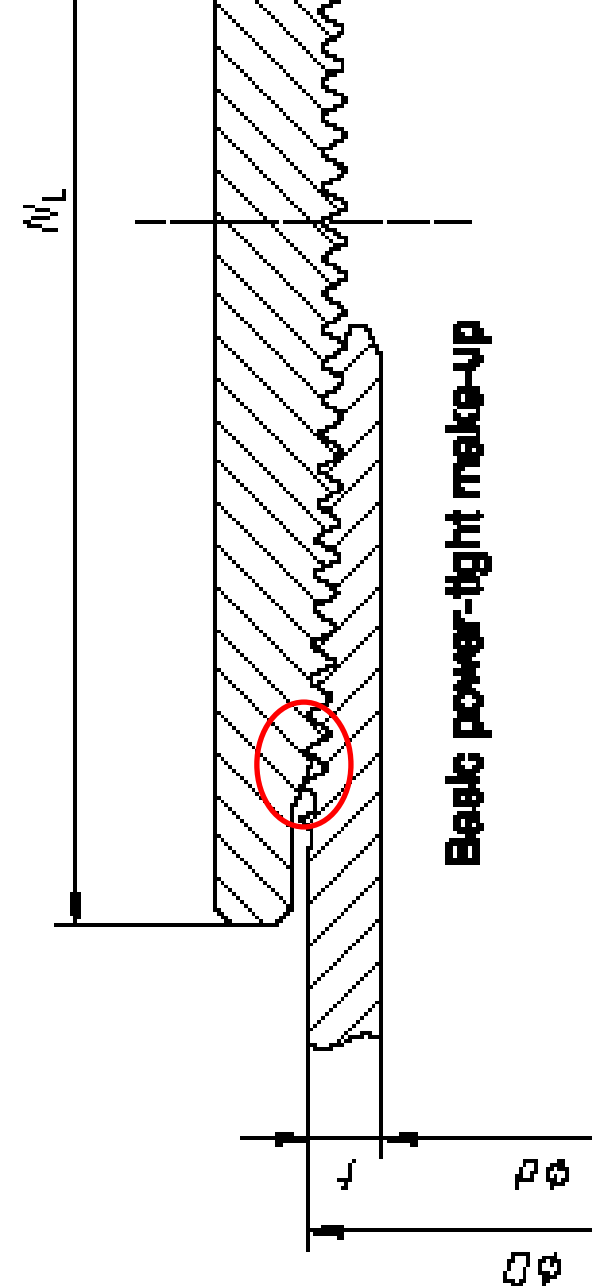
4. Vibrations in wellhead

- Diagnosis (continued)
 - Pressure/rate pulsations from pumps cause lines to cycle back and forth
 - Frac tree rocks back and forth
 - Reverse bending cycles in thin wall casing. Low cycle fatigue crack initiated at thread root (notch).

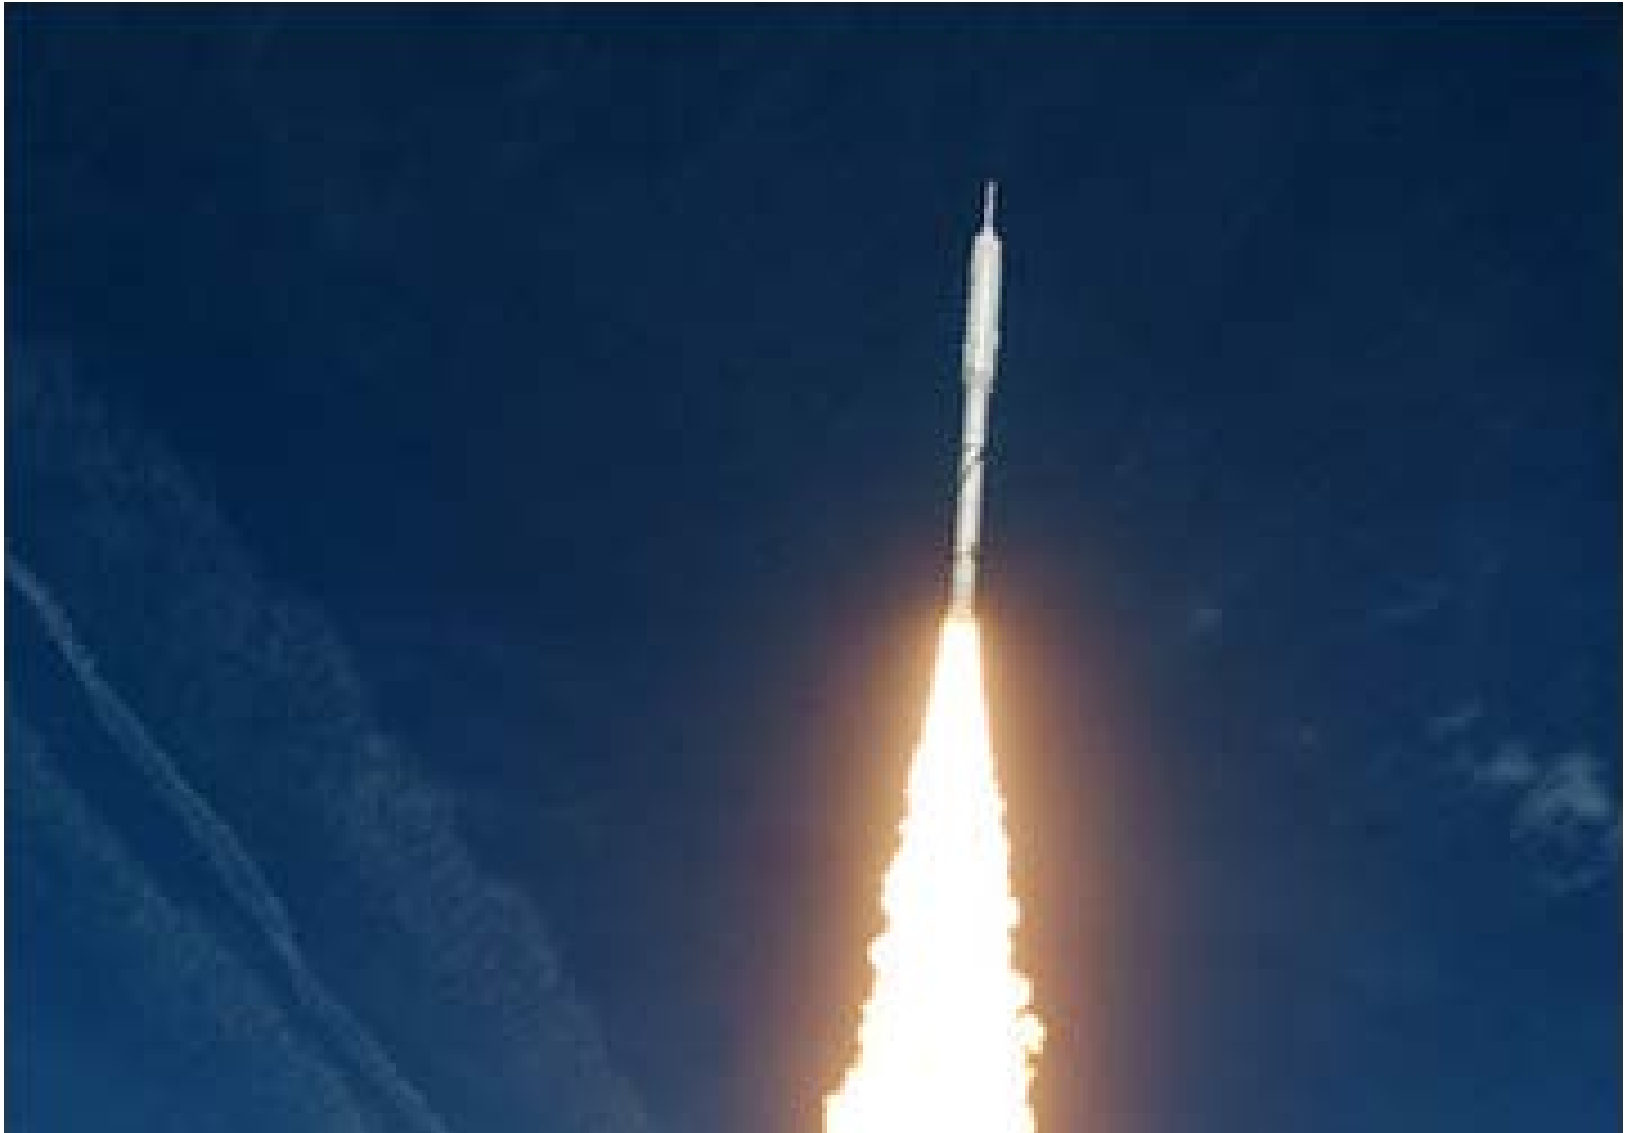
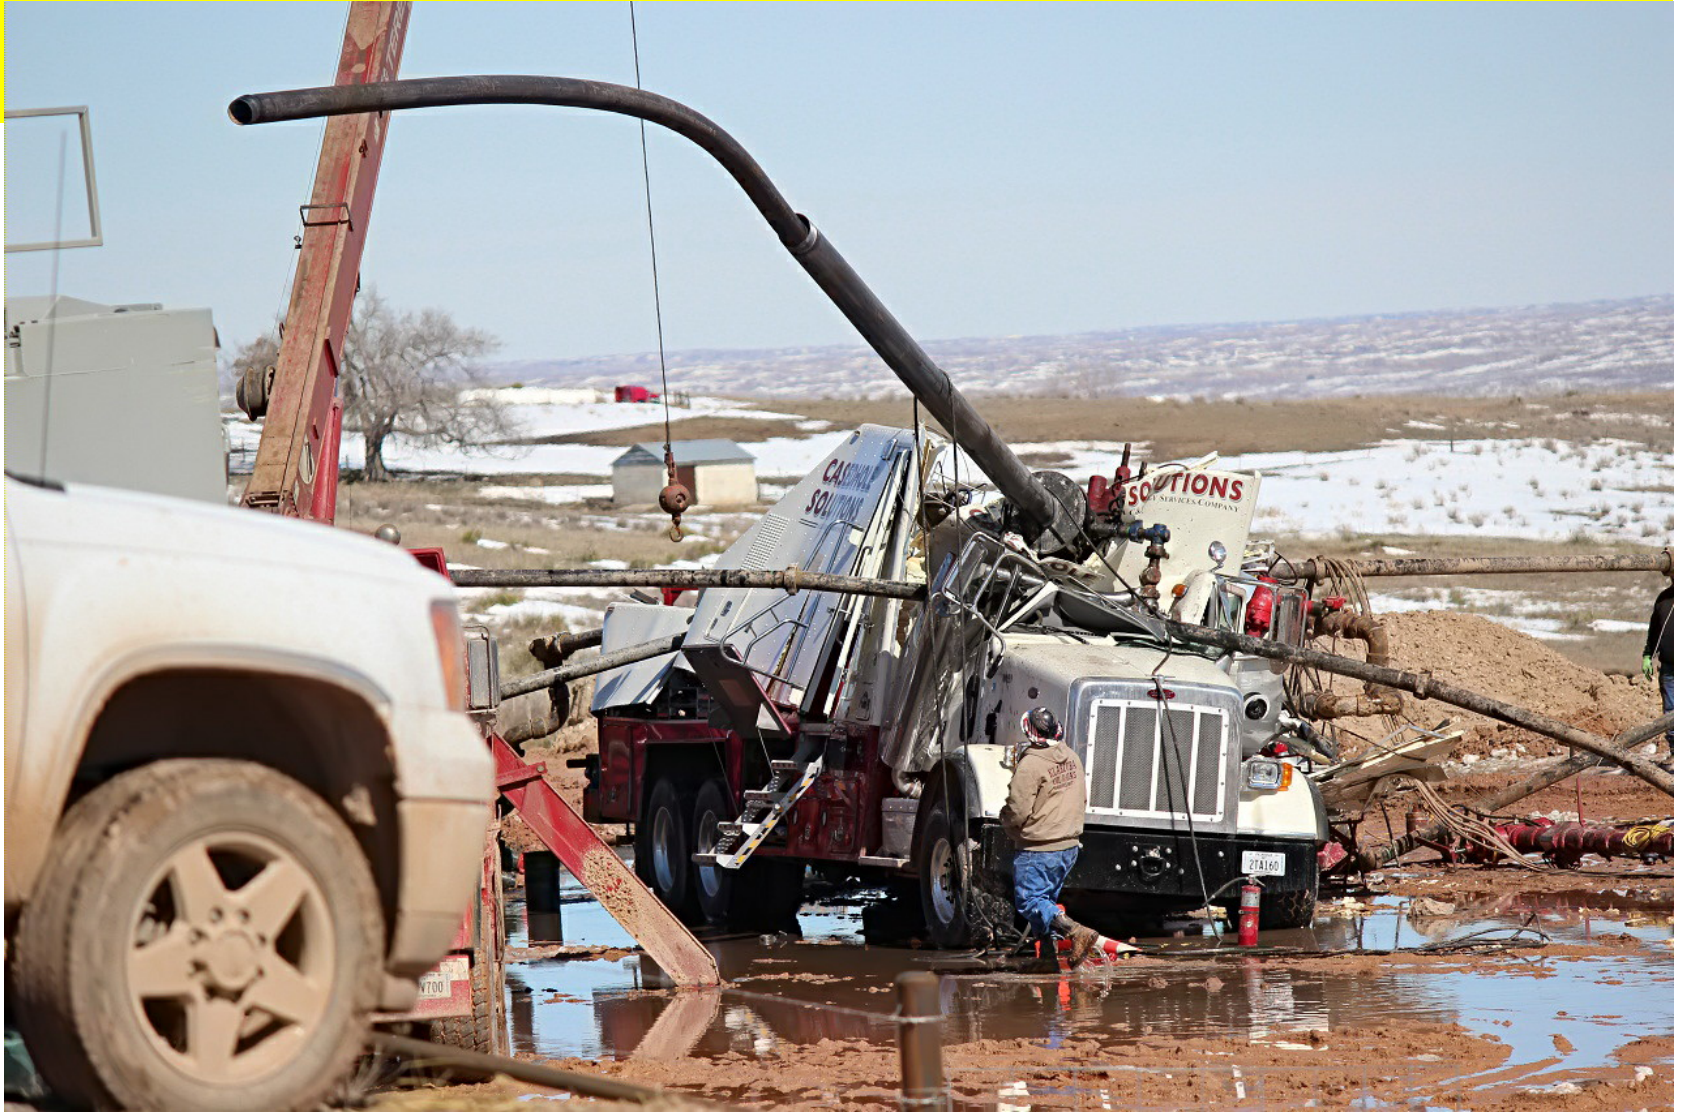
5. Poor joint strength in production casing near surface

- Obviously, a production casing connection failed while frac treating the well
- High pressure and rebound of jumped casing causes surface casing connection to jump
- Mission control: “We now have liftoff.”

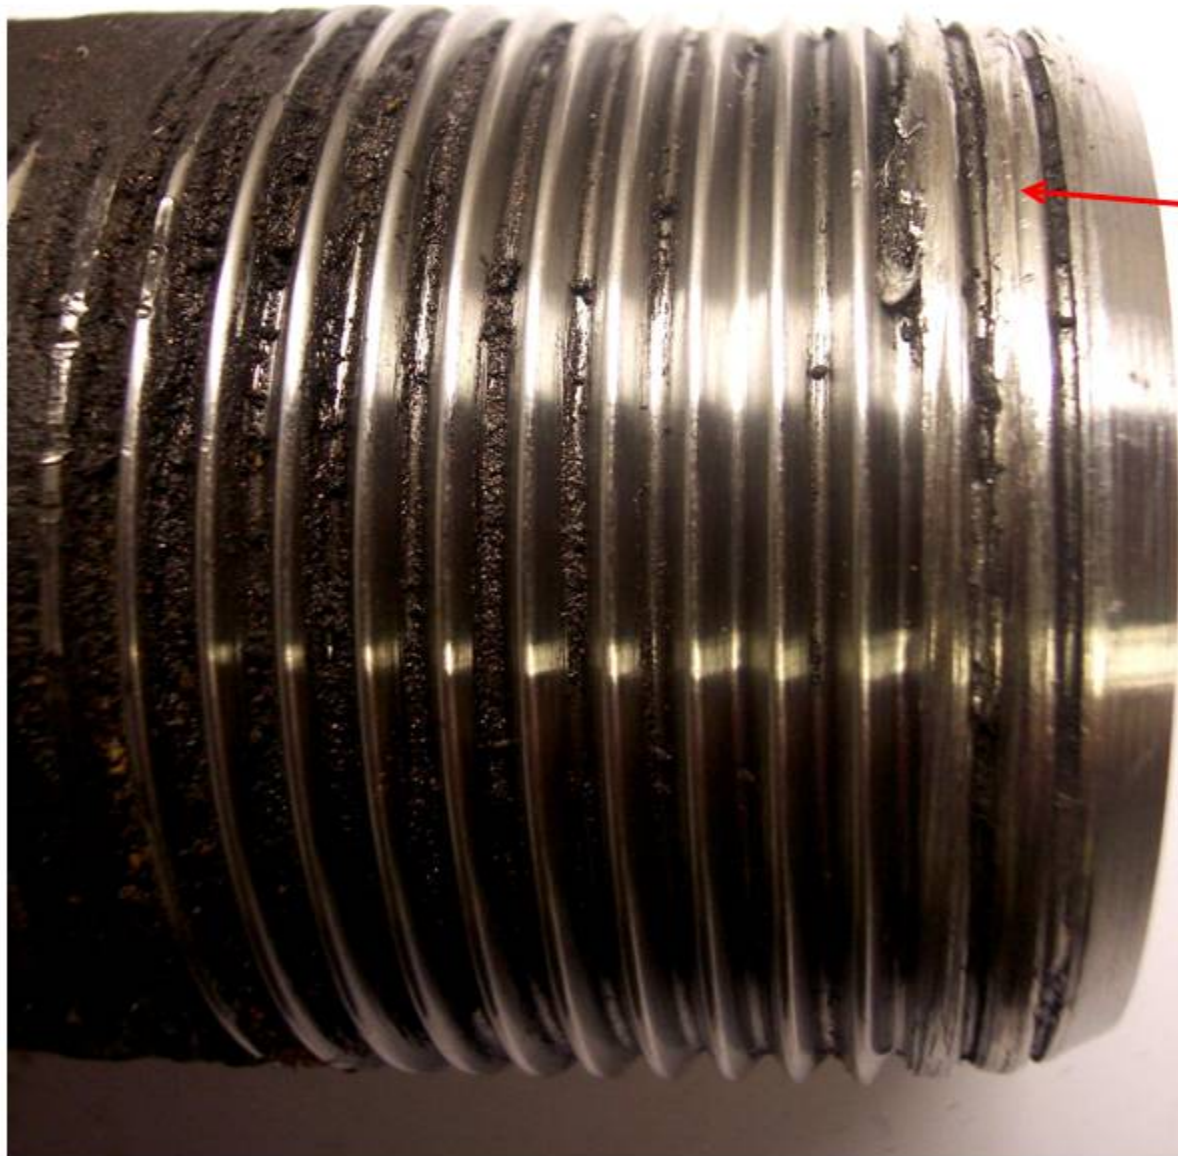
Jumped thread
due to cross-
threading

- Mitigation – Cross threading
 - Use experienced stabber/tong operator
 - If no stabber, level rig for exact alignment of elevators over hole
 - If no tong operator, switch to premium connections – cross-thread resistant thread form

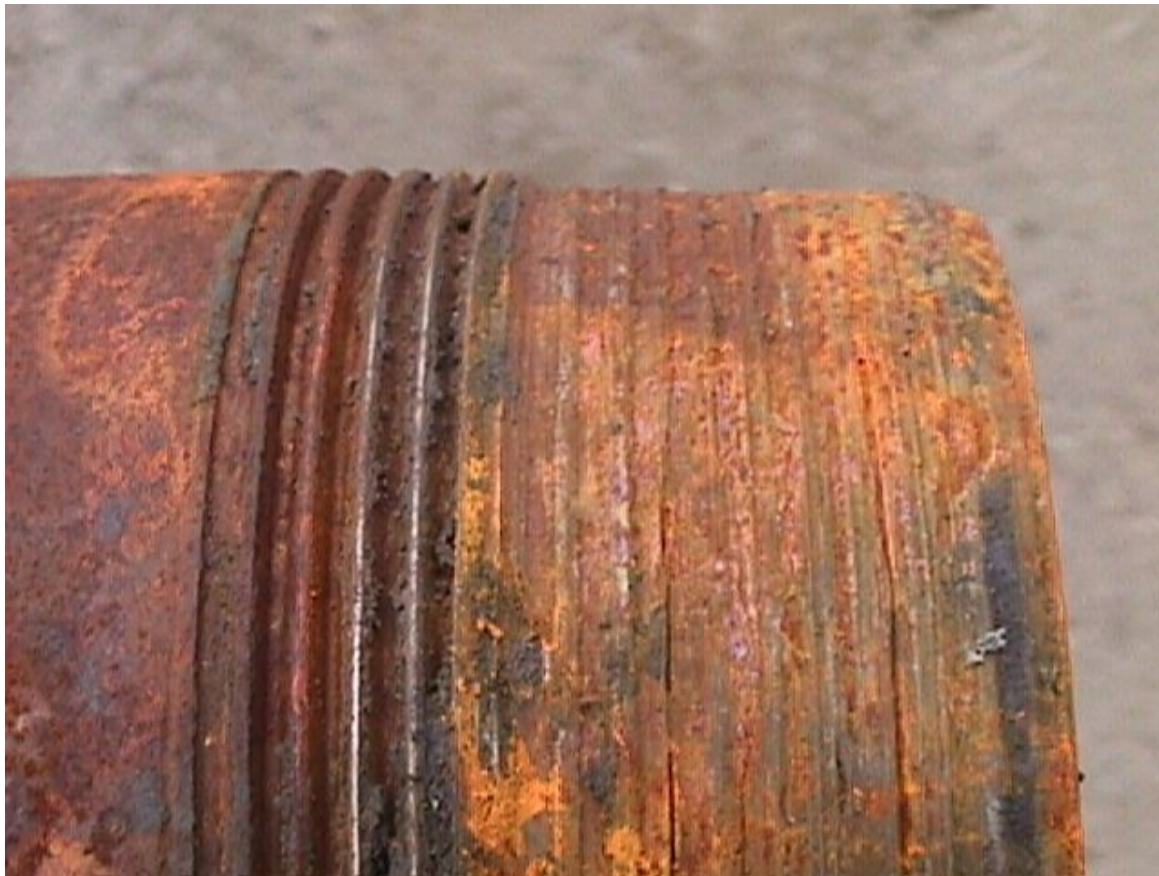
- Diagnosis – Two options
 1. Cross threaded connection – weak connection

1. Cross threading is common while running API connections
2. Best option to avoid cross threading: Stabber (to find sweet spot) and tong operator
3. Recent trend to top drive rigs & safety is taking stabber out of the derrick – increased risk of CT
4. Recent trend to make up csg with top drive – no tong operator – loss of CT awareness

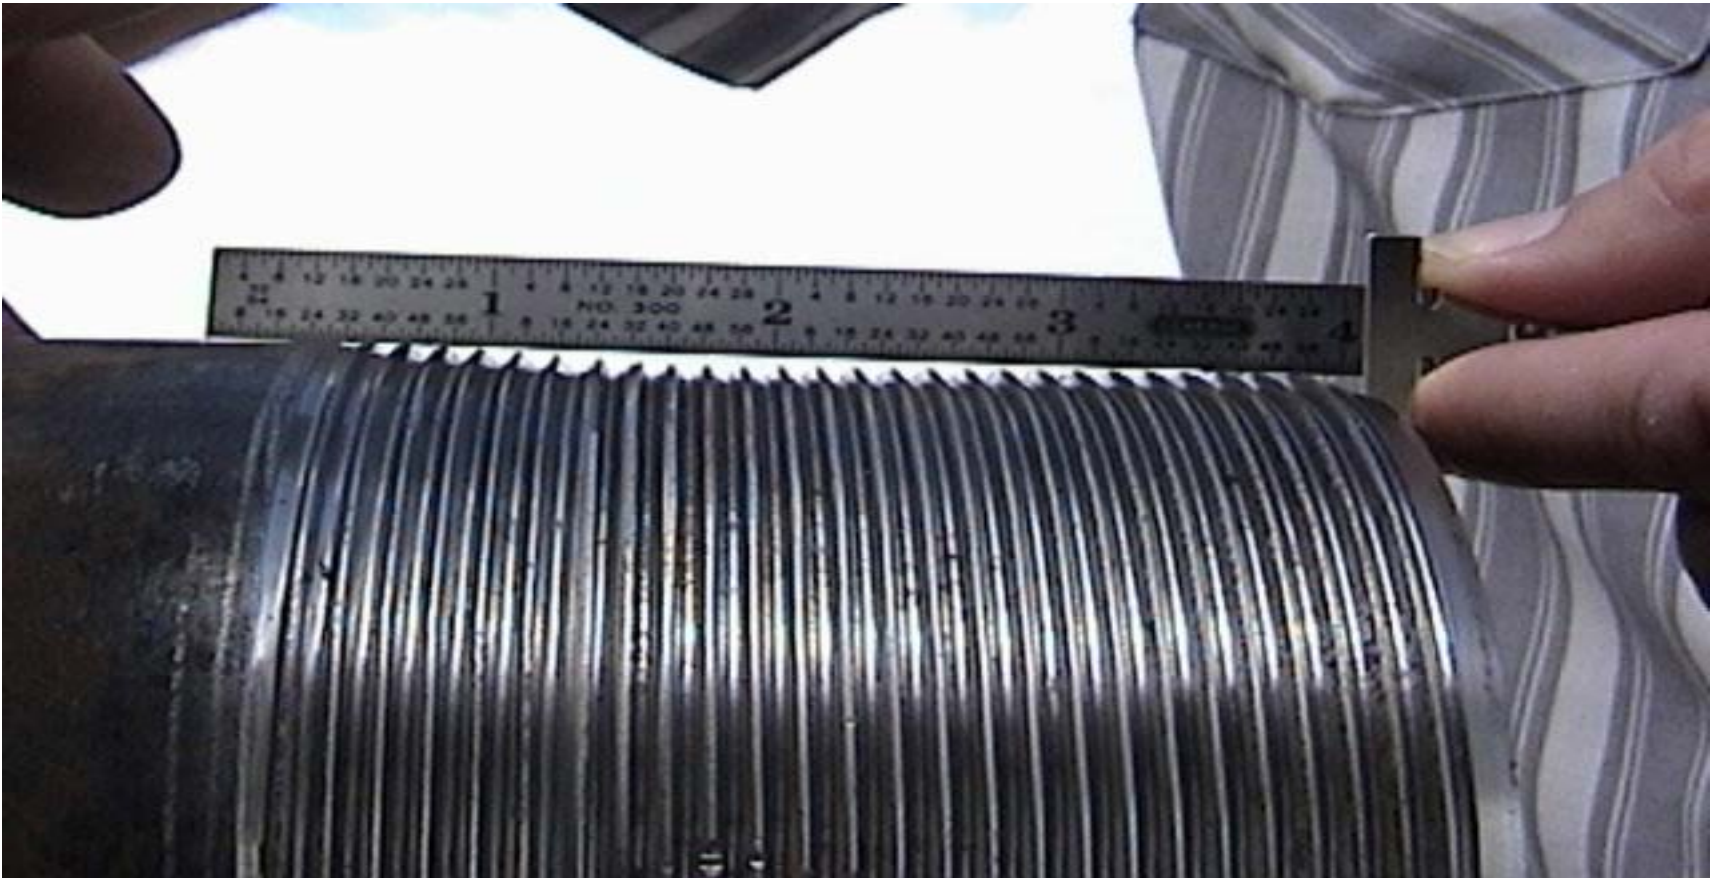
- Diagnosis – Two options
 1. Jump-out – hanging load exceeded joint strength
 2. Jump-out – hanging load exceeded joint strength

- Jump-out pin has been deformed – pinched
- Threads unzipped – Why?

- Mitigation – Jump-Out
 - Make-up to no less than nominal position
 - Set minimum design factor = 2.00
 - In other words – cut joint strength in half
 - Do not allow tension to exceed half of book value - ever
 - Include temperature effect during pump job

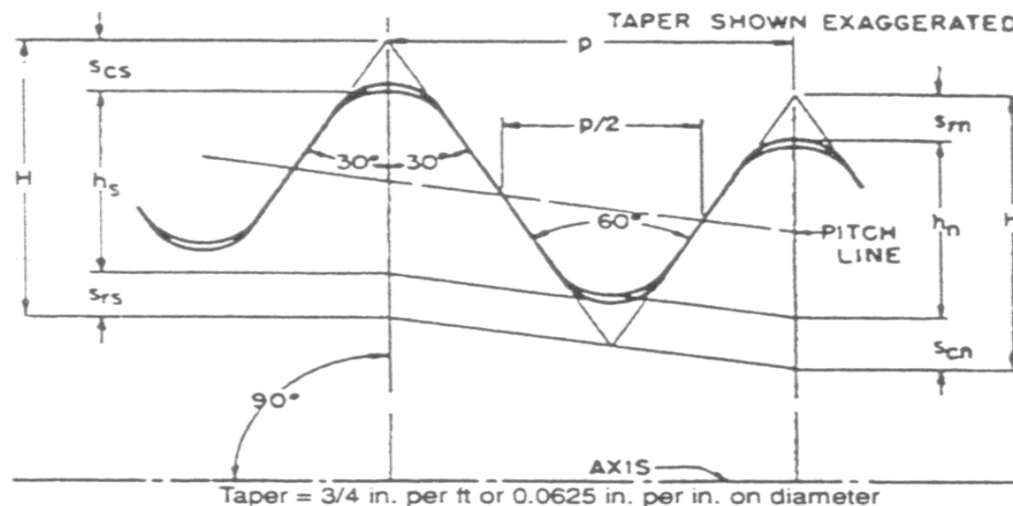
- Large OD pipe & nominal wall thickness (to avoid black crested threads) - thin wall under the pin thread
- Threading tolerances – more thin wall
- 30° load flank
