# Case Study of Drillstring Failure Analysis

Dave Bert, Chesapeake Energy

AADE Mid-Continent Symposium January 20, 2010

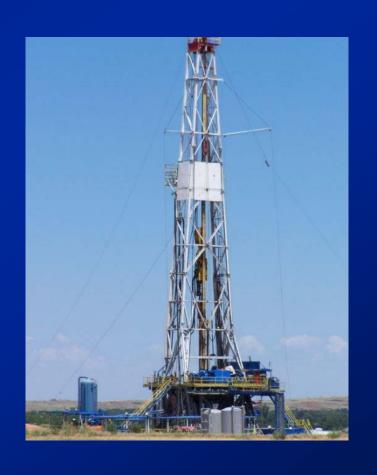
# Well A: 1<sup>st</sup> Drillpipe Failure

- Pipe parted at 6,787 ft while pulling out of hole.
- Lower string assembly fell to bottom.
- Fish was recovered except 3 bit cones.
- Unsuccessful recovering bit cones at 16,525 ft.

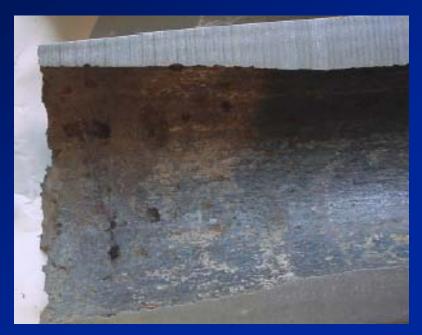
ID Corrosion pitting.

- Well B had 0.09-in. deep pitting (25% of wall thickness).
- Pits were not related to failure mechanism.

- Pipe inspection was <u>not</u> the root cause of the failures.
- Failed drillstrings were originally inspected with a mid-level inspection (UT Wall and EMI).
- Slip/upset areas were not inspected.
- For wells with TD >15,000 ft, MPI and UT Slip/Upset inspection is recommended to identify ID corrosion pitting and potential crack initiation sites.

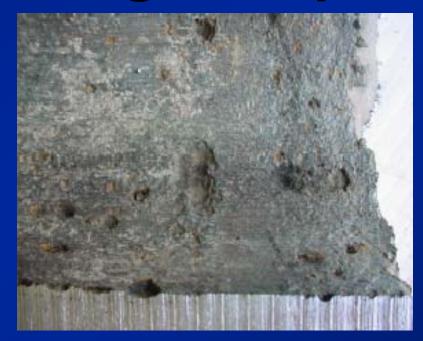
Close-up image.
