Evaluating Cement as a Containment Barrier for Underground Hydrogen Storage

Athar Hussain, Hossein Emadi, Sugan Raj Thiyagarajan, and Diana Maury Fernandez; Texas Tech University

Copyright 2023, AADE

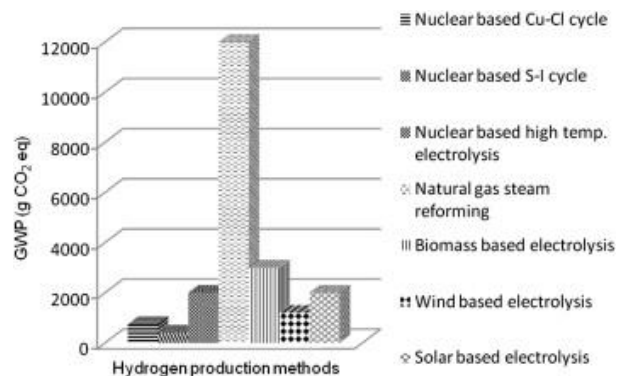
Figure 2 Hydrogen Production Methods (Ozbilen et al., 2011)

Hydrogen is considered a valuable energy carrier because it can be produced using renewable energy sources (Figure 2) and can be used in various applications, including transportation, electricity generation, heating, and industrial processes.

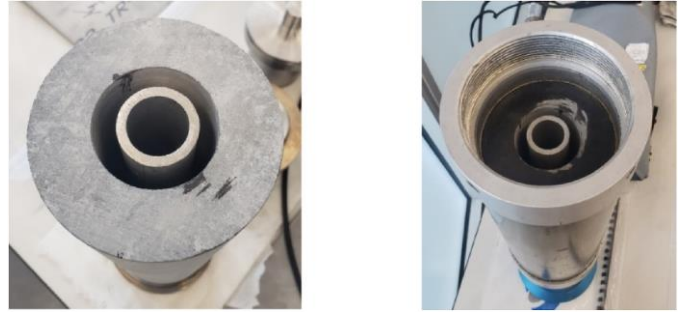
Figure 6 Wellbore Model for cement placement

A precise batch of Class H slurry was produced in accordance with the API-RP-10B-2 regulations (API, 1997), with a slurry density of 15.5 lbs./gal (1.87g/cm³). Lab-scale wellbore for the cement mixture was created (Figure 6). The equipment used for the experiments is a pressure vessel made primarily of lightweight aluminum alloy, which is reinforced with carbon fiber for high-pressure applications. The vessel can

hold a wellbore that measures up to 304 mm in height and 101 mm in diameter.

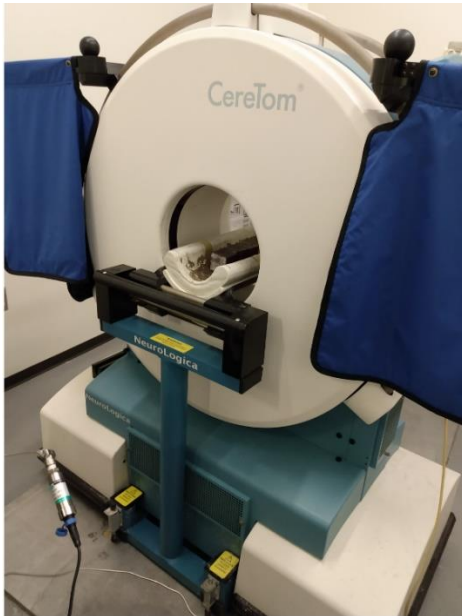
Figure 8 Ceretom CT Scanner

To obtain images, a Ceretom® NL3000 scanner with a maximum slice thickness of 1.25 mm was used, and for hydrogen injection tests (Figure 8), an Ametek Chandler Engineering 2-cylinder Quizix pump was used. The CT scanner has 8 detector rows that can simultaneously acquire 8 image slices during a full rotation. The scanner operates at tube voltages between 100 to 140 kV and current values from 1 to 7 mA, with a rotation time range of 2 to 6 seconds and a

maximum scanning range of 64 cm. Each image slice has a thickness of 1.25 mm. Figure 9 shows the 3D volume image of the wellbore model generated by the CT Scanner.

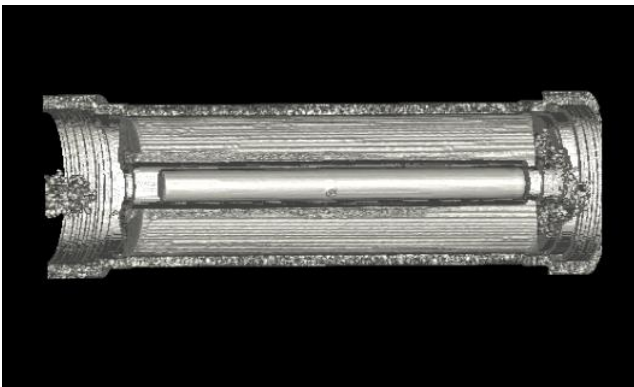
Figure 9 3D Volume image of the wellbore model.

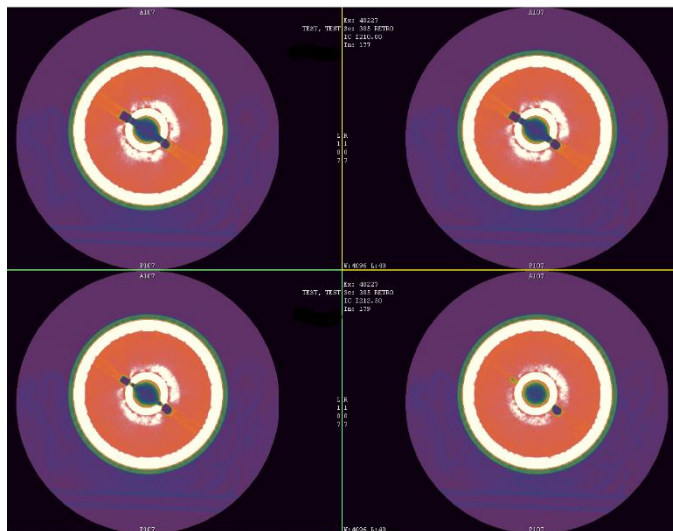
Figure 13 CT Scan images showing debonding

Inadequate bonding between the cement and the casing or formation rock can occur if there is insufficient mechanical interlock or chemical adhesion between the cement and the surfaces it is meant to bond with. This can result in the formation of gaps or voids that allow fluid migration or gas leakage through the wellbore, which can compromise the integrity of the well and lead to environmental or safety risks. Figure 13, Figure 14, and Figure 15 demonstrate the debonding at the cement/casing interface.
