RISER SYSTEM WEAR – AN UNRECOGNIZED DRILLING RISK

Tom Prosser – Maurer Engineering Inc.

Copyright 2001 AADE National Drilling Technical Conference

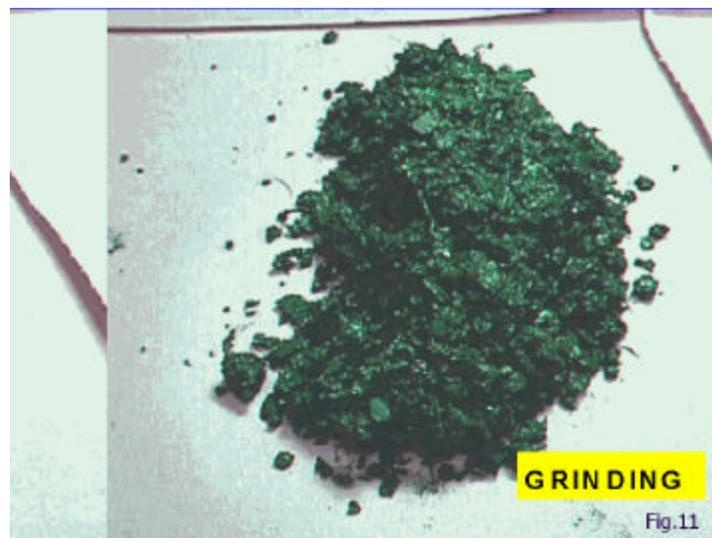
Fig.12

cuttings. Four types of wear can occur: galling, machining, grinding and polishing. Galling is adhesion failure caused by high lateral loads, no solids in the drilling fluid and similar hardness levels in the tool joint and the riser or casing hardness (Figure 9). Machining is caused by the tool joint hardbanding, and specifically, the hard inclusions in the softer overlay matrix. When the matrix wears away, these inclusions are exposed and physically machine the internal wall (Figure 10). Grinding occurs when solid particles roll between the tool joints and the riser or casing. Strong particles, of sufficient size, and the absence of softer particles, leads to surface hardening, heat generation and the brittle failure of the steel (Figure 11). Polishing takes place when fine particles, trapped in a soft material, rub the interior walls and produce a very low wear rate. The relative wear rates of these four mechanisms are important: galling = 100, machining = 10, grinding = 1, and polishing = 0.001 (Figure 12).

Relative Wear

Machining	100
Galling	10
Grinding	1
Polishing	0.01
