PDC Corrosion Resistant Cutter Testing and Validation in the Permian

Greg Andreasen, Chad Conry, Ron Eyre, Fen Yu, Paul Higgins, Mike Siracki and Neil Chaney, SLB

Copyright 2023, AADE

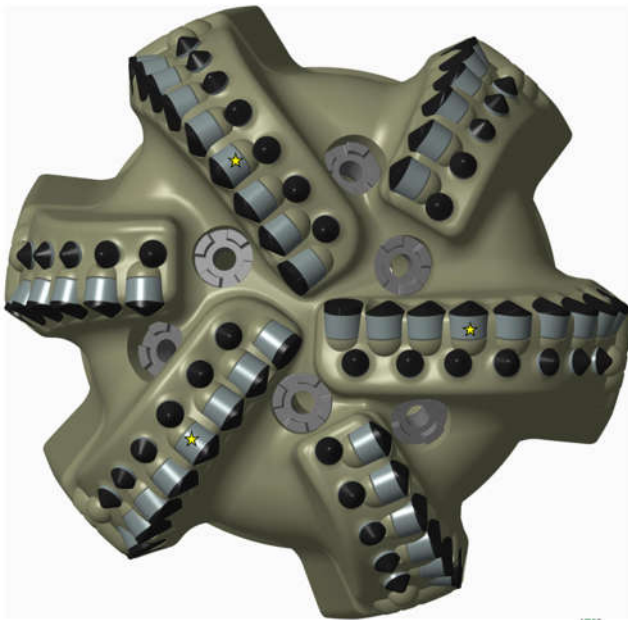
Once the new corrosion resistant cutters had been developed, they were ready to be tested in the field. Partnering with a local operator who had extensive experience drilling in corrosive environments, A test well was identified. The chosen cutters were brazed into a 9.875" 6 blade – 16mm cutter design. Both standard cutters and the new corrosion resistant cutters were strategically positioned on the primary blades 1, 3 and 5, at the 4th cutter position. They were placed between two non-corrosion resistant cutters which allowed for a comparison of cutters facing similar forces and work rates and the impact of corrosion on their dull conditions. The test cutter quantity was limited to three in order to minimize the risk of failure (Figure 6).

Figure 6 Cutting Structure Layout with Corrosion resistant cutter positioned at the location identified with yellow stars

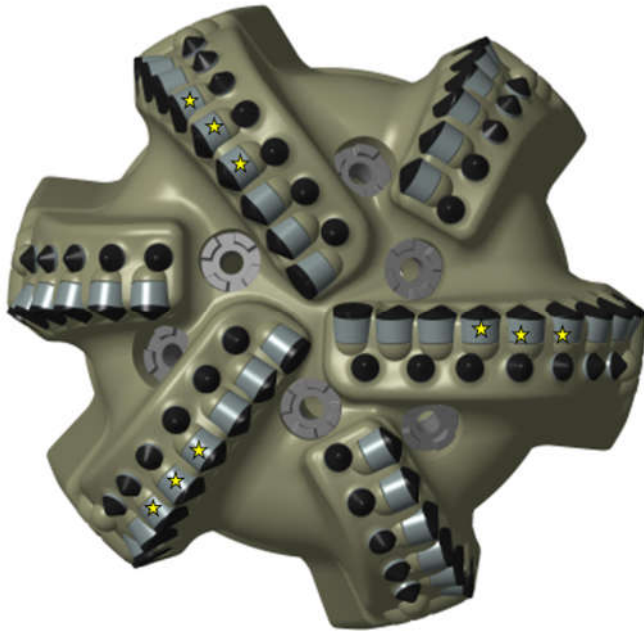
Following the initial positive result, another test was planned to verify the capabilities of corrosion resistant cutters on other areas of the bit. The cutter quantities increased from three (3) cutters positioned on each primary blade to three (3) per blade totaling nine (9) cutters. The goal of increasing the quantities was to further evaluate the cutters in higher work rate areas of the cutting structure. Figure 10.

Figure 10 Second Cutter Test with increase corrosion cutters, positions designated by yellow stars
